**Targeted Brownfields Assessment
Oklahoma Army National Guard
Atoka Armory (Readiness Center)
Atoka, Oklahoma**

**ASTM E 1527-05
Phase I Environmental Site Assessment
All Appropriate Inquiry**

February 5, 2007

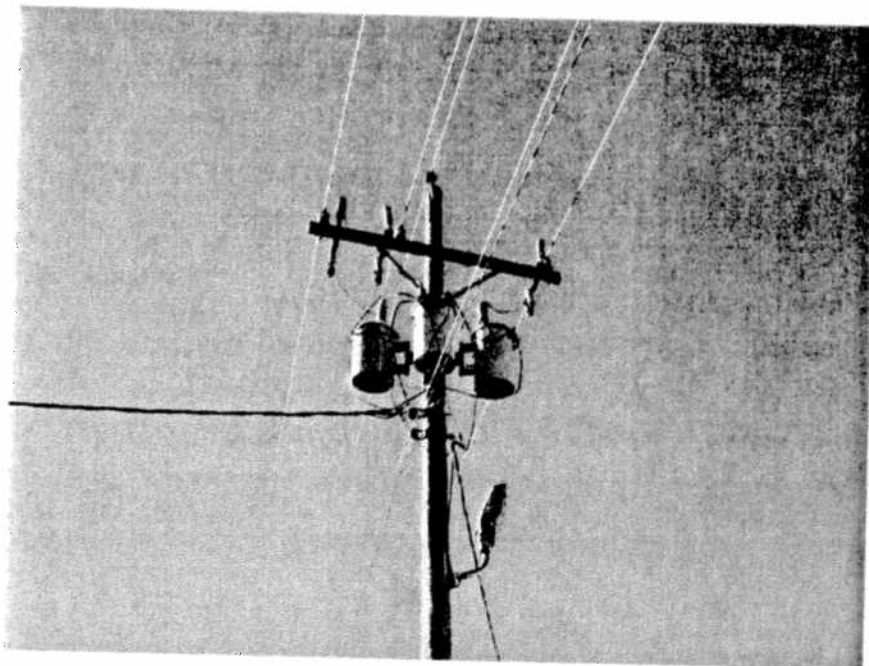
Figure 7. Pole mounted transformers marked “Non-PCB” (not visible in photo).

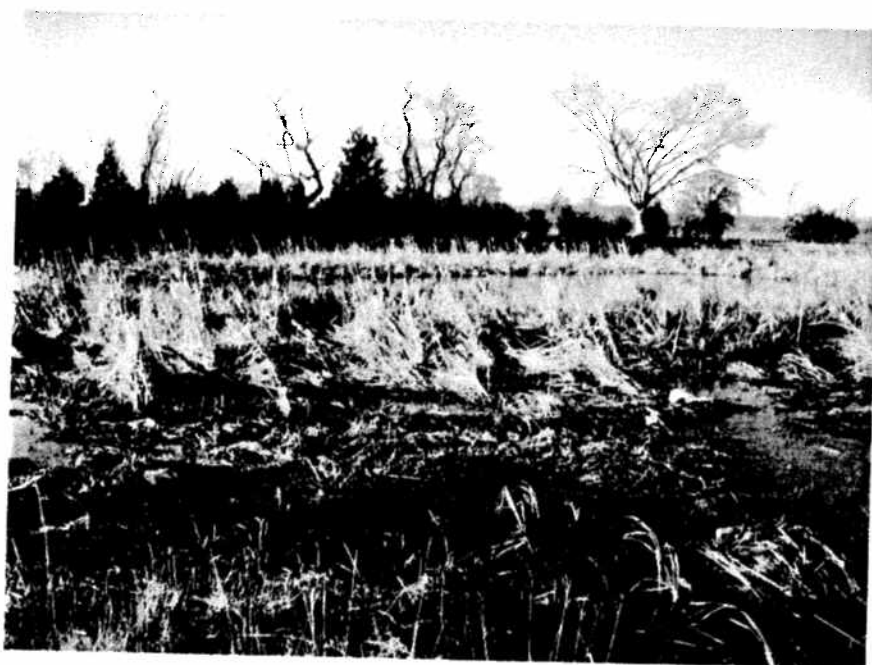
A small pond is located west of the Facility outside the fenced vehicle compound area. According to the City Manager, Don Walker, the pond is natural and has always been located there. The pond receives surface water runoff from the facility. When full, the pond spills over into a series of ditches and culverts to the east and north toward Muddy Boggy Creek. Vegetation around the pond appears dense. The down gradient ditches do not appear to be impacted by contaminants. No evidence of stress due to contaminants was observed during the site visit (Ref. 4). No impact from surface water at the site affects the impoundment. Adequate drainage from the pond prevents flooding impact from the impoundment affecting the facility.

Figure 8. Small pond west of vehicle impoundment - facing west.

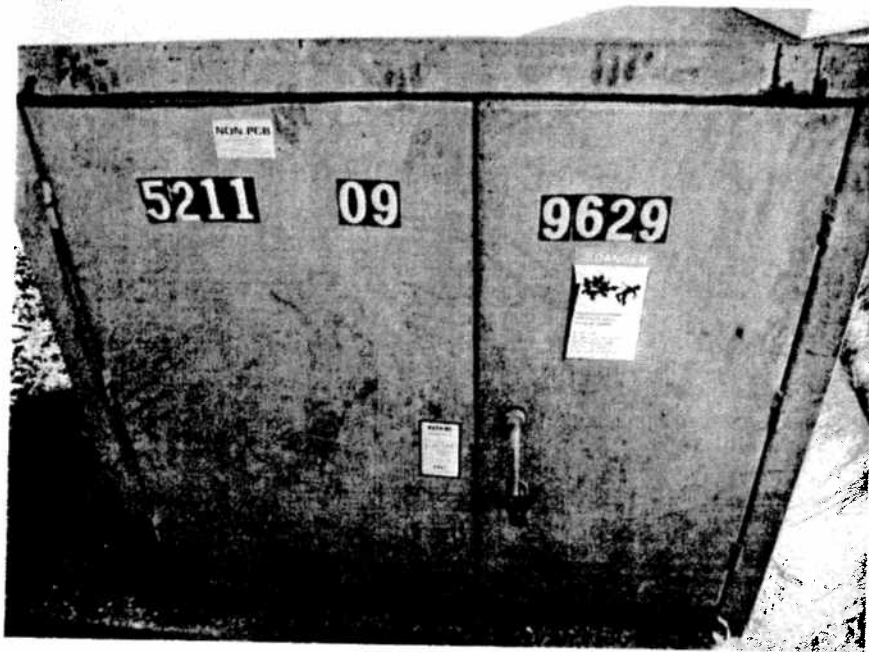
Figure 13. Transformer box on east side of building marked 'Non-PCB'.

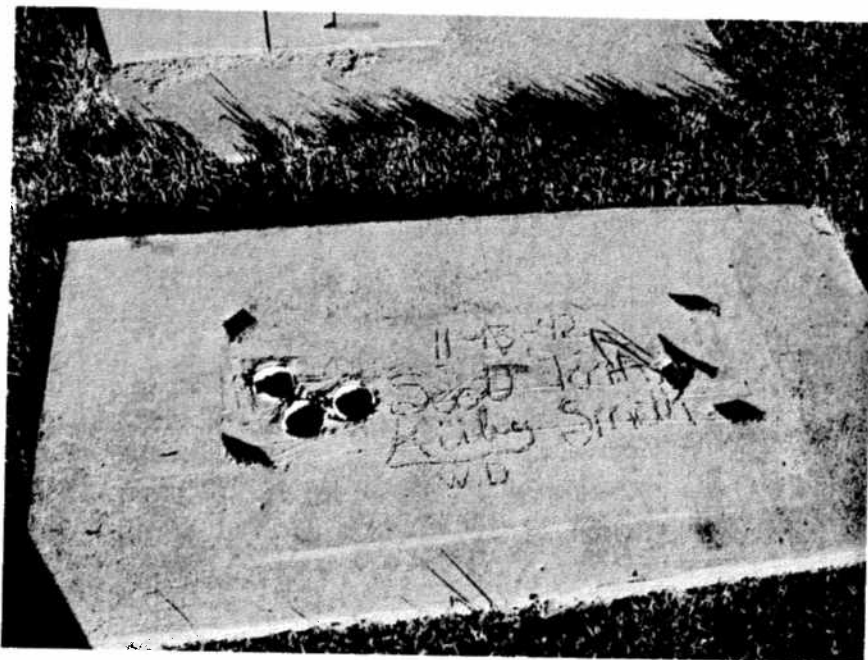
Figure 13 Concrete pad south of transformer box on east side of building. Note open conduit piping - facing north.

located in the grass southeast of the drill floor. The pipe was used as a sewer vent pipe but is now sheared off to ground level. Open electrical conduit pipes are found east of the kitchen area outside the facility adjacent to a transformer box. The remains of a gasoline pump island are located near the closed UST on the northwest side of the vehicle compound. The piping and electrical conduits are capped. An in-ground valve box is located in the southeast quadrant of the vehicle compound area. Two valves in the box control the water supply to two spigots near the fence line. The valves are in the closed position (Ref. 7). The open pipe and transformer conduit should be capped or plugged to prevent any potential migration of contaminants.

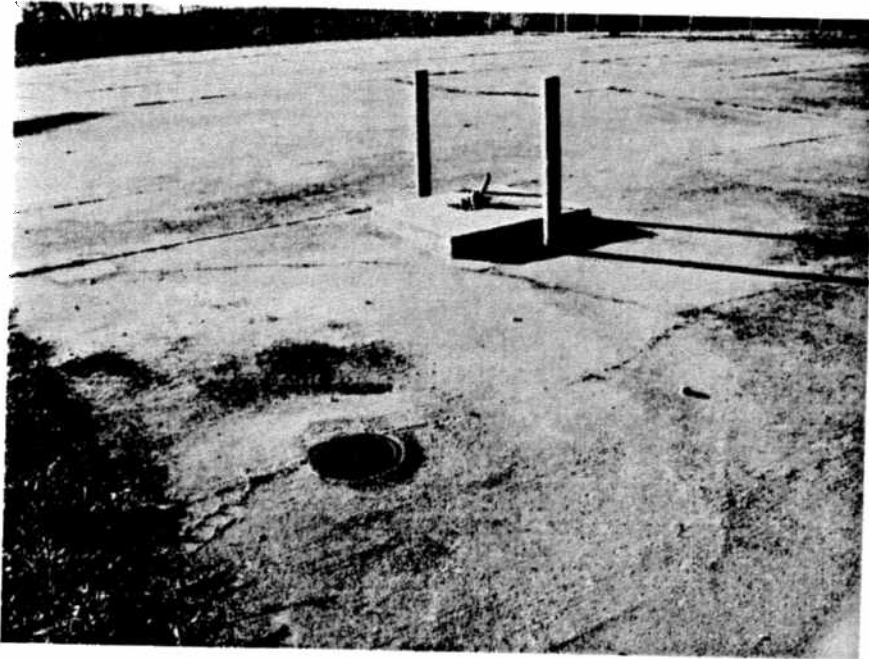
A 5,000-gallon underground storage tank (UST), used to store gasoline, is located on the property. There is no indication the tank leaked. The tank was filled with mud and closed in place under Oklahoma Corporation Commission jurisdiction in 1989. Underground utility lines run along the north and east perimeter of the facility. No evidence of oil or gas exploration or production was observed during the site visit. No oil or gas leases associated with the property were found during the property record search. Floor drains are located in the facility restrooms, kitchen, vault room, and indoor firing range. Wastewater from the readiness center is directed to the City sanitary sewer system. The vault room drain was used to drain condensation from a dehumidifier. The dehumidifier was removed from the vault room by the National Guard. The indoor firing range drain also leads into the city sanitary sewer. According to an interview with the Oklahoma National Guard representative, Sergeant Major Michael Scott, the drain was never used. According to representatives from the City and the National Guard, no septic tanks or cisterns were used at this property. No evidence of septic tanks or cisterns was observed during the site visit. An open four-inch pipe is located in the grass southeast of the drill floor. The pipe was used as a sewer vent pipe but is now sheared off to ground level. Open electrical conduit pipes are found east of the kitchen area outside the facility adjacent to a transformer box. The remains of a gasoline pump island are located near the closed UST on the northwest side of the vehicle compound. The piping and electrical conduits are capped. An in-ground valve box is located in the southeast area of the vehicle compound area. Two valves in the box control the water supply to two spigots near the fence line. The valves are in the closed position (Ref. 7). The open pipe and transformer conduit should be capped or plugged to prevent any potential migration of contaminants.

Figure 18. Former pump island and fill port for UST in north side of vehicle impoundment.

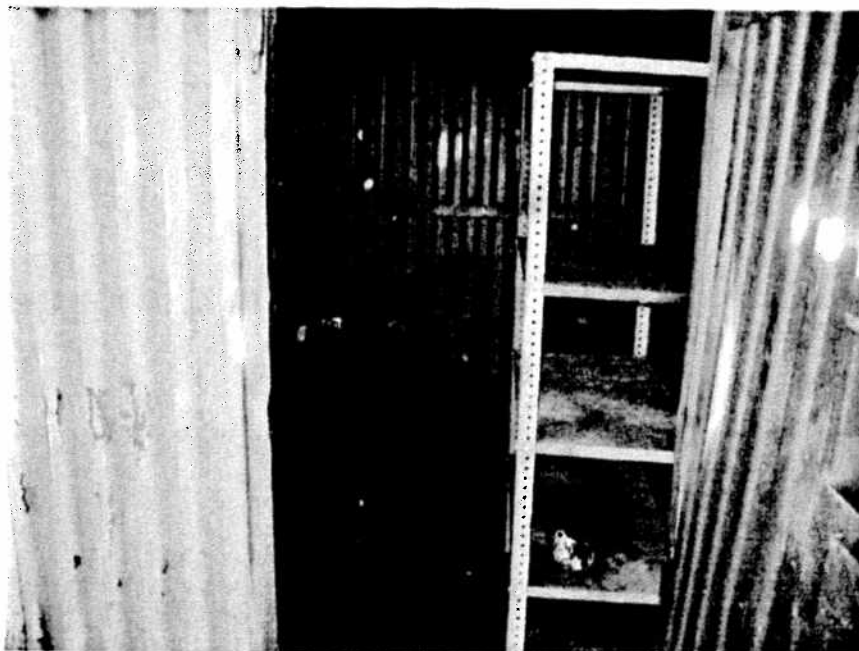
Figure 19. Flammable liquid storage box in the southwest side of vehicle impoundment near IFR bay door.

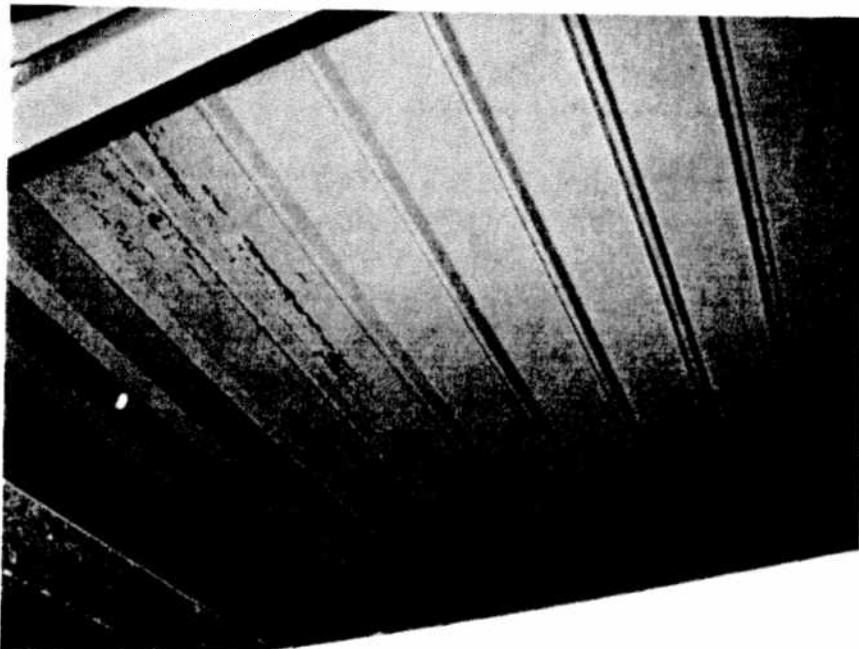
Figure 28. View of plenum above drop ceiling typical throughout the facility. Note minor paint chipping exposing steel primer coating observed in less than 5% of total observed surface area.

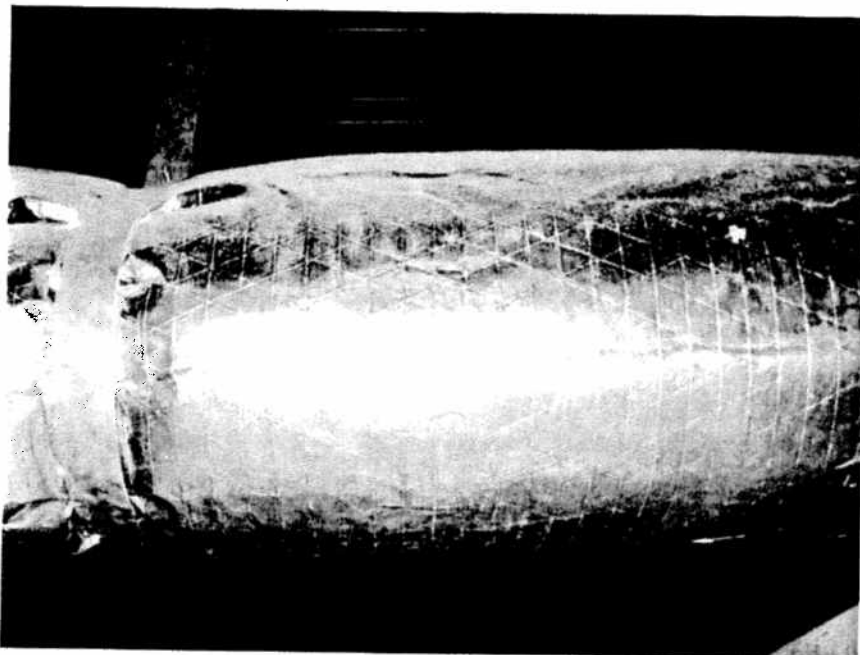
Figure 29. View of wrapped ducting typical throughout the facility.

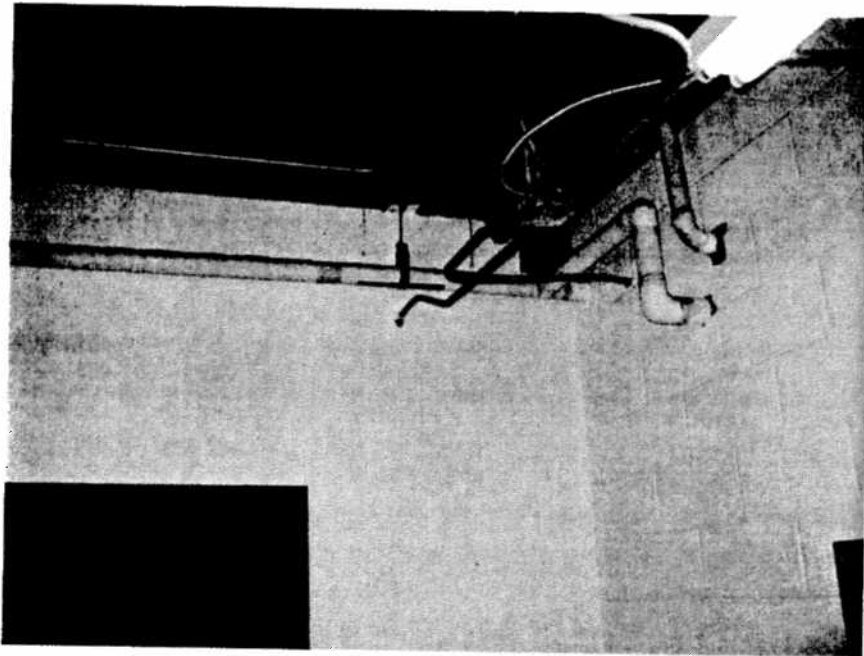
Figure 31. Suspect ACM seen in pipe wrap insulation in heating system room in west wing of the building.

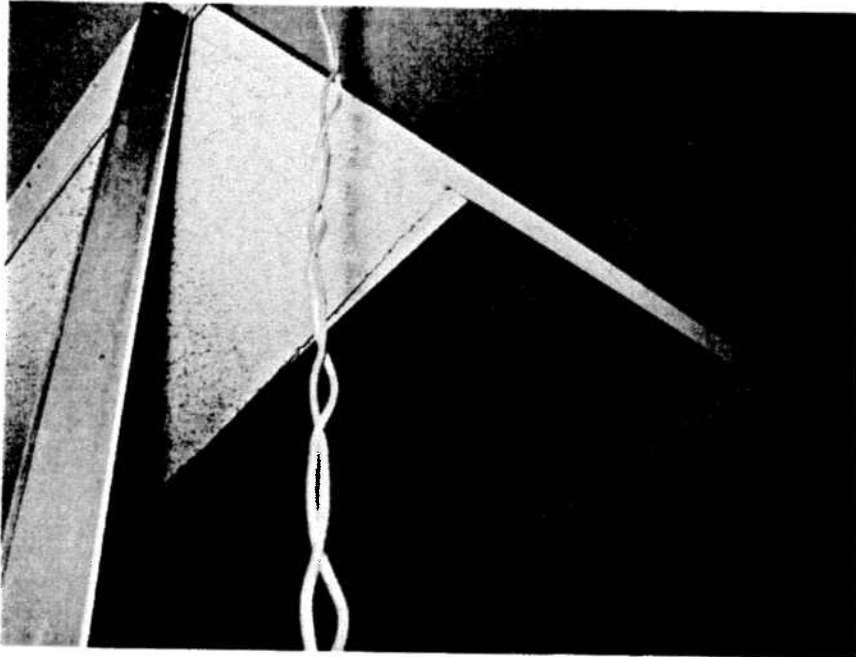
Figure 42. Second drop ceiling above current ceiling seen in “commo room” north of the kitchen.

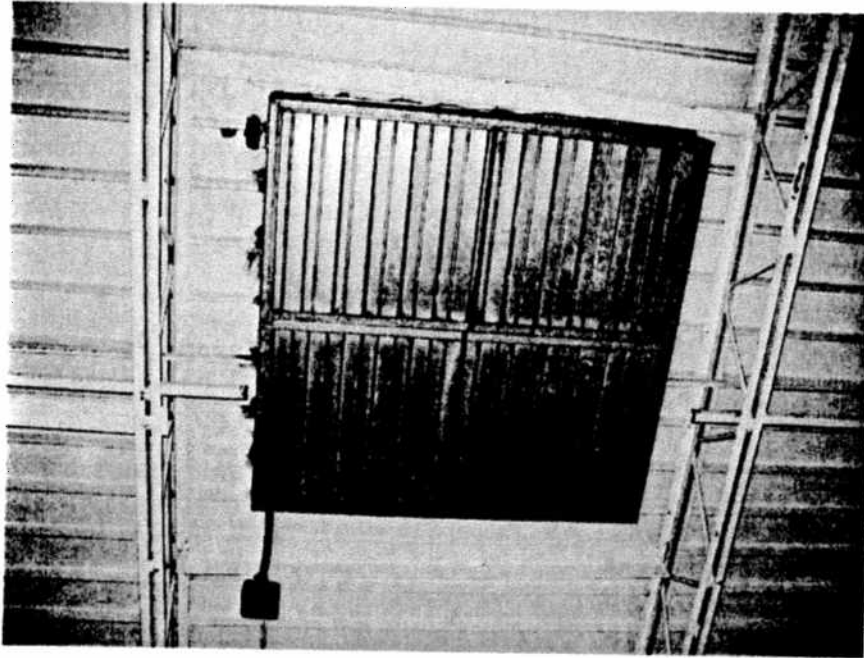
- 1983.0 ug/ft² of lead was found at the east end of the IFR near the fan.
- <16.00 ug/ft² of lead was found on the drill floor outside the IFR.
- 101.55 ug/ft² of lead was found at the north central wall IFR.

Figure 54. IFR vent on ceiling in the east half of the IFR room
