**OPERABLE UNIT 1  
OPERATION & MAINTENANCE  
ANNUAL REPORT 2022-2023**

TAR CREEK SUPERFUND SITE  
OTTAWA COUNTY, OKLAHOMA

APRIL 2023

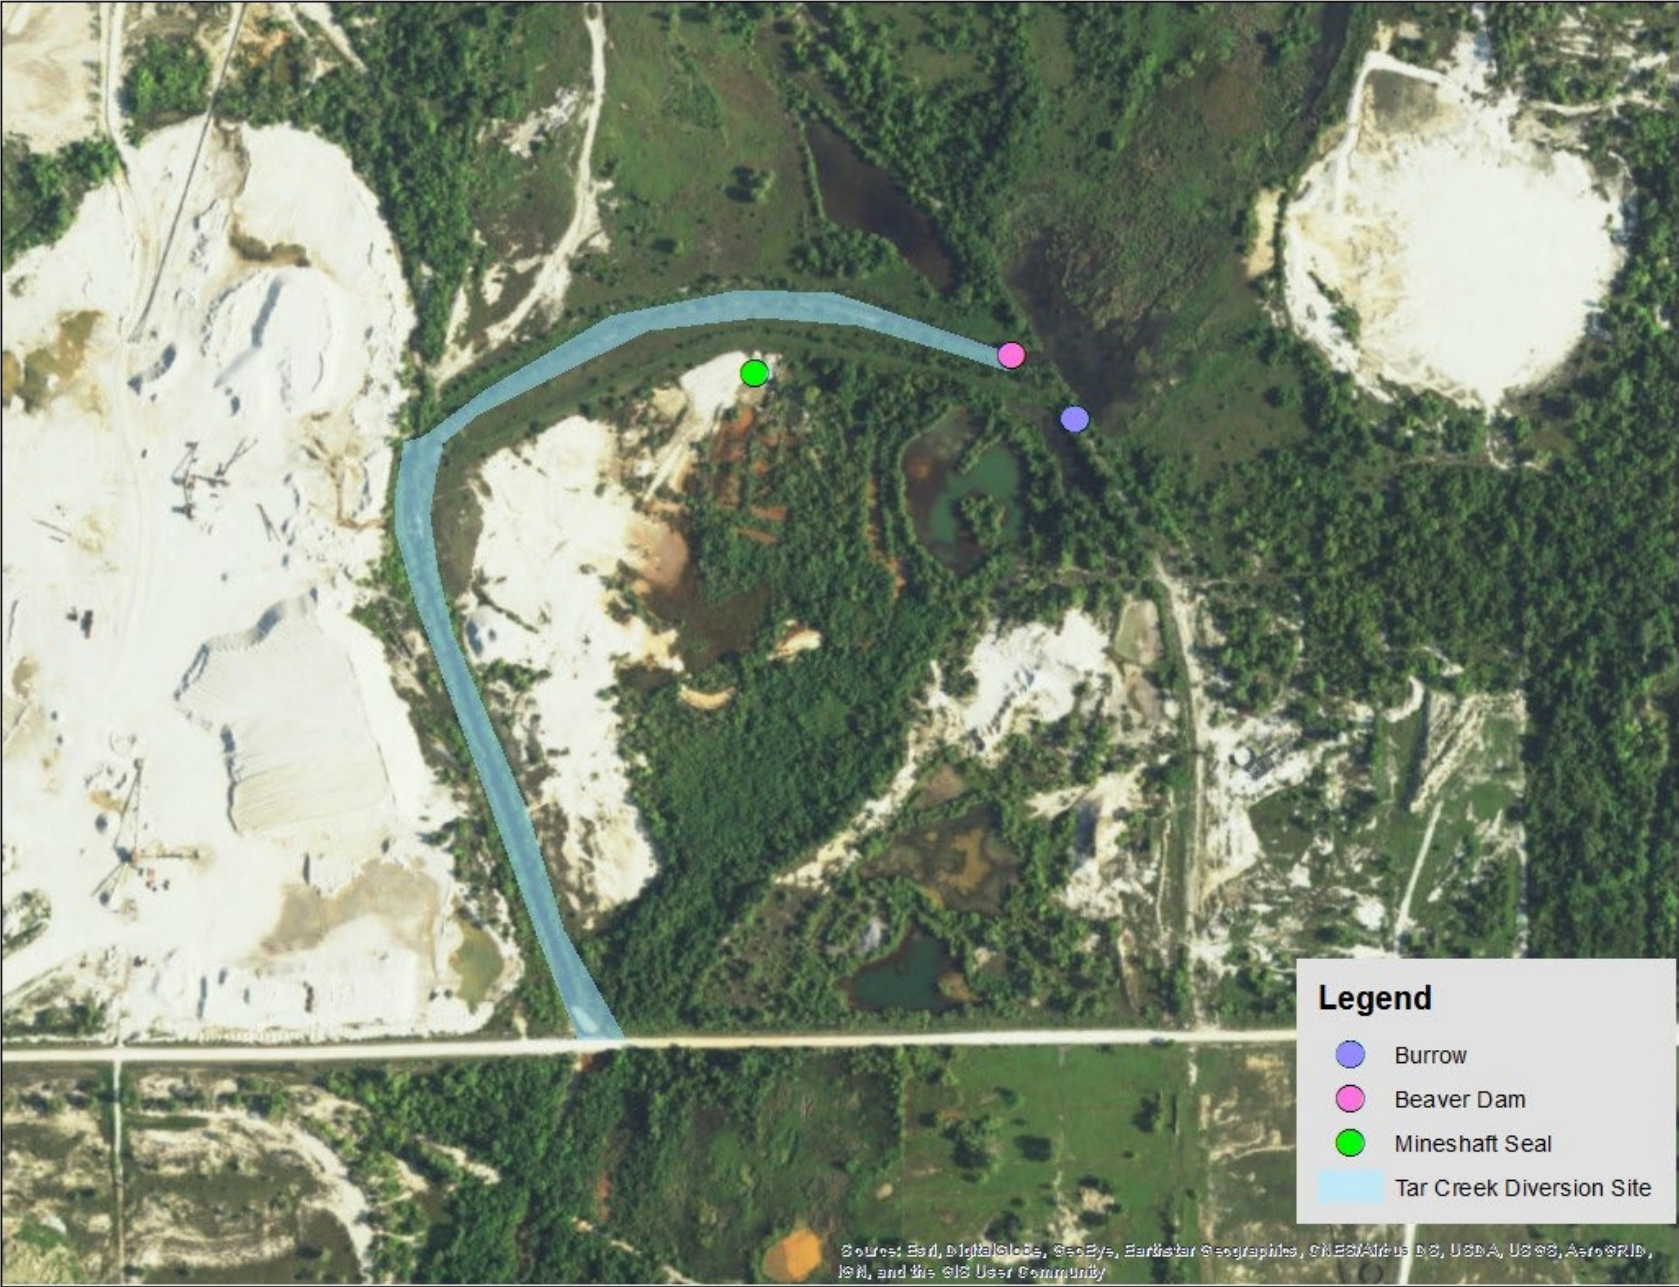
Figure 2: The Douthat Diversion Site (O-3) as observed during O&M inspection

The diversion dike is in good condition and there is no evidence of erosion, settlement, or sloughing. All brush along the dike has been removed and maintained by the owner of the property. In November of 2022, the creek water could be described as low. The streambeds are visible and there is no evidence of recent beaver activity. Any remaining materials from the previous beaver dams appear to be abandoned. Average streamflow for the nearby Spring River on this date was recorded by the United States Geological Society (USGS) as 300 cubic feet per second (cfs). This is “below normal” for Spring River’s mean flow of 900 cfs. Although the water level and streamflow are below normal, there does not appear to be anything that might impede the flow once the water rises. Flow from the watershed to the north of the dike is being conveyed through the constructed channel that diverts Lytle Creek into an upper reach of Tar Creek.

2.	<b>Erosion</b>	<input type="checkbox"/> Location shown on site map	<input checked="" type="checkbox"/> Erosion not evident
Areal extent _____ Depth _____			
Remarks: <u>No significant erosion, but some riparian areas on the east/northeast side of the dike have been affected by wildlife which could lead to erosion. Something to keep track for future inspections.</u>

Remarks: The previous inspection noted several beaver dams. Heavy rains appear to have altered and broken up the beaver dams. Any remaining materials see to have been abandoned by the animals. Should future action be required on beaver dams, USDA Wildlife Services relocates the animals, but there are services that can be explored to bridge the dam allowing water flow if relocation is not a good option. Photos included.

In addition to groundwater sampling, the Douthat O-3 inspection should continue annually. If the property owner stops maintaining the area and trees begin to grow on the dike or if vegetation growth becomes excessive and hinders O-3 inspections, DEQ should take steps to have it mowed and maintained.

Continued monitoring of beaver dams at the diversion dike is recommended. Road maintenance and other wildlife intrusion should continue to be monitored.

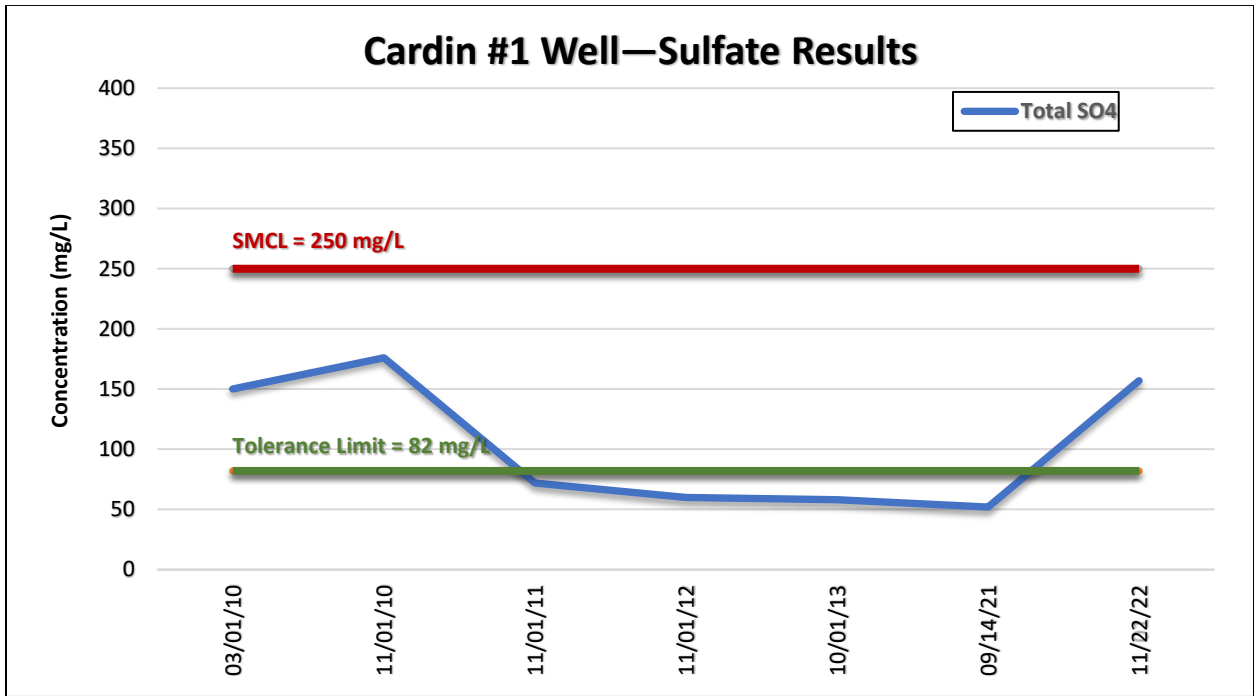
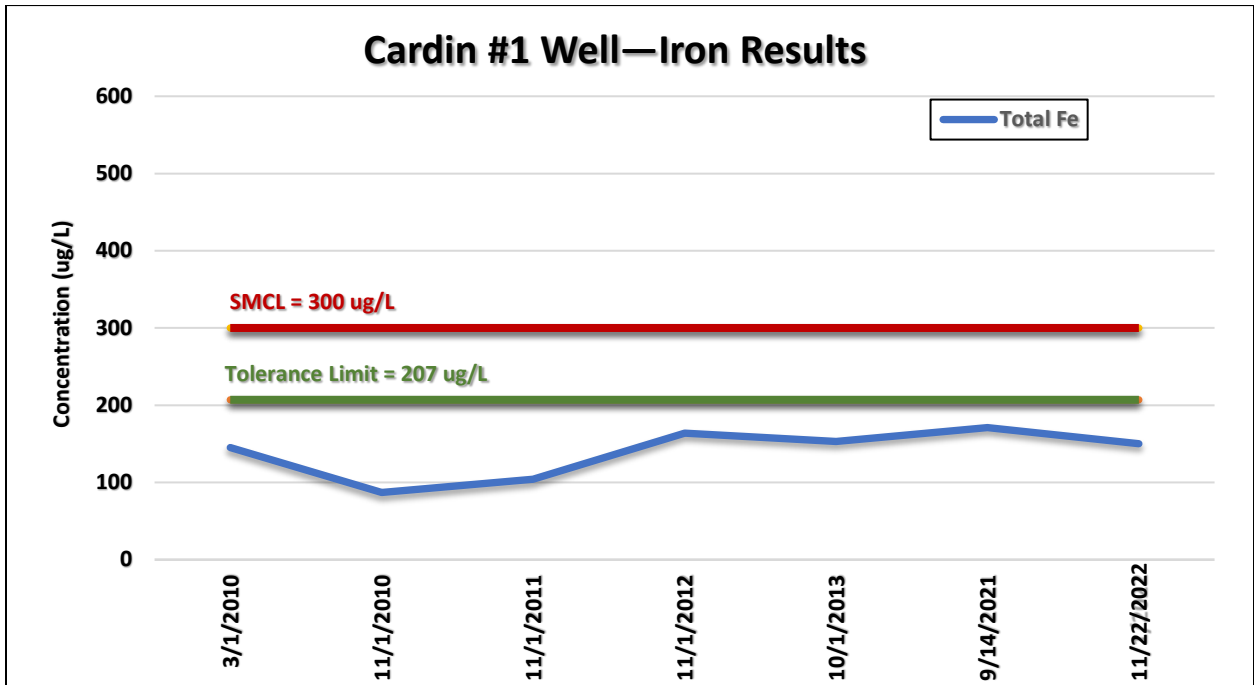
Figures 3A and 3B: Sulfate and Iron concentrations at Cardin #1 well compared to tolerance limits and SMCLs

CA1 has tested above the Tolerance Limit for SO<sub>4</sub>. This is a change from the last sampling in which there were no exceedances of Tolerance Limits. Confirmation will be needed to determine if this is an aberration or a consistent trend. The exceedance warrants additional sampling based on the general response action plan (**Figure 8**).

Although Pb and Cd concentrations were below detection limits, the wells considered possibly or probably impacted will require additional monitoring. Moving forward, the CA1 and C5 wells will be tested every 6 months instead of every 12 months (until confirmation or elimination of a trend can be determined). The P6 and P7 wells will resume testing every 6 months to keep track of any trends and ensure no Pb or Cd are present.

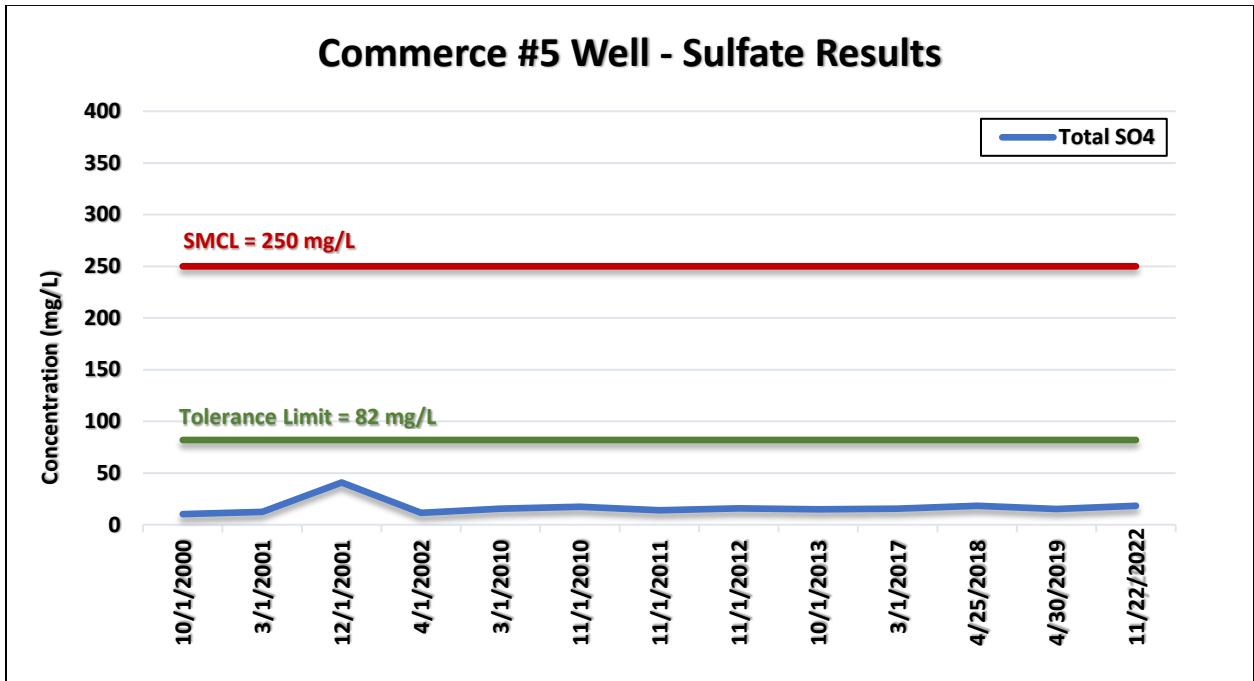
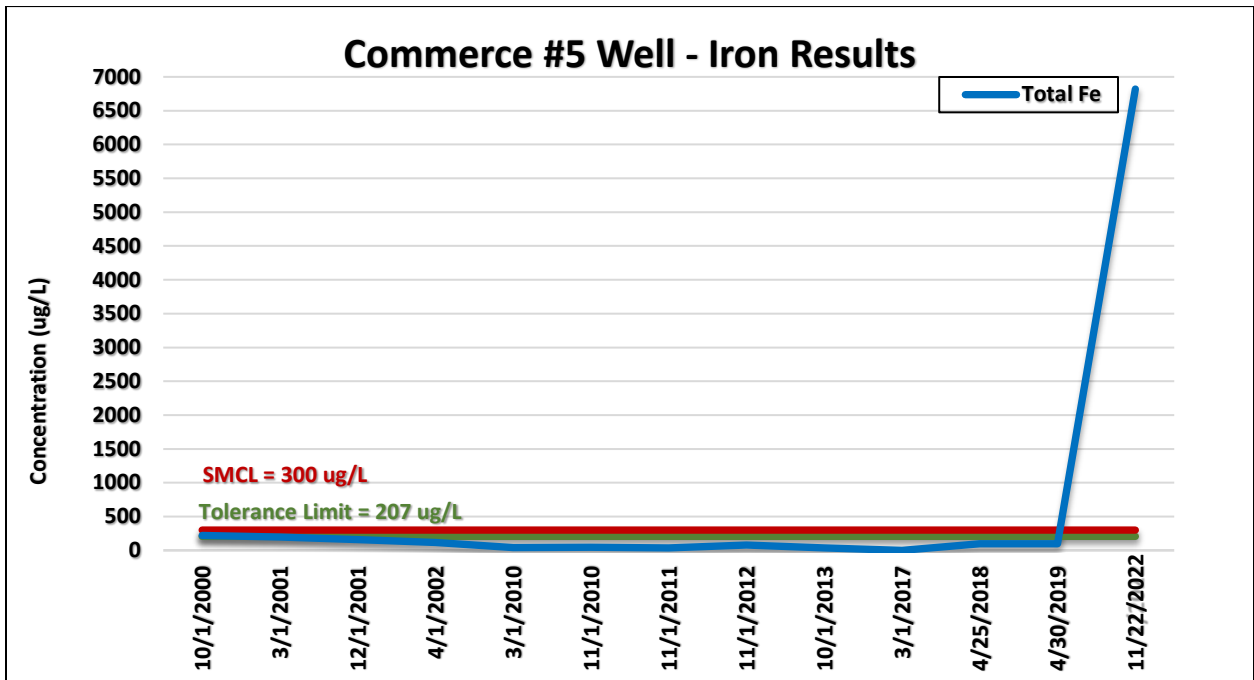
Figures 4A and 4B: Sulfate and Iron concentrations at Commerce #5 well compared to tolerance limits and SMCLs

C5 tested above the Tolerance Limit **and** SMCL for Fe. This is also a change from the last sampling in which there were no exceedances of Tolerance Limits. Confirmation will be needed to determine if this is an aberration or a consistent trend.

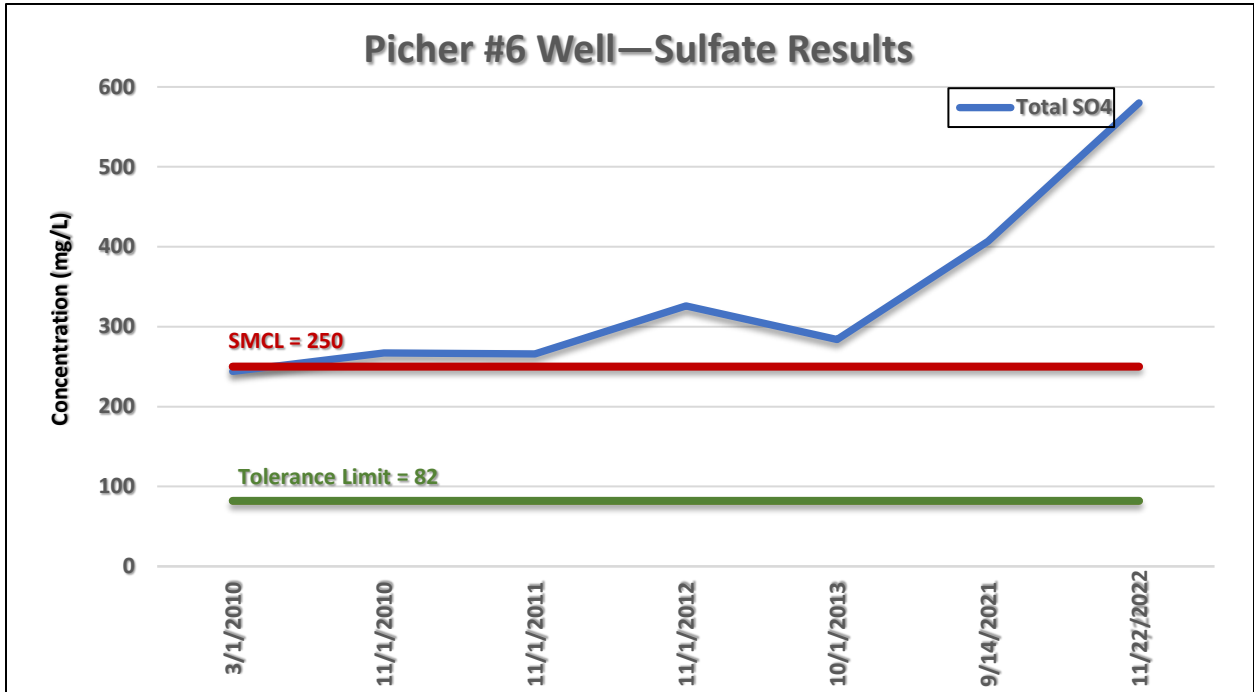
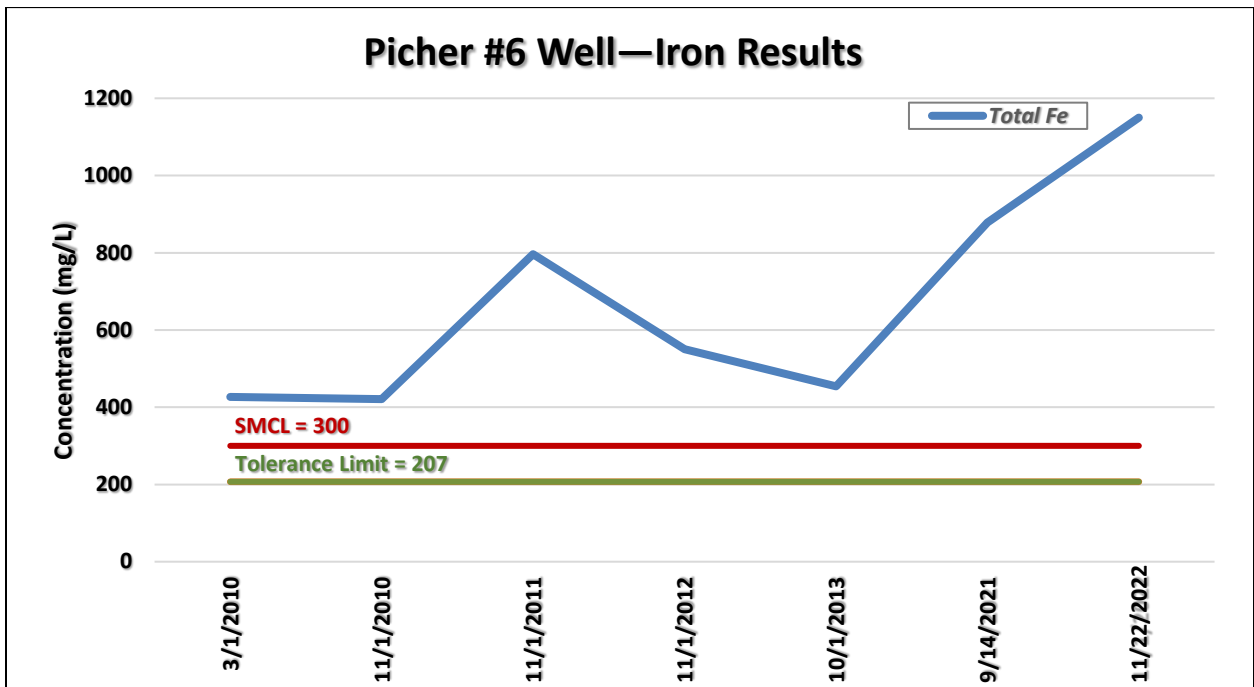
Figures 5A and 5B: Sulfate and Iron concentrations at Picher #6 well compared to tolerance limits and SMCLs

The P6 well is privately owned and had not been tested from 2014 to 2021. Since testing has resumed, P6 has consistently exceeded the Tolerance Limits **and** SMCLs for both SO<sub>4</sub> and Fe, as well as the Background Level for Zn.

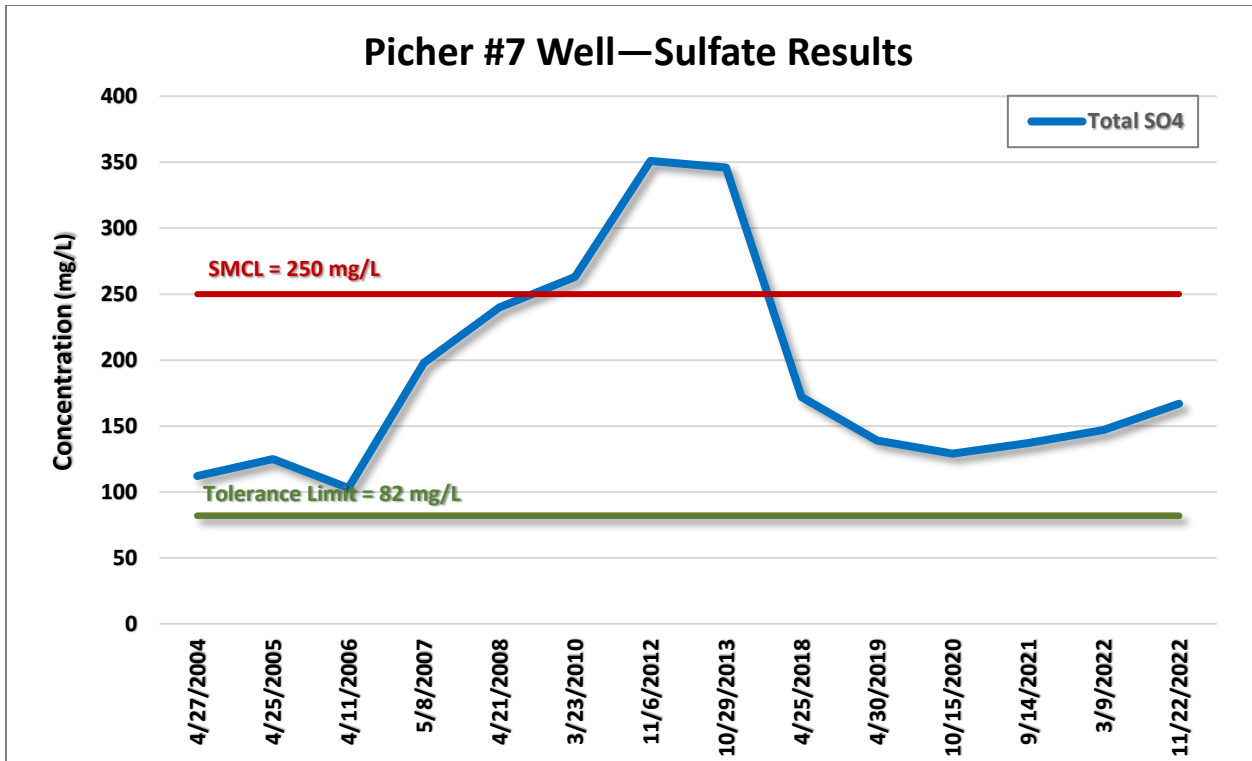
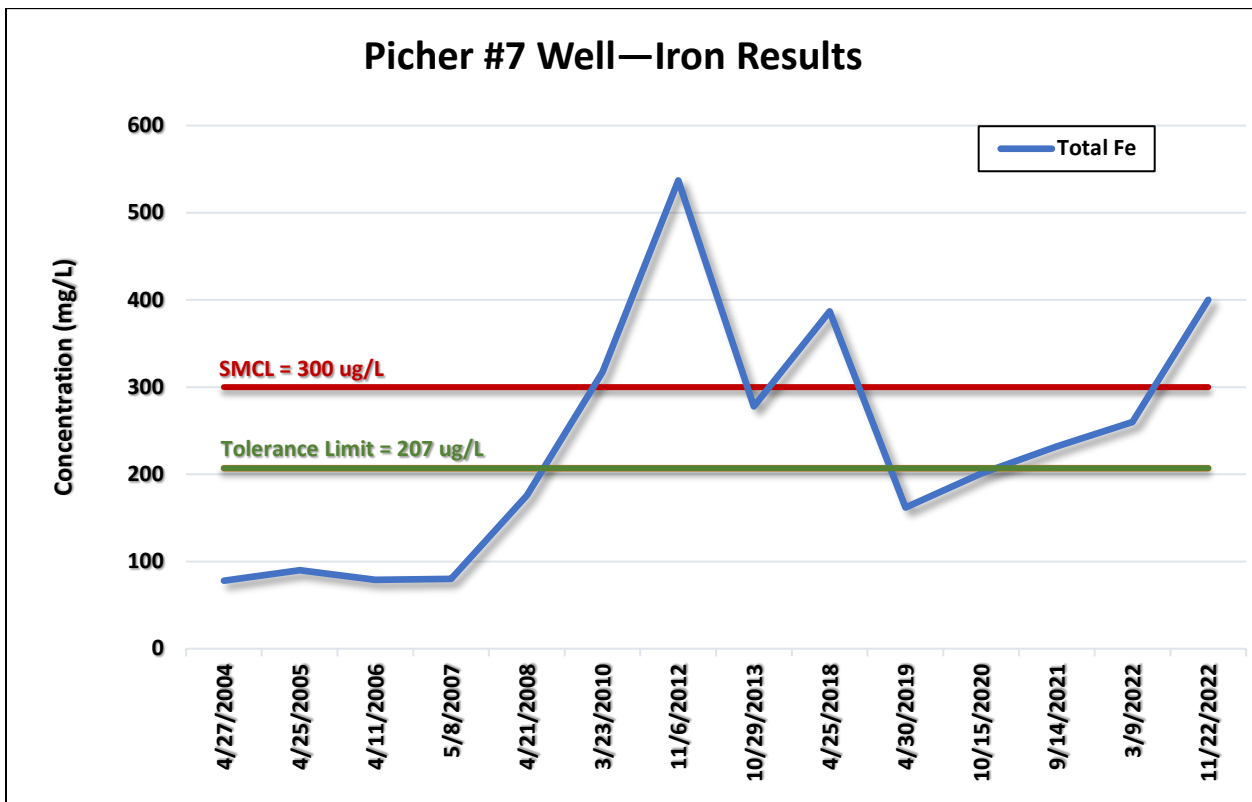
Figures 6A and 6B: Sulfate and Iron concentrations at Picher #7 well compared to tolerance limits and SMCLs

SO<sub>4</sub> concentrations at P7 have historically exceeded the Tolerance Limit, as shown in **Figure 7A**. The P7 well also exceeded the Tolerance Limit **and** SMCL for Fe (**Figure 7B**). This has suggested a concerning trend at P7.
