**Targeted Brownfields Assessment
Oklahoma Army National Guard
Healdton Armory
Healdton, Oklahoma**

**ASTM E 1527-05
Phase I Environmental Site Assessment
All Appropriate Inquiry**

December 5, 2006

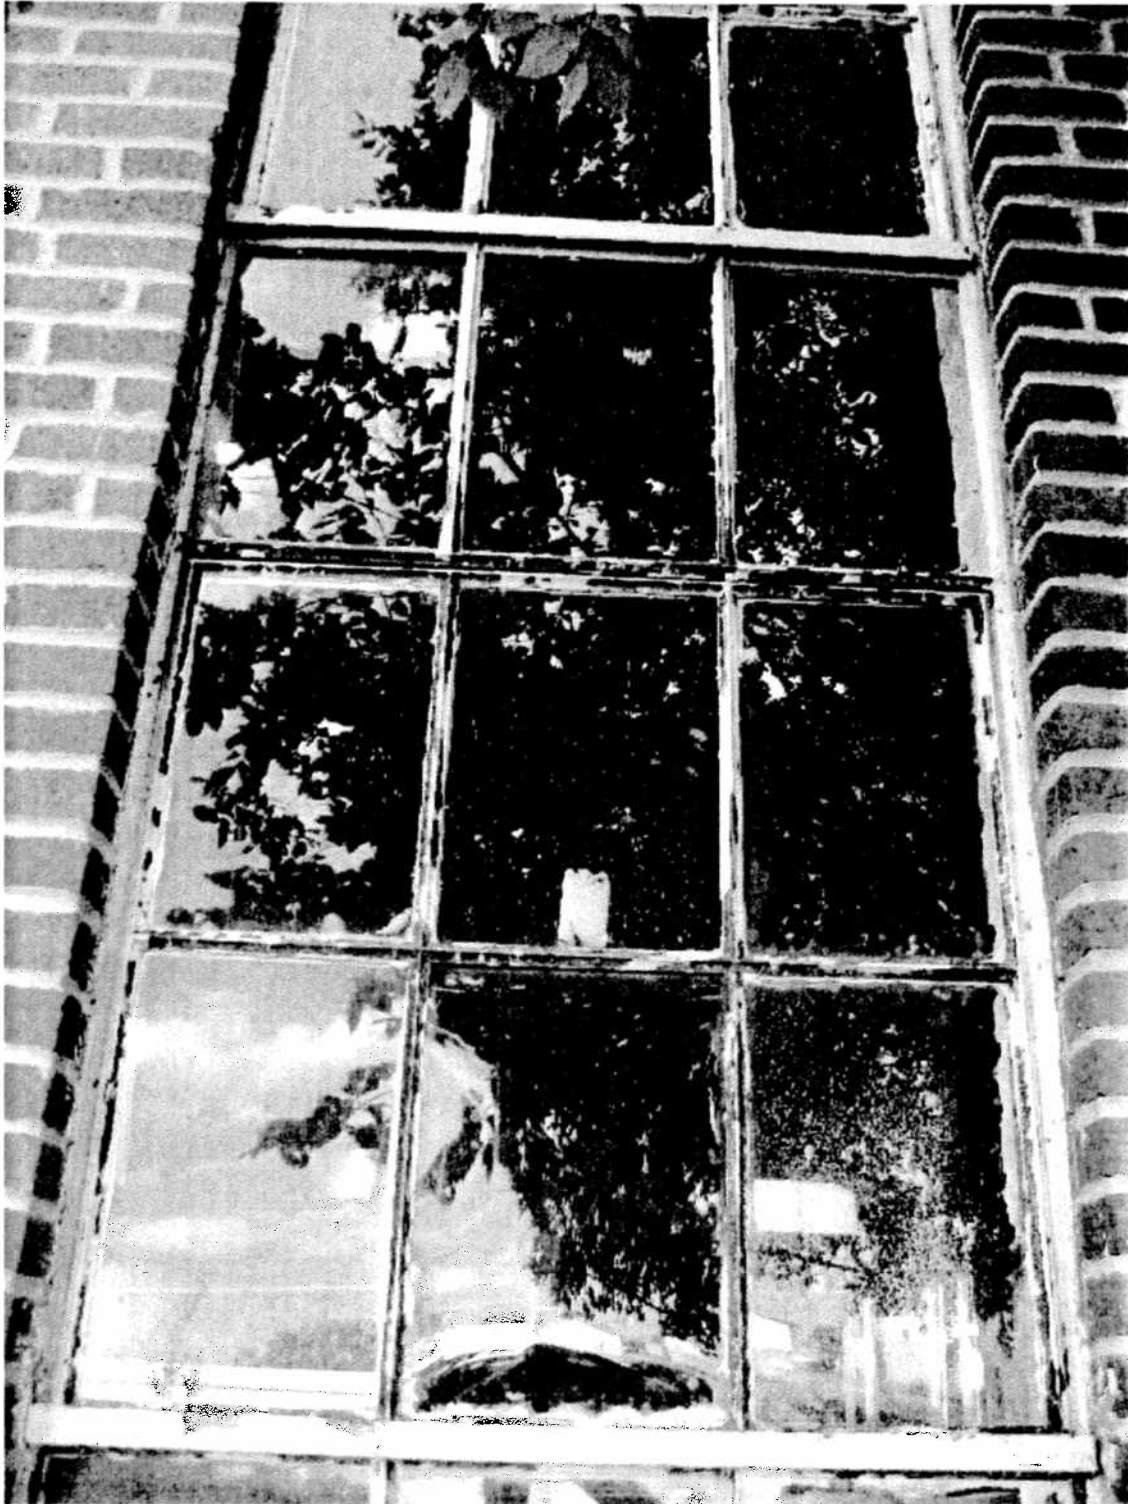
Painted surfaces and peeling paint on windows, doors, walls, and floors in the armory building could contain lead. Chipped, cracked, and peeling paint was observed both inside and outside the armory. Soils beneath windows where lead-based paint was used may contain lead concentrations.

Figure 4: Healdton Armory – south window on outside west wall with chipped paint.

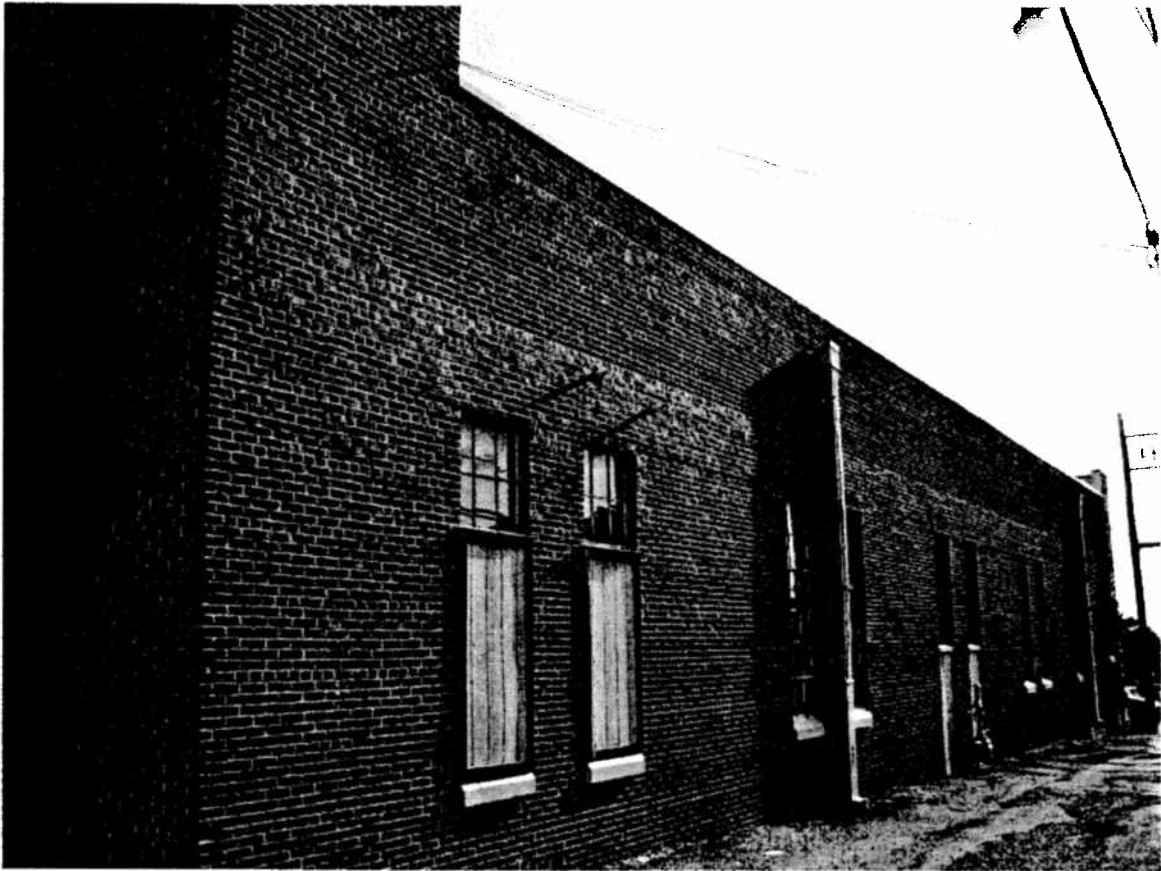
Chipped and peeling paint around the windows was observed. A crack in the south west corner of the building was observed. It is unknown if the crack is structural or aesthetic. Transformers were observed in the south alley behind the armory. No sign of leaks or staining from the transformers was observed. An open pipe was observed protruding from the ground approximately six inches on the southeast corner of the building. It was undetermined what the pipe is used for. An abandoned gas station is located to the north west of the armory. An active gas station is located to the south east one block from the armory (Ref. 7).

Figure 5: Healdton Armory – southwest corner facing west-northwest (note crack on southwest corner wall (left) and roof drains).

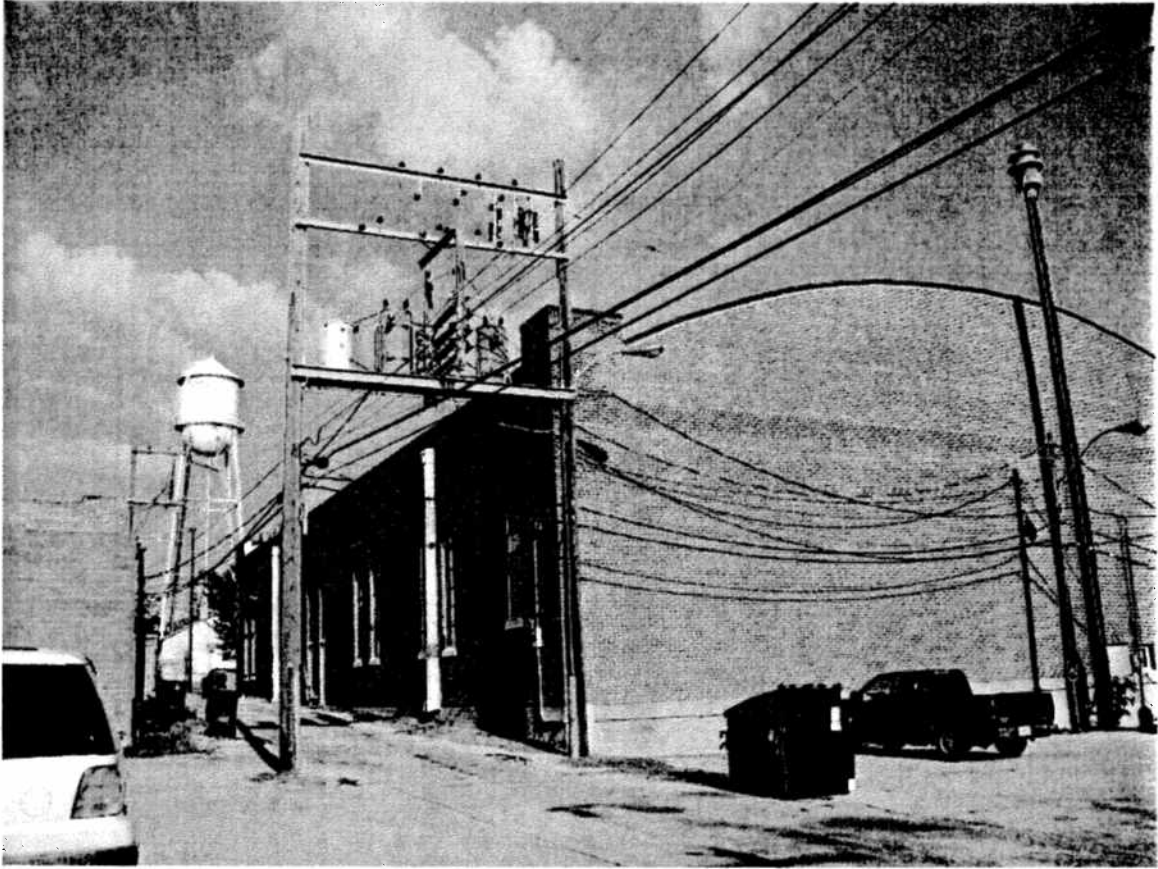
Electrical transformers located in the alley to the south of the armory. It was not determined during this investigation if they may contain PCB's. The pole-mounted transformers appears to be in good condition. No evidence of leaks or staining was observed during the site visit. The light fixtures in the gymnasium (drill floor) area have recently been replaced by the City (Ref 7). The original light fixtures have been placed in the IFR. Due to the age of the light fixtures the ballasts may contain PCB's.

Figure 6: Healdton Armory- southeast corner facing east-northeast with electrical transformers in alley way.

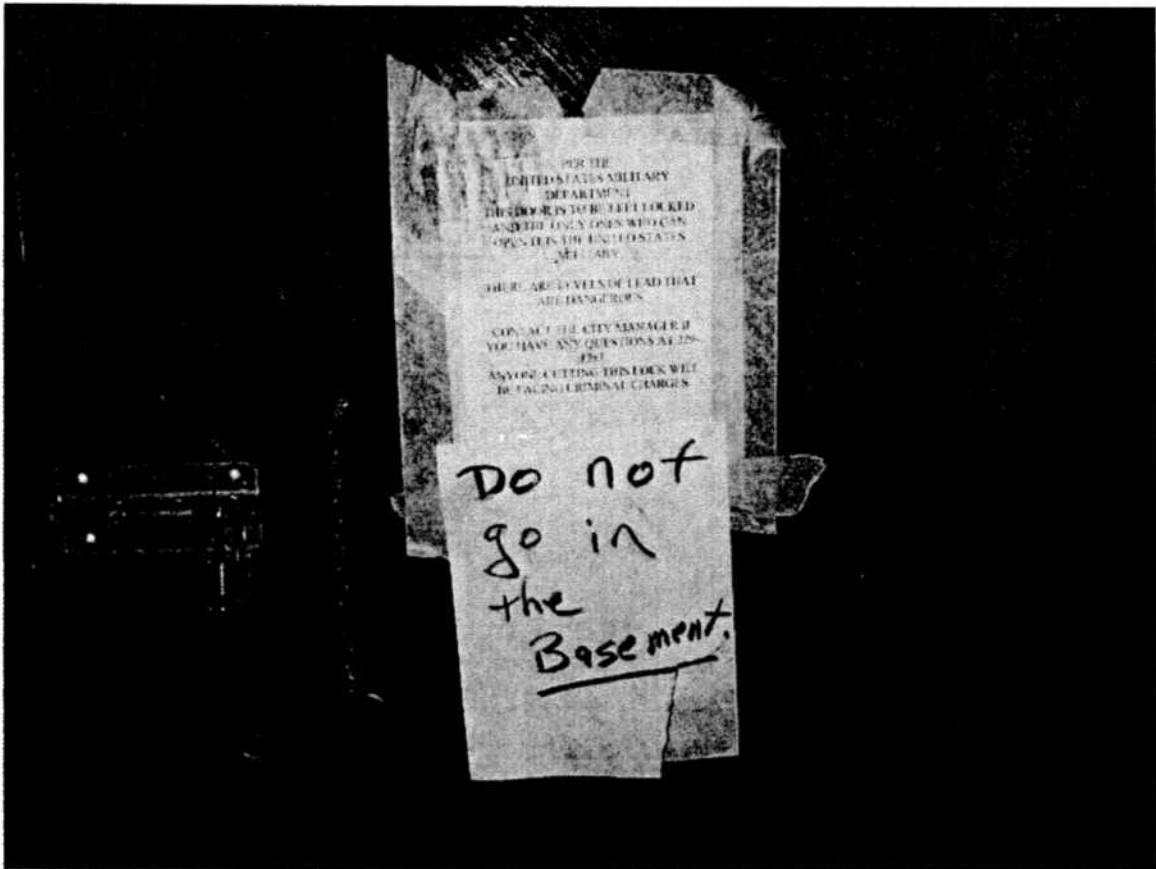
Figure 9: Healdton Armory – close-up of the warning signs placed on the entrance to the indoor firing range.

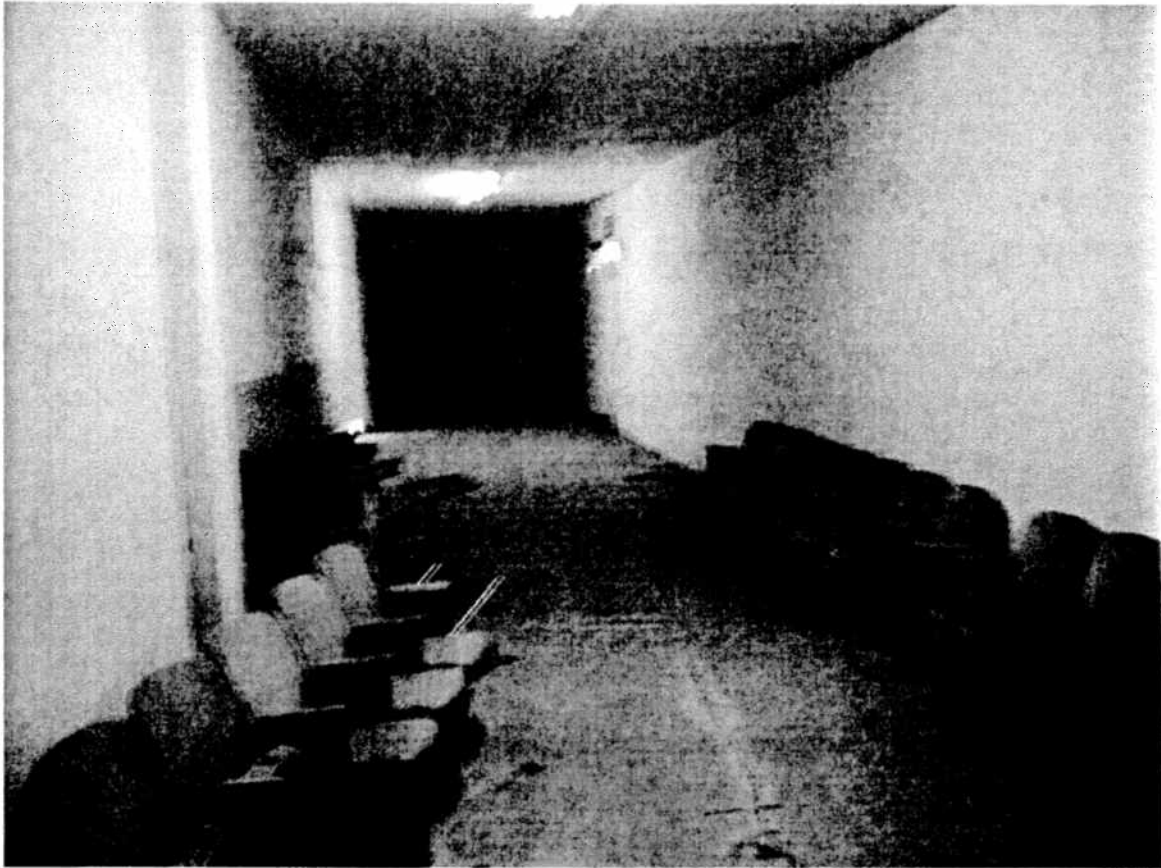
The indoor firing range (IFR) is contaminated by lead. Samples adjacent areas near the entrance of the IFR also appear to be contaminated by lead. During the site visit, it was observed that the IFR is currently used to store miscellaneous items. Surfaces of these items may also be contaminated by lead. Past sampling has been conducted to characterize the lead concentration in these areas. A statewide sampling event for lead was conducted by C.H. Guernsey & Company for the Oklahoma Army National Guard on all armories containing indoor firing ranges. This report is called the "Indoor Firing

Figure 10: Healdton Armory – indoor firing range, near entrance, facing north showing stored chairs.

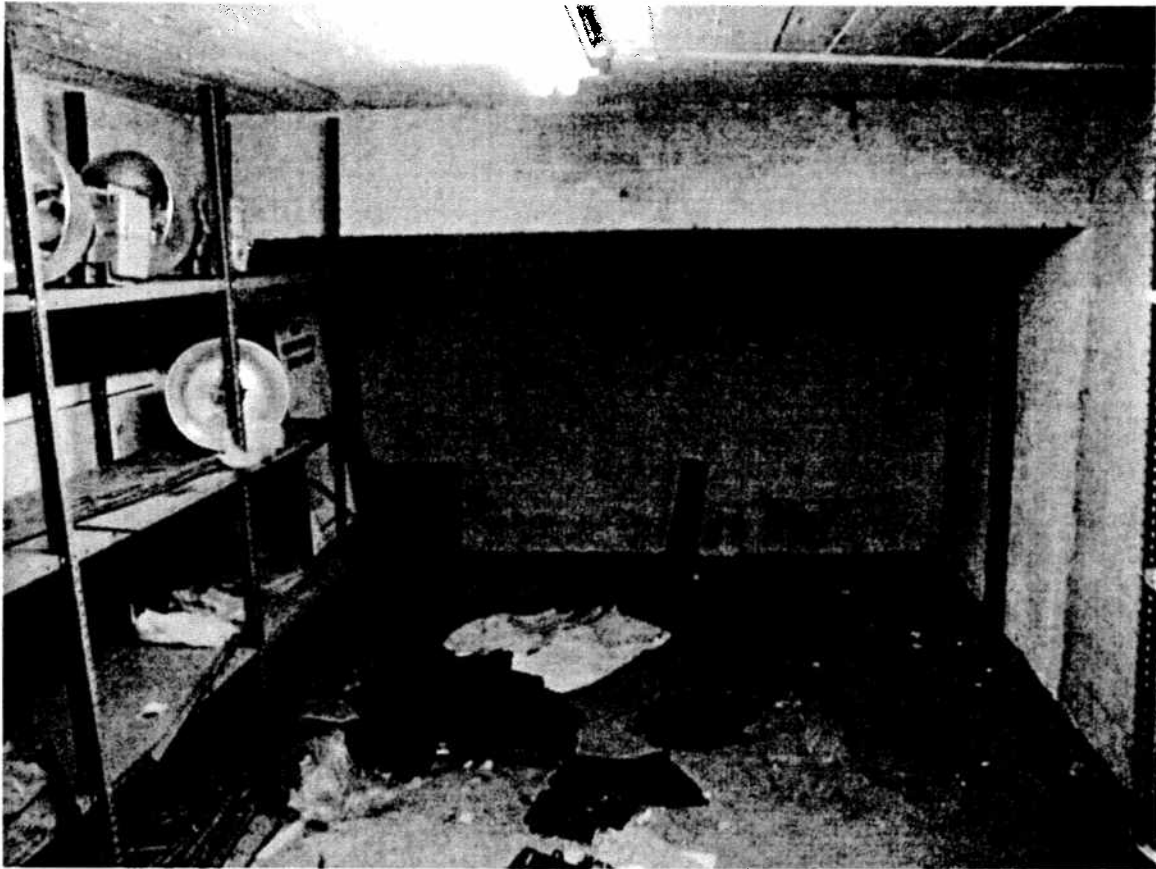
Figure 12: Healdton Armory – indoor firing range, small room located off the northwest corner of the indoor firing range showing recently replaced lighting held in storage.

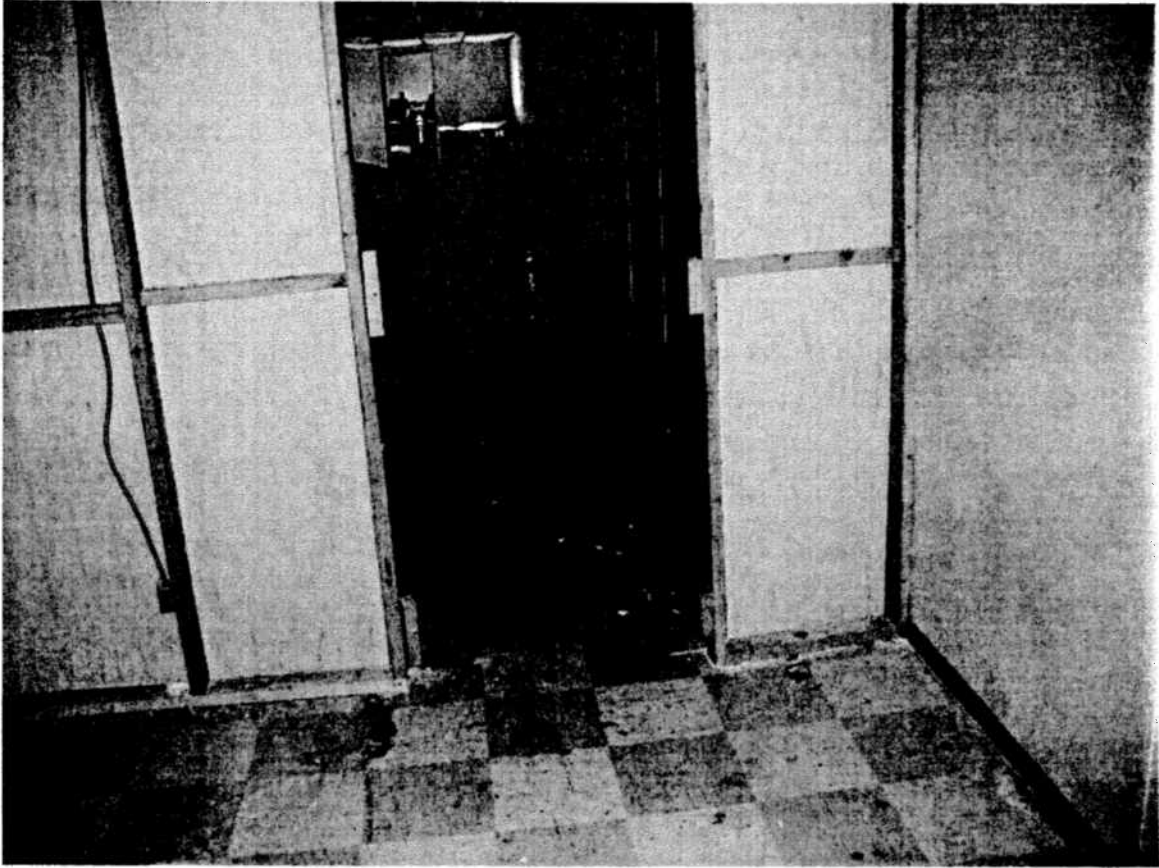
Figure 13: Healdton Armory – mess hall area located at the east end of the gymnasium (drill floor) showing 12"x12" tiles and stored items in the background.

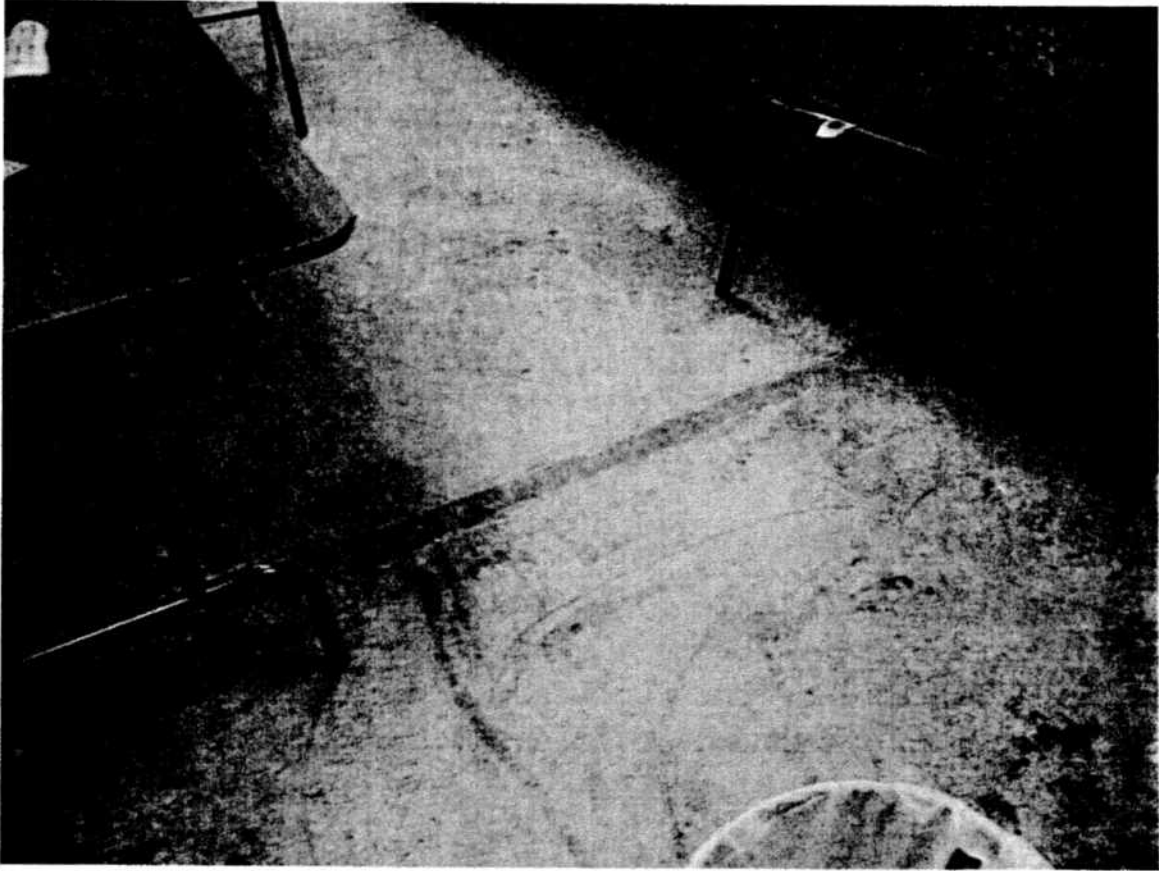
Figure 17: Healdton Armory: Healdton Fire Department meeting room in west side of the building. Carpeting used by the National Guard was removed. This picture shows the carpet glue left behind.
