**Former National Guard Armory
Hobart, Oklahoma**

Remediation Final Report

Prepared by:
Department of Environmental Quality
707 North Robinson
Oklahoma City, Oklahoma 73101

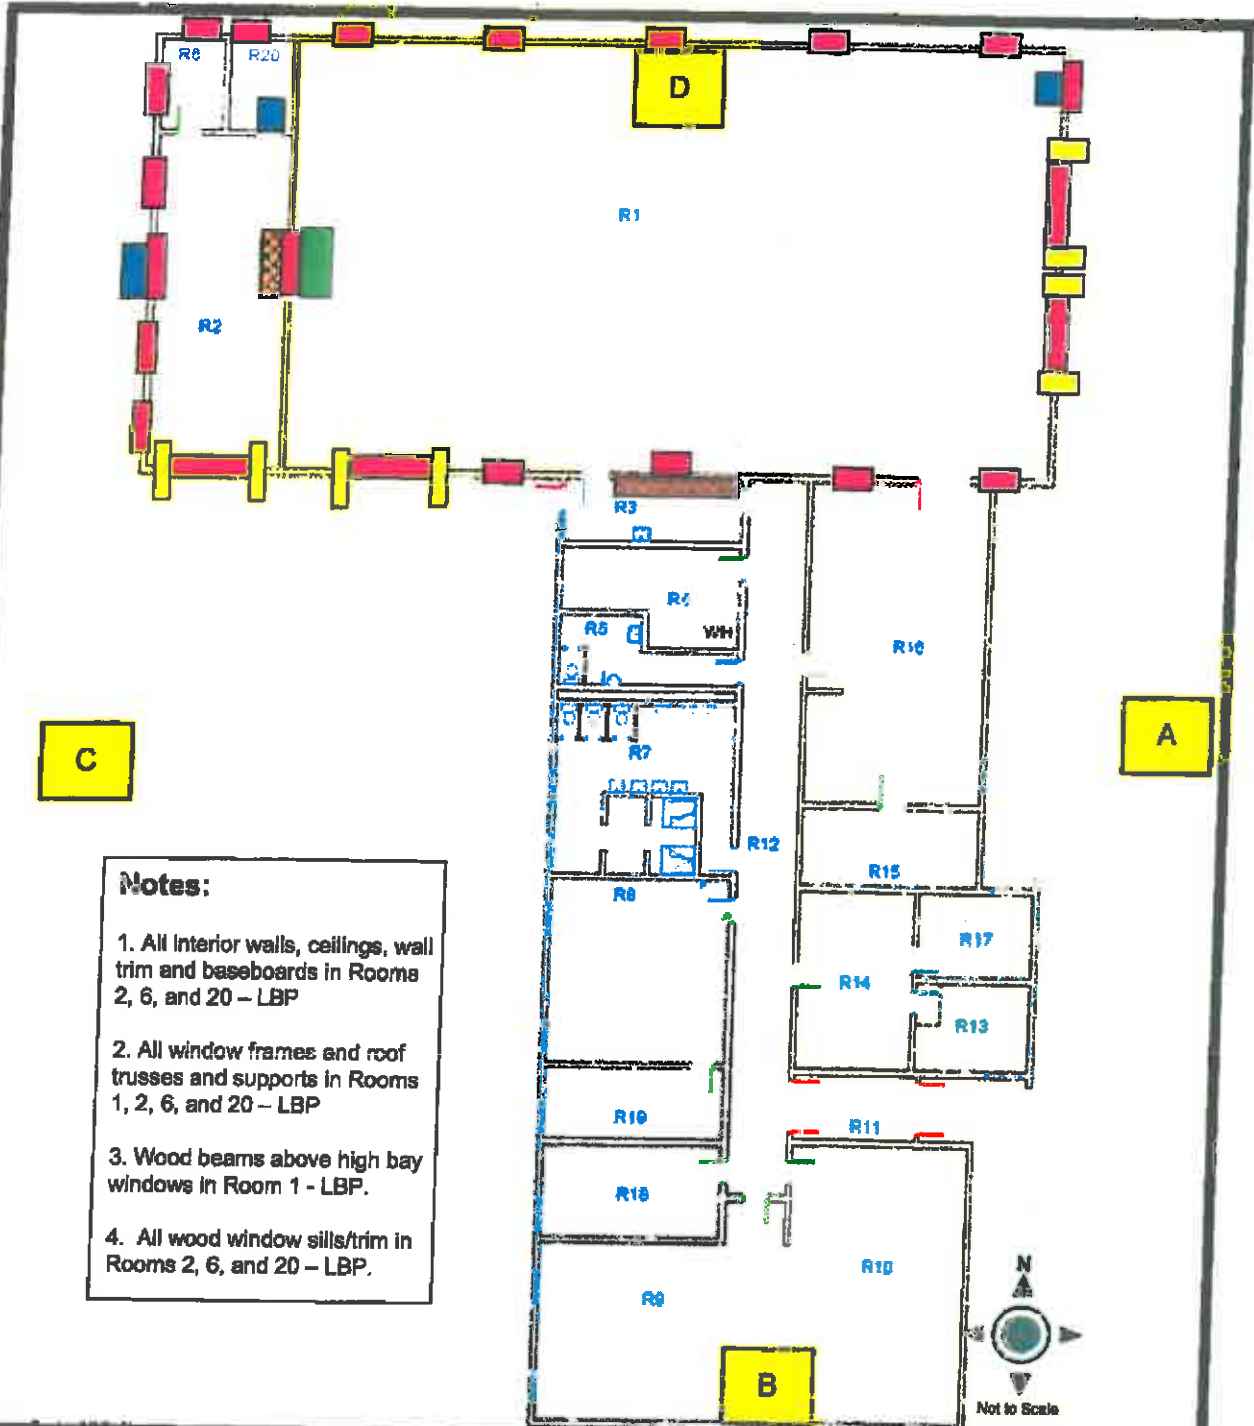
FIGURE 1
Lead-Based Paint Locations

- Notes:**
1. All interior walls, ceilings, wall trim and baseboards in Rooms 2, 6, and 20 – LBP
 2. All window frames and roof trusses and supports in Rooms 1, 2, 6, and 20 – LBP
 3. Wood beams above high bay windows in Room 1 - LBP.
 4. All wood window sills/trim in Rooms 2, 6, and 20 – LBP.

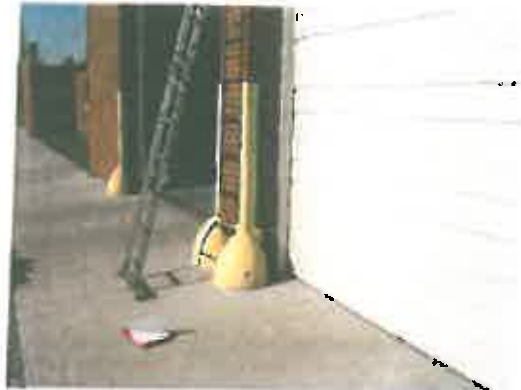
Photo #2: Modified bollards and edge protectors - LBP.

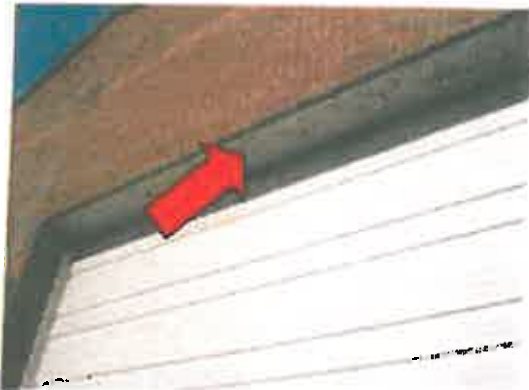
Photo #3: Lintel above roll-up door - LBP.

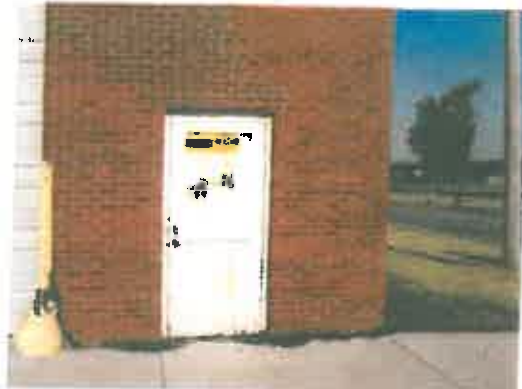
Photo # 4: Beige door, door frame, and lintel - LBP.

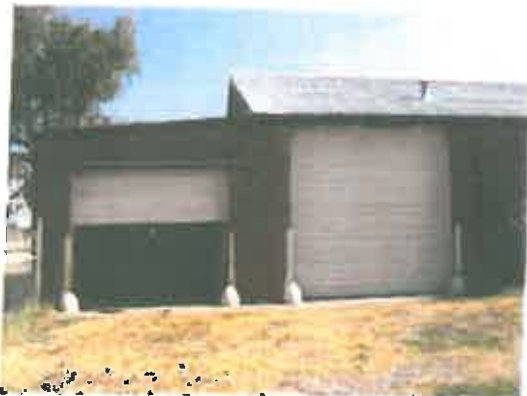
Photo # 5: Modified bollards and edge protectors - LBP.

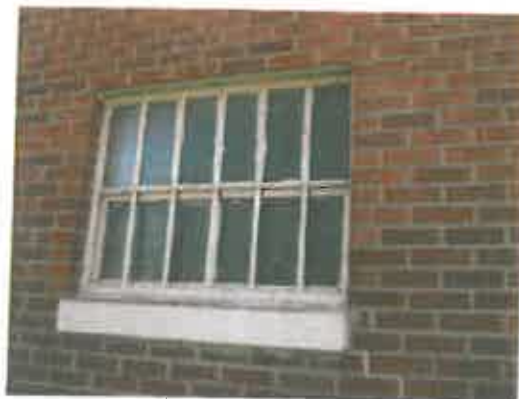
Photo # 6: Window frame and lintel - LBP.

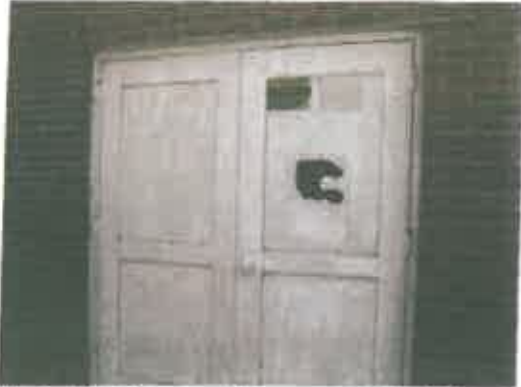
Photo #7: Door and frame and intel Side C Exterior - LBP

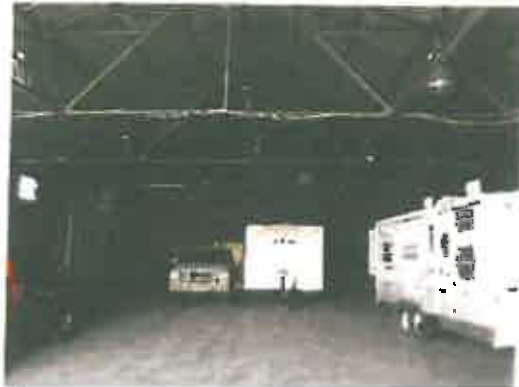
Photo #8: Roof trusses and supports in Room 1 - LBP.

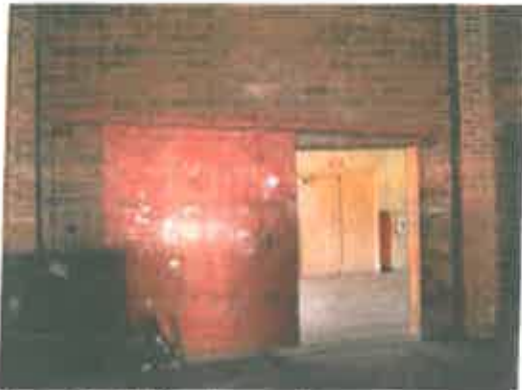
Photo #9: Sliding door and track on Side C of Room 1 - LBP.

- The sliding door and track located between Room 1 and Room 2 shall be removed, wrapped in 6 mil poly sheeting, and properly disposed.
- Deteriorated paint removed from building surface will be properly disposed.

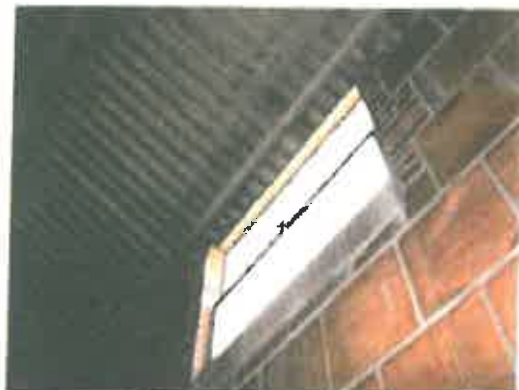
Photo #10: High bay window in Room 1 - LBP

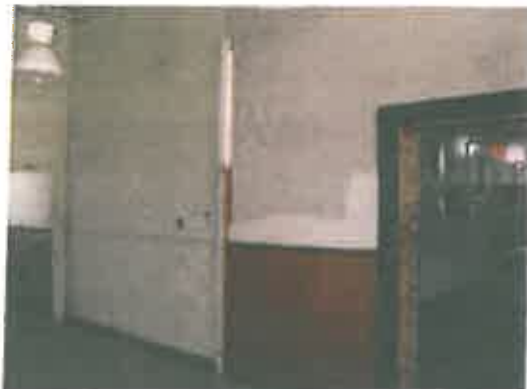
Photo #11: Walls, door frame, wall trim, and baseboard-Room 2 - LBP.

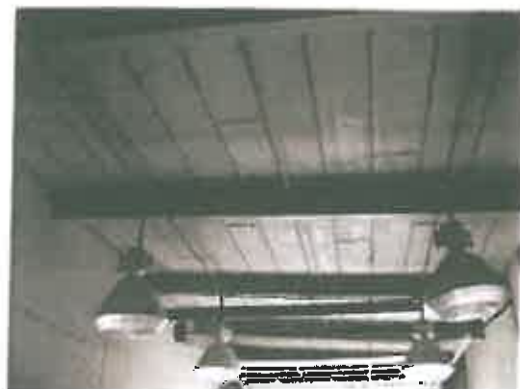
Photo #12: Kaylo ceiling in Room 2 - LBP

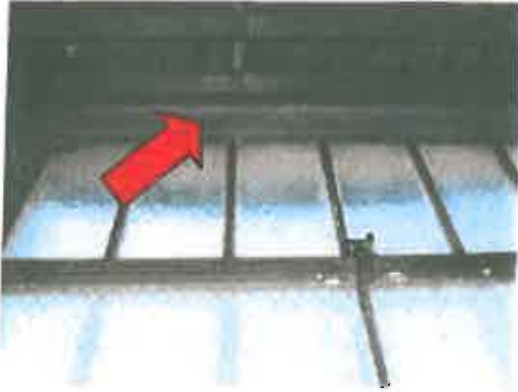
Photo #13: Gray painted wood beam above high-bay windows in Room 1 - LBP

4. The painted brick wall in Room 3, the wood beams above windows in Room 1, and the door frame and door lintel located between Room 1 and Room 2 were scrapped and encapsulated with lead-based paint encapsulant. These surfaces need to be re-encapsulated if lead-based paint encapsulant shows signs of deterioration, damage, or flaking. See Attachment 2 for Hobart Armory Floor Plan Map.

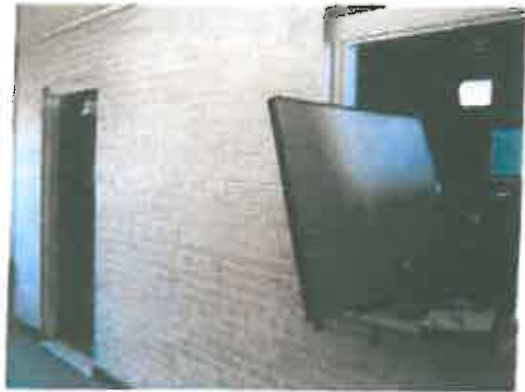
Photo #14: White painted brick wall in Room 3 - LBP
