**Targeted Brownfields Assessment  
Oklahoma Army National Guard  
Hominy Armory  
Hominy, Oklahoma**

**ASTM E 1527-05  
Phase I Environmental Site Assessment  
All Appropriate Inquiry**

**December 20, 2006**

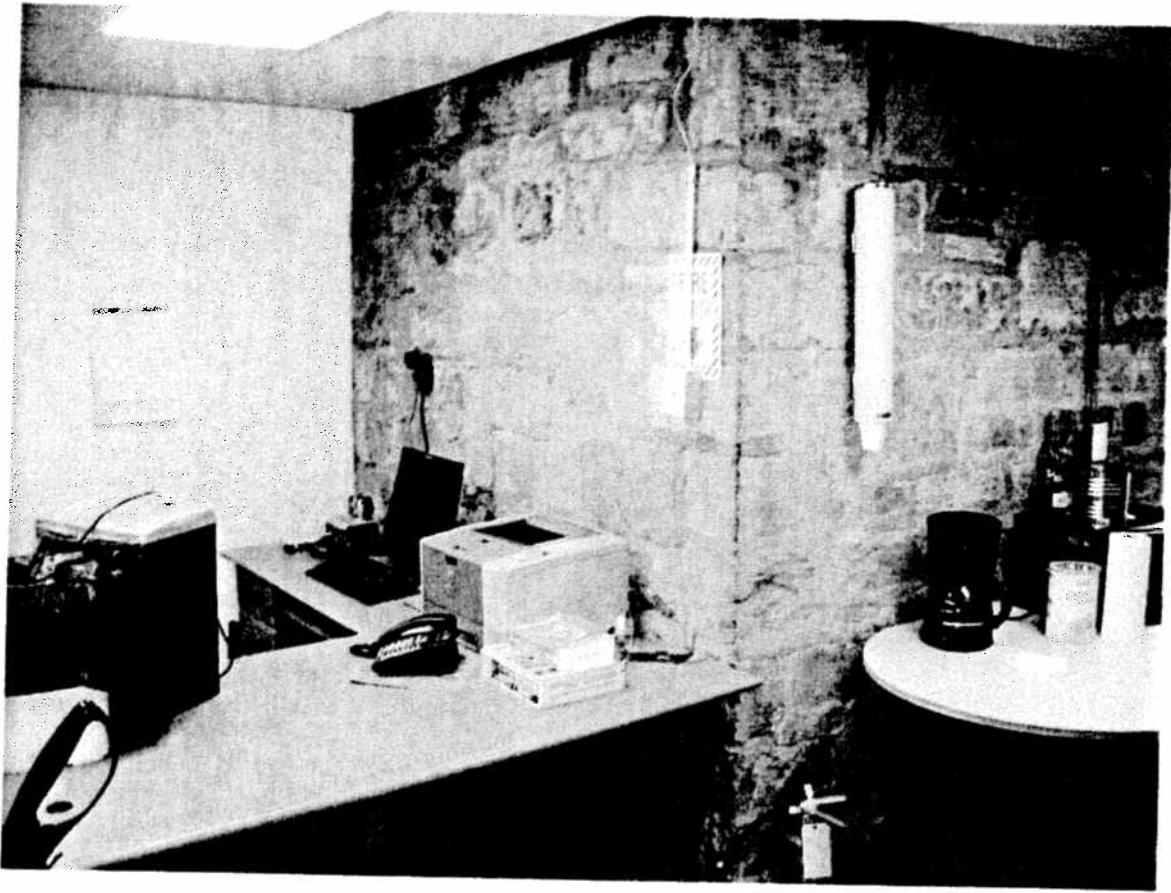
Figure 9. Hominy Armory – remodeled police office space on north side showing original stone exterior wall – note the original wall was not painted.

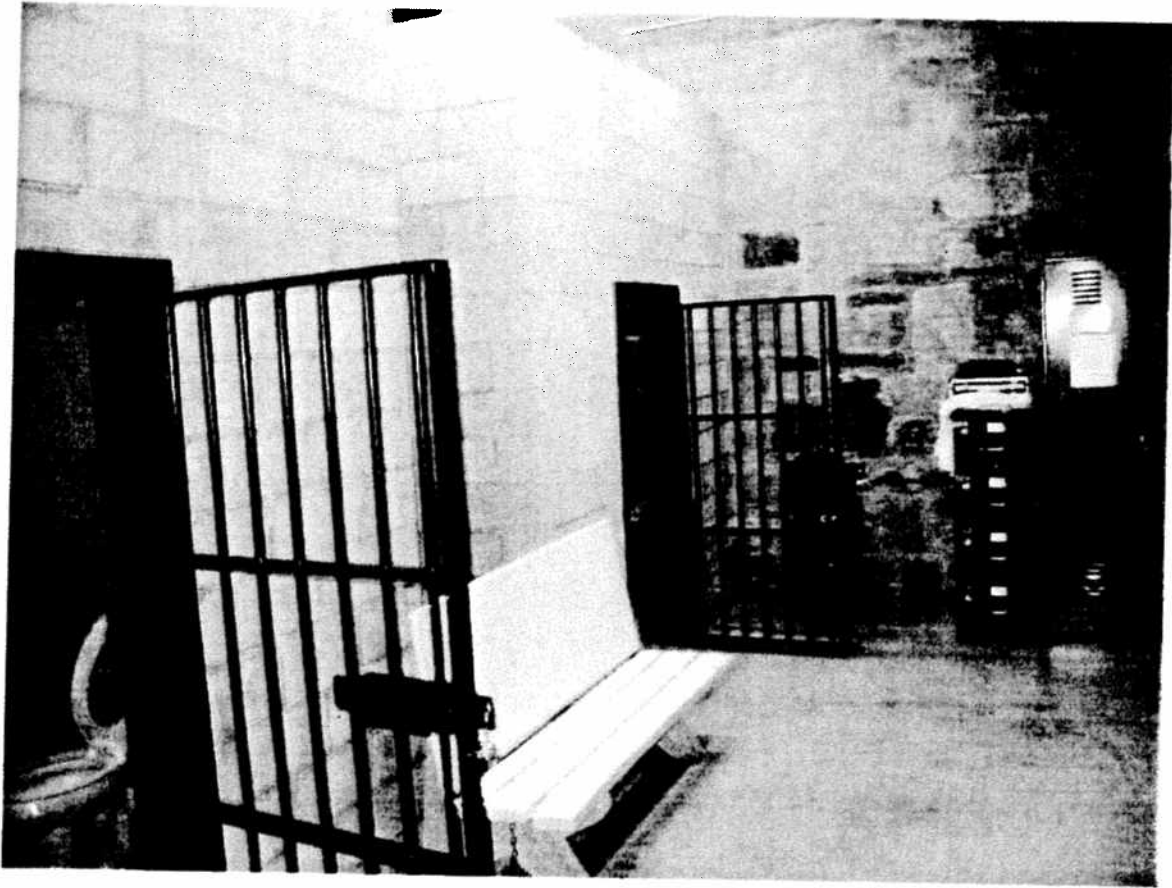
Figure 10. Hominy Armory – Hominy jail facility in the northeast side of the building – note the original walls were not painted

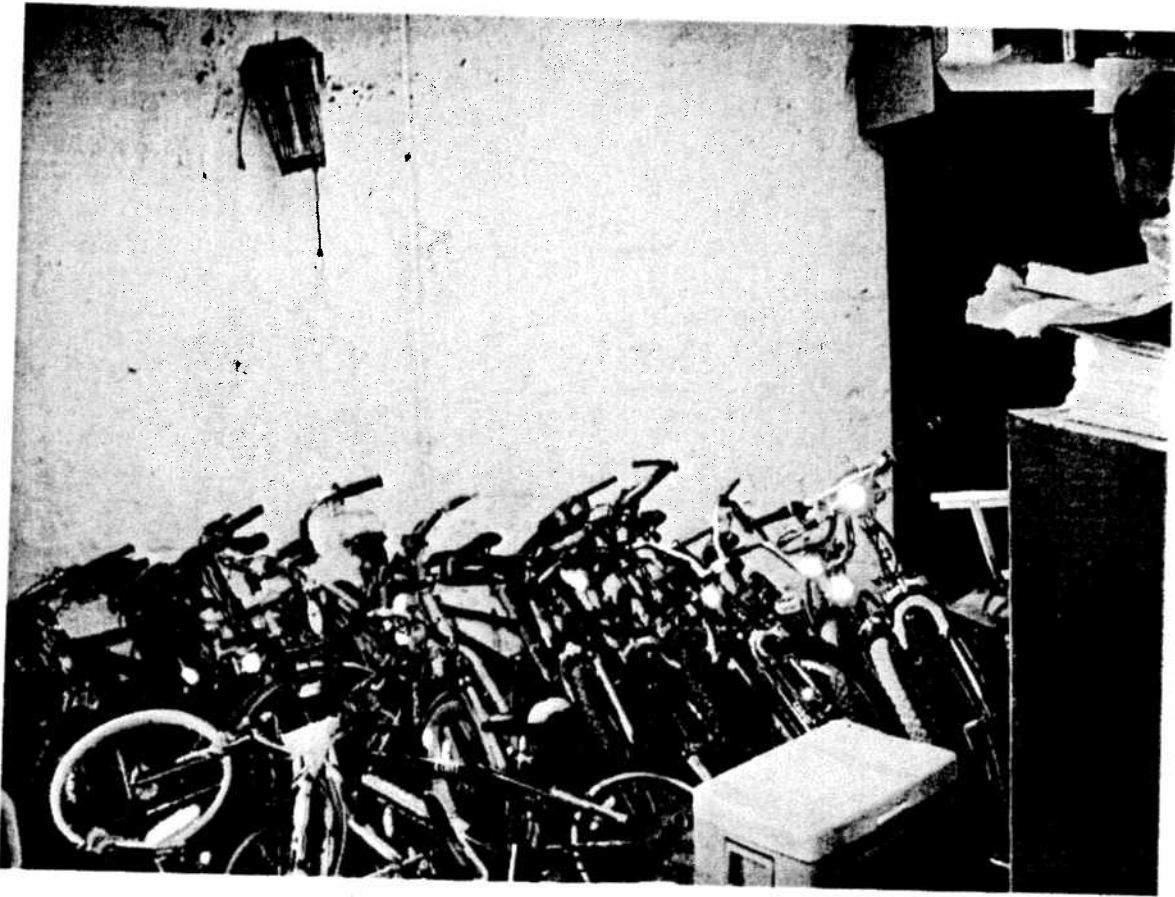
- The original paint in the armory has been painted over in most areas of the building. Some rooms may still have original paint. Chipped paint was observed in some of storage rooms adjacent to the vehicle bays. Due to the timeframe the building was constructed, lead based paint may have been used.

Figure 11. Hominy Armory – Hominy police impound storage room – note flaking original painted wall.

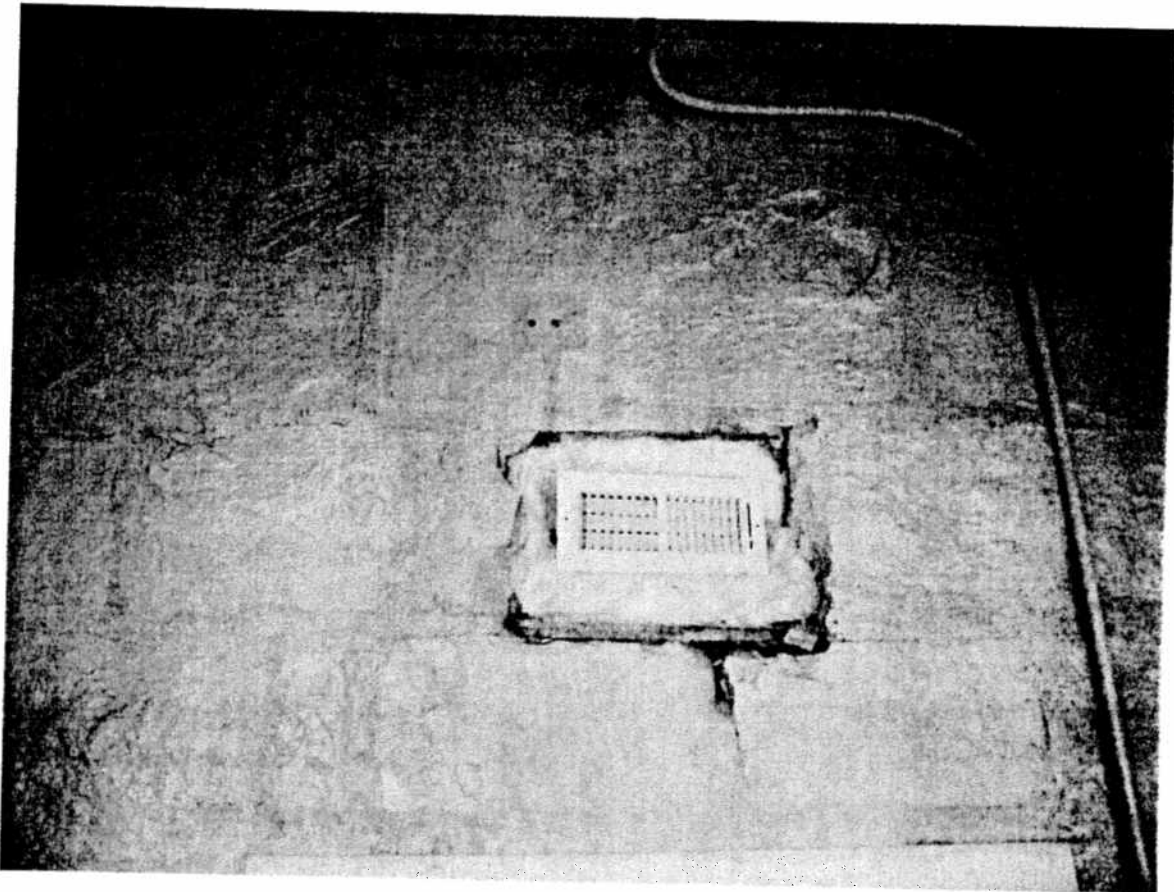
Figure 15. Hominy Armory – fire department office space and storage area in the north side of the building in the former mess hall area – note original green painted surface shows where an outlet was removed above the vent.

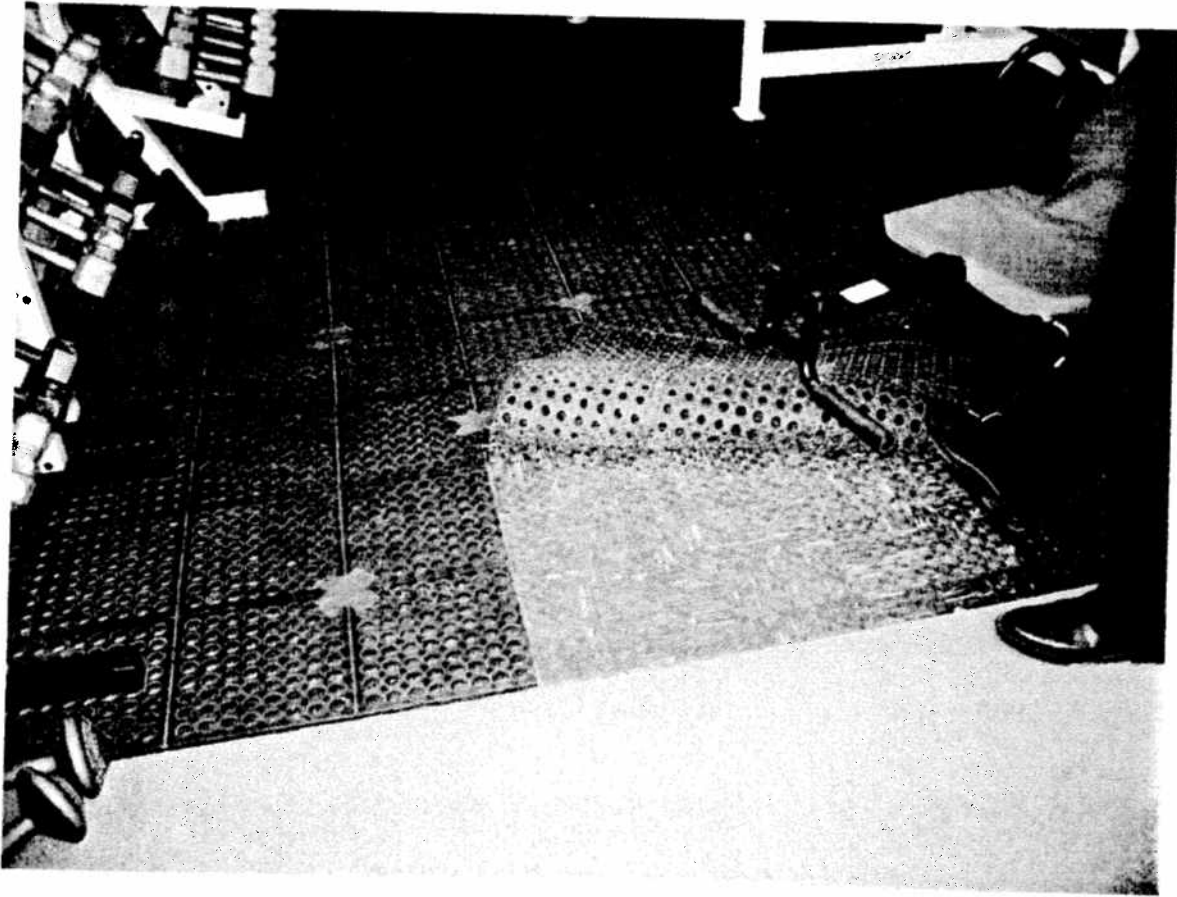
Nine-inch square tiles, which often contains asbestos, were observed in the former mess hall area now used as the fire department weight room. The tiles appear to be in good condition and are covered with protective rubber matting. Additional tile may be present in the building but can not be readily observed due to recent remodeling. Other asbestos containing materials (ACMs) may include roofing products, insulation in the space heaters and wrapping around the elbow connections.

Figure 16. Hominy Armory – fire department workout room floor showing 9”x 9” suspected ACM tile under rubber matting and likely continuing under the newly installed carpet. The tile appears to be in good condition.

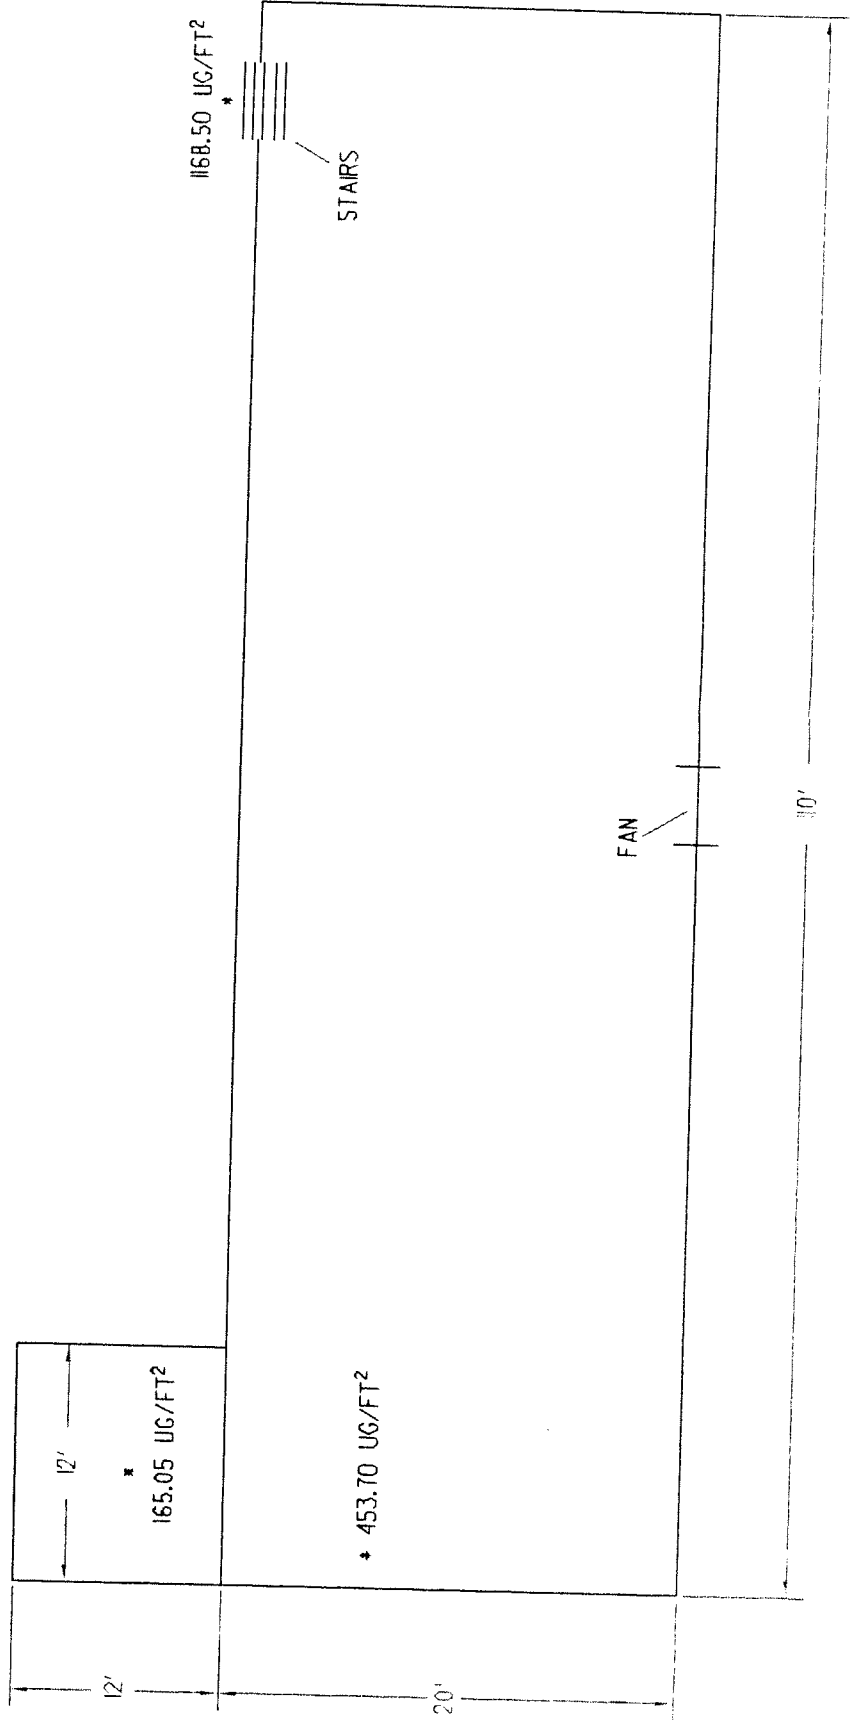
HOMINY FIRING RANGE NOTES:

- 453.70 ug/ft<sup>2</sup> of lead was found at the east end of the IFR near the bullet trap.
- 1168.50 ug/ft<sup>2</sup> of lead was found in the stair well at the entrance to the IFR.
- 165.05 ug/ft<sup>2</sup> of lead in the room adjacent to the IFR to the south.
