**Former National Guard Armory
Madill, Oklahoma**

Remediation Final Report

The Oklahoma Department of Environmental Quality (DEQ) is pleased to present the Marshall County Chamber of Commerce with the Final Remediation Report for the former Madill Armory.

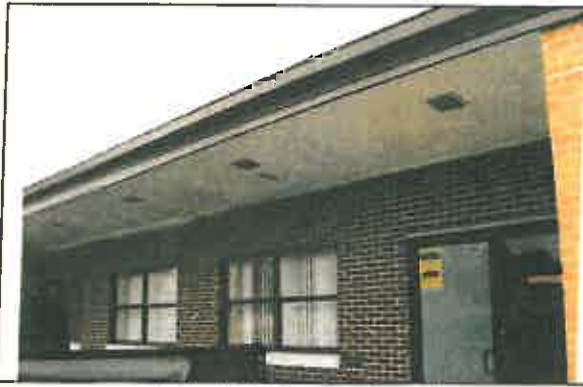
HA #1: Transite Panels

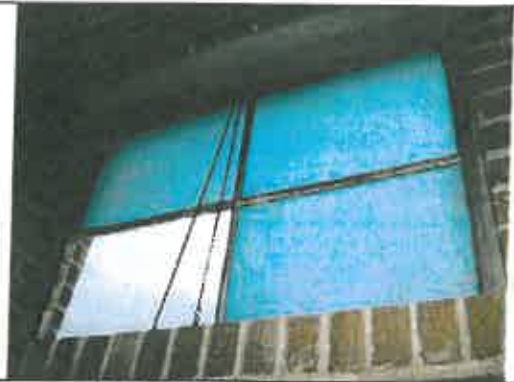
HA # 2: Window Caulking

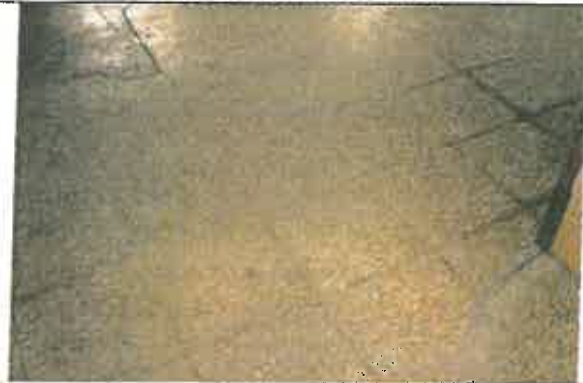
HA #3: 1x1 Floor Tile (Red/Beige)

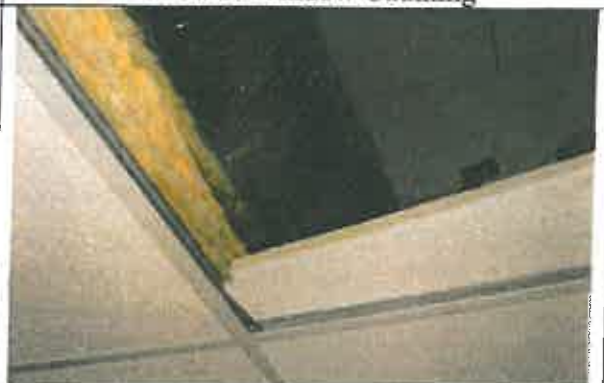
HA #4: 2x4 Ceiling Tile

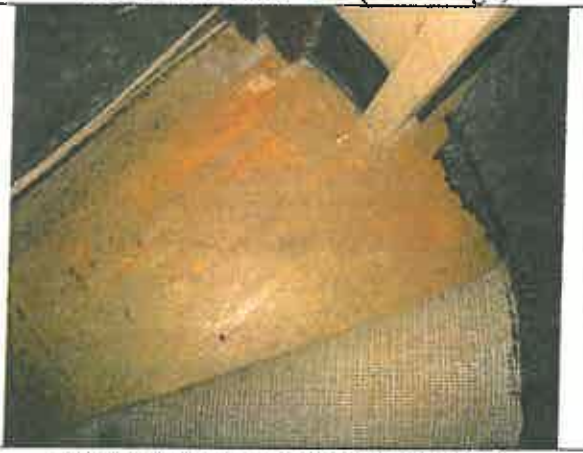
HA #5: 1x1 Floor Tile (Tan/Brown)

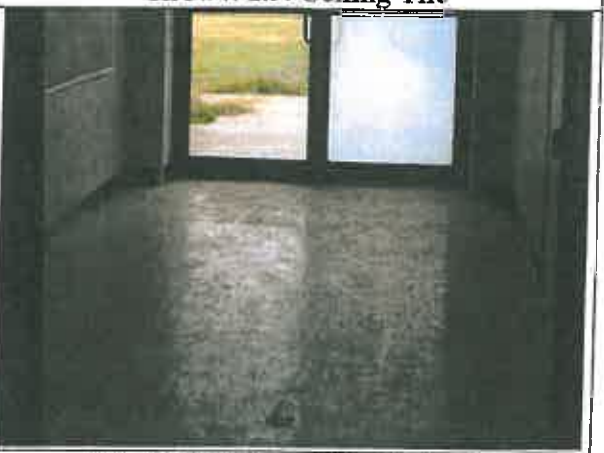
HA #6: 1x1 Floor Tile (Yellow)

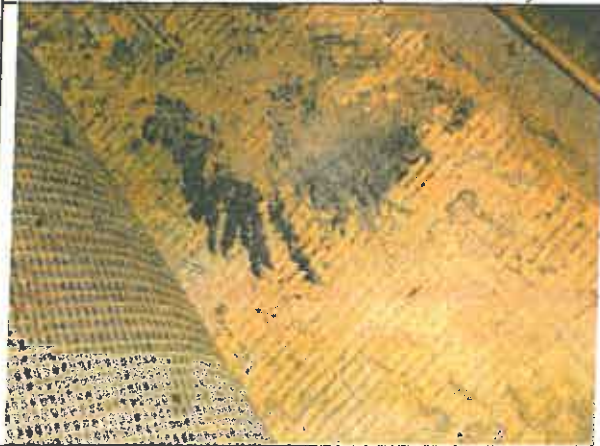
HA #7: Carpet Mastic (Yellow/Black)

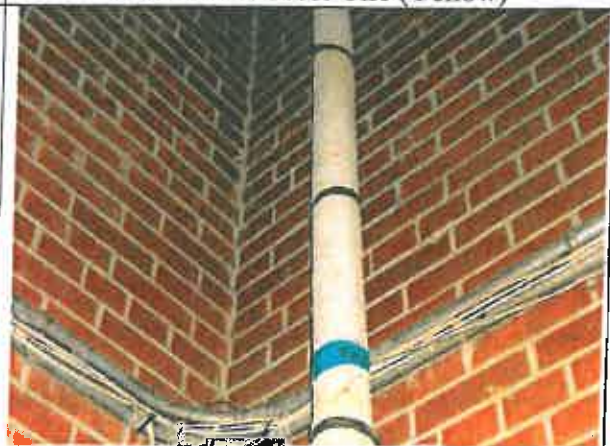
HA #8: Pipe Insulation (Cold)

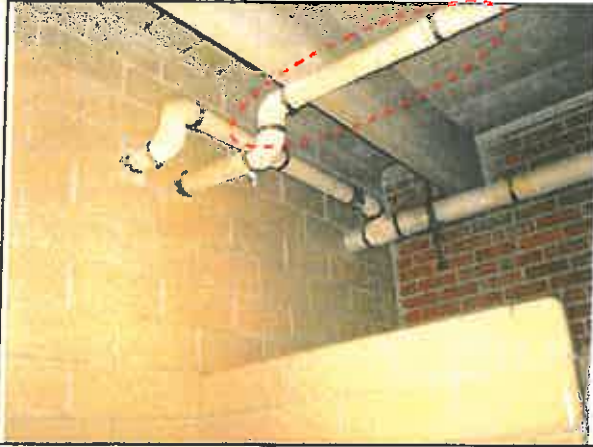
HA #9: Piping Insulation (Hot)

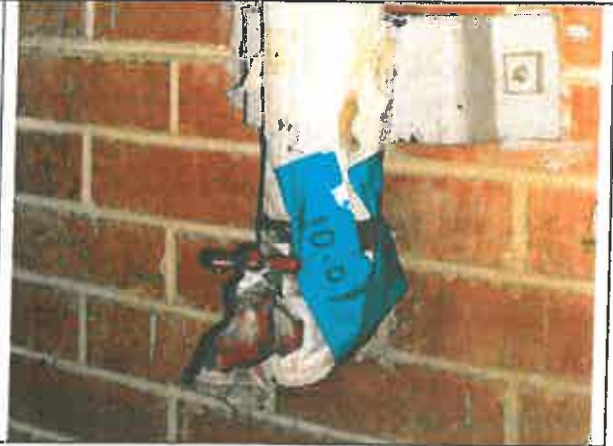
HA # 10: Pipe Fitting (Cold)

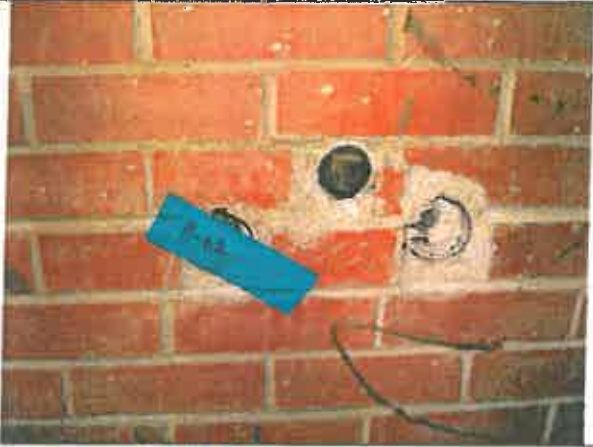
HA #11: Pipe Fitting (Hot)

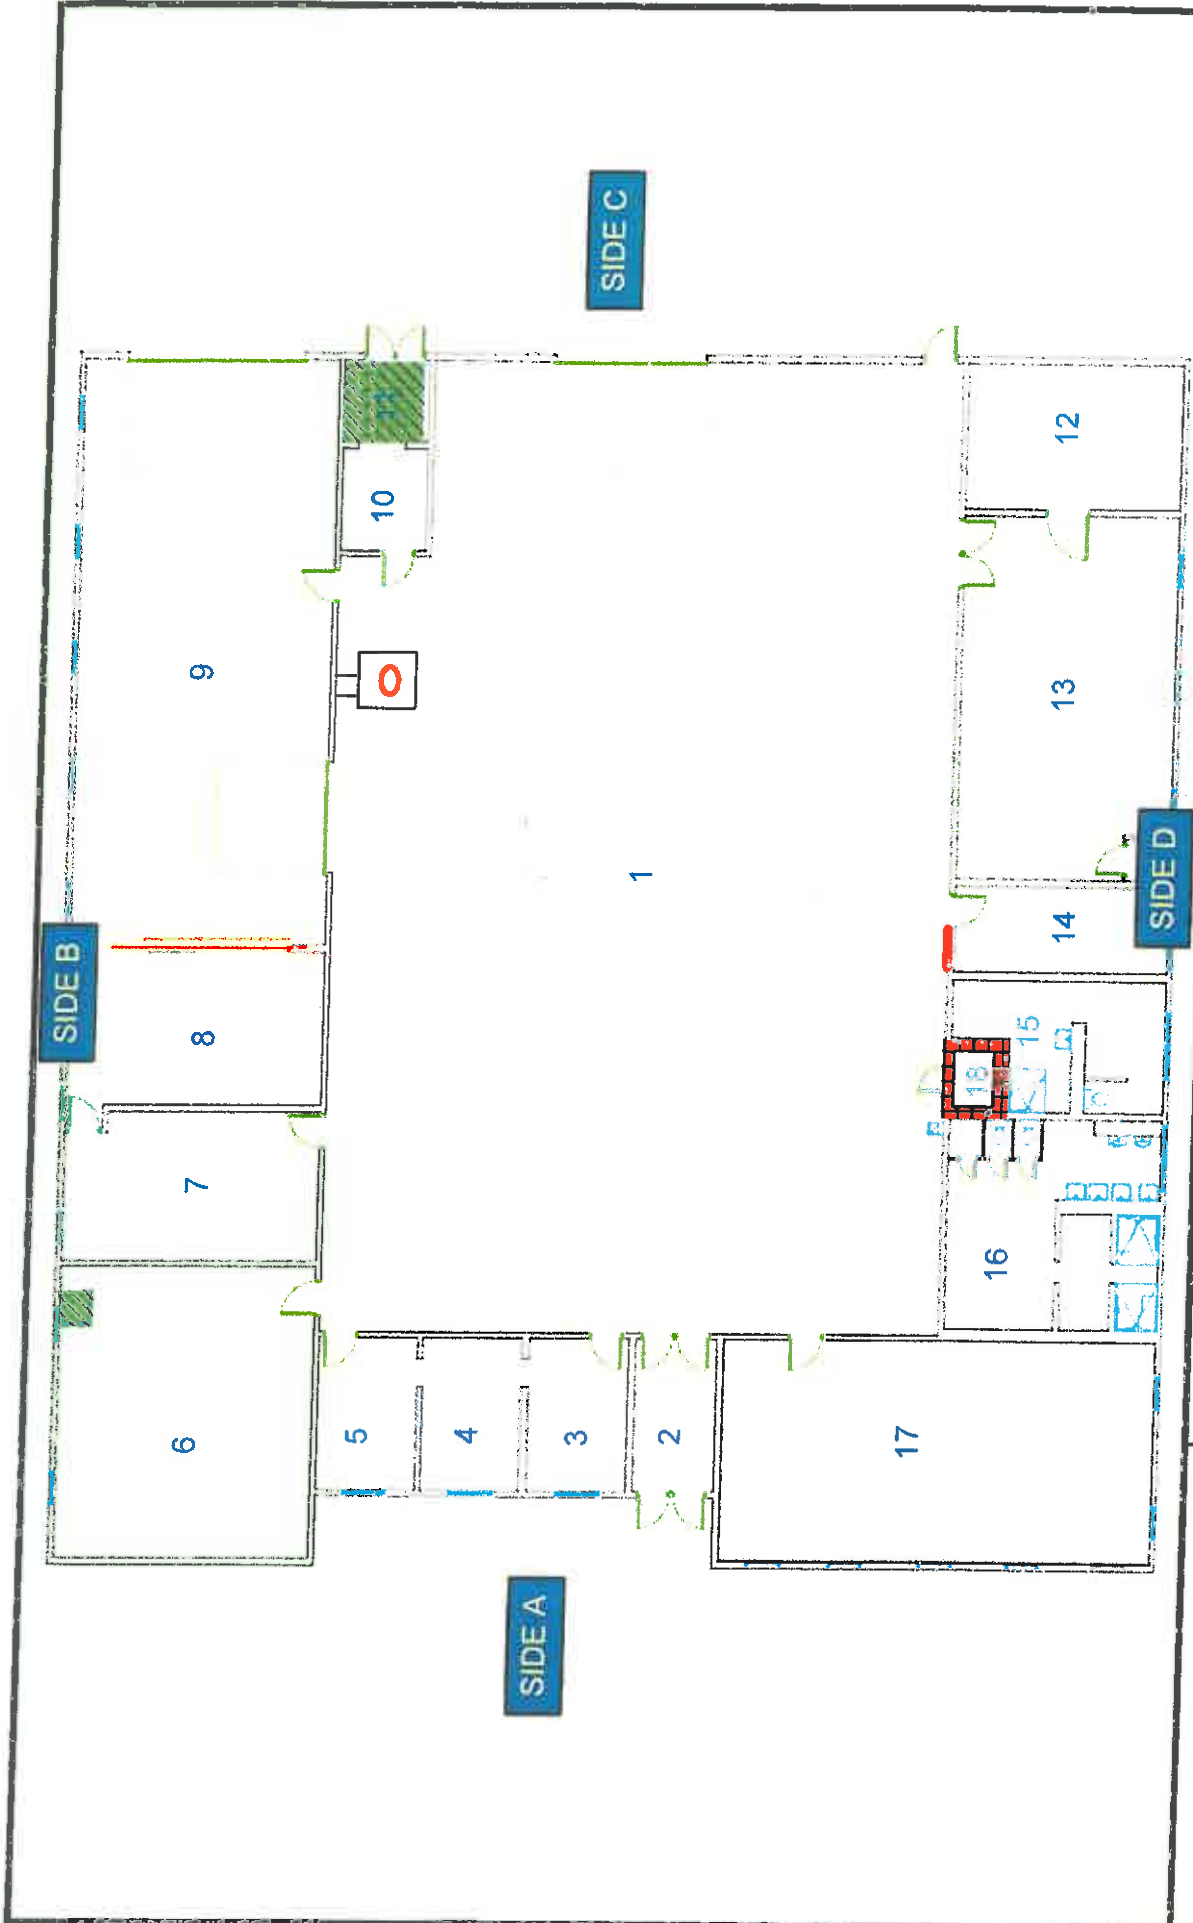
**Figure 1
LEAD-BASED PAINT LOCATIONS**

A total of 182 XRF samples were collected, including calibration and null readings. Figure 1 in Appendix A shows the location of the components with LBP. Tables 1, 2, and 3 provide a summary of building components with LBP as identified by XRF sampling along with their locations and sizes. The painted surfaces sampled during the survey ranged from intact to poor condition. Representative photographs were taken of components where positive readings (1.0 mg/cm² or greater) were obtained and are provided in Appendix B.

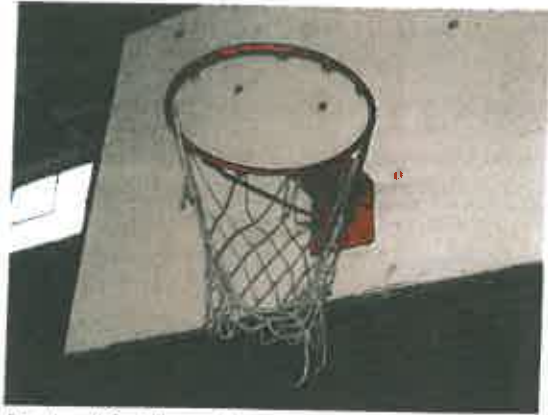
Photo #2: View of orange painted basketball hoop in Room 1 - LBP.

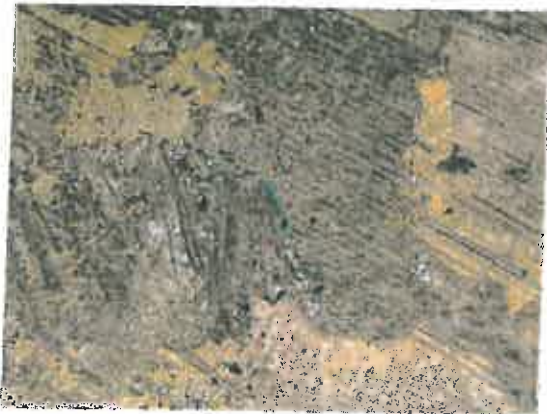
Photo #3: View of green painted concrete floor in Room 6 - LBP.

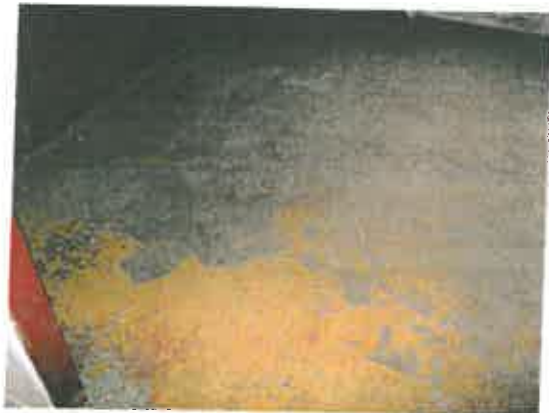
Photo # 4: Yellow, red, and gray painted concrete floor in Room 11 - LBP.

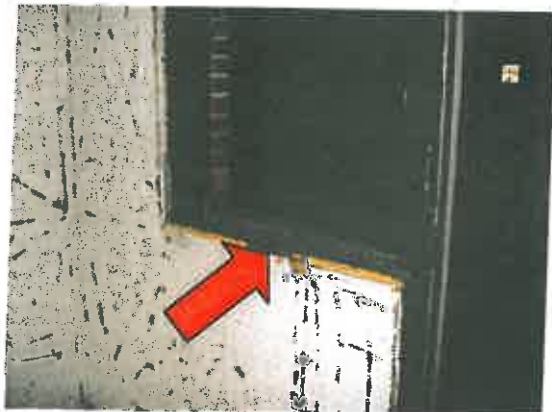
Photo # 5: Black painted pass through window sill in Room 14 - LBP.

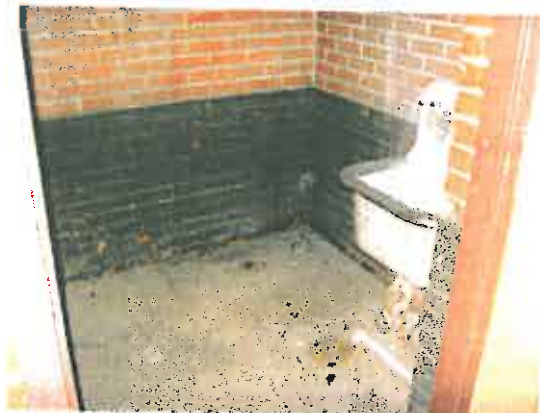
- Interior: The basketball hoop in Room 1, a small area of the concrete floor in Room 6, the concrete floor in Room 11, the pass through windowsill in Room 14 and the painted lower portion of the brick walls in Room 18 were coated with LBP.
- Exterior: No LBP was found on the exterior of the building.

Photo # 6: Green painted brick wall in Room 18 - LBP.

1. All painted walls in Room 18 were scrapped and encapsulated with lead-based paint encapsulant. These surfaces need to be re-encapsulated if lead-based paint encapsulant shows signs of deterioration, damage, or flaking. See Attachment 2 for Madill Armory Floor Plan Map.
2. The floors of Room 6 and Room 11 had lead-based paint visibly removed, were cleaned and sealed to remediate surfaces below 40 μ g/SF for lead. These surfaces need to be resealed if sealant shows signs of deterioration, damage, or flaking. See Attachment 2 for Madill Armory Floor Plan Map.

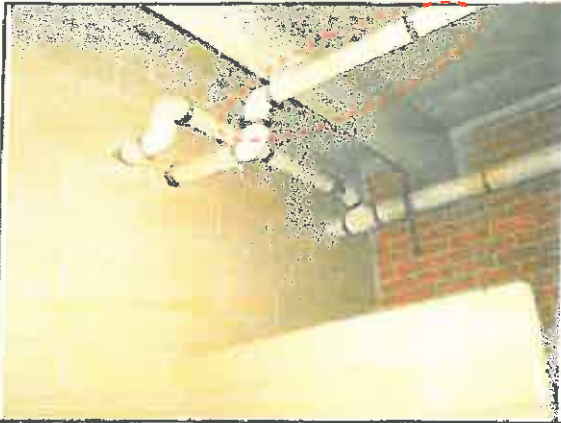
HA #9: Piping Insulation (Hot)

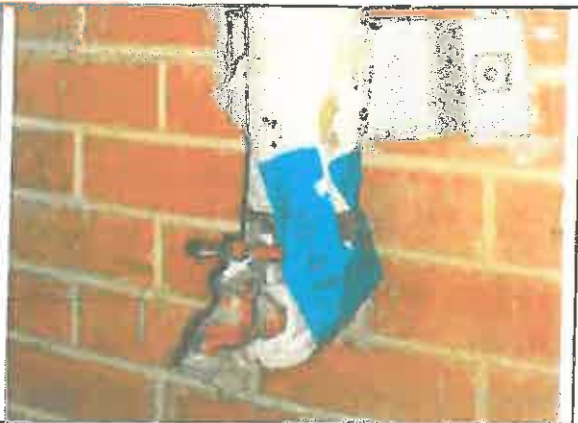
HA #10: Pipe Fitting (Cold)

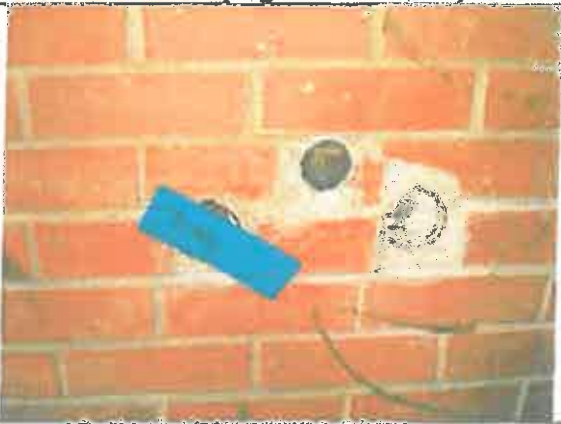
HA #11: Pipe Fitting (Hot)

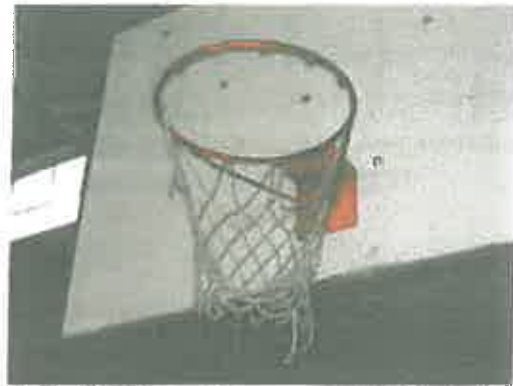
Photo #2: View of orange painted basketball hoop in Room 1 - LBP.

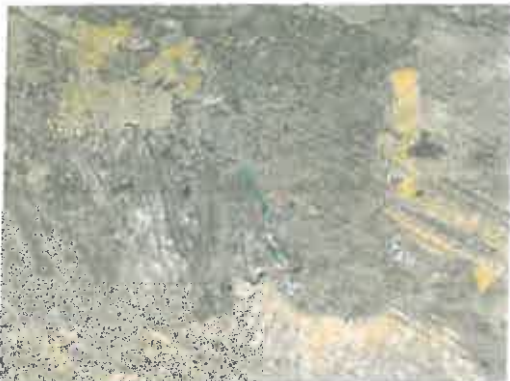
Photo #3: View of green painted concrete floor in Room 6 - LBP.

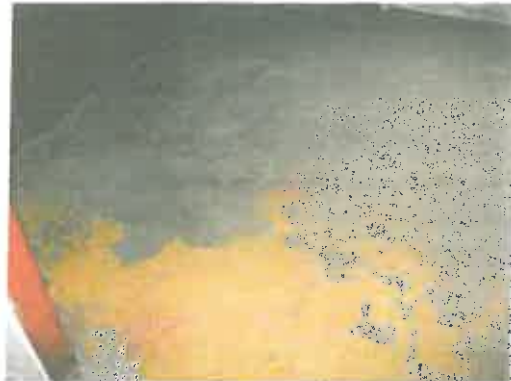
Photo # 4: Yellow, red, and gray painted concrete floor in Room 11 - LBP.

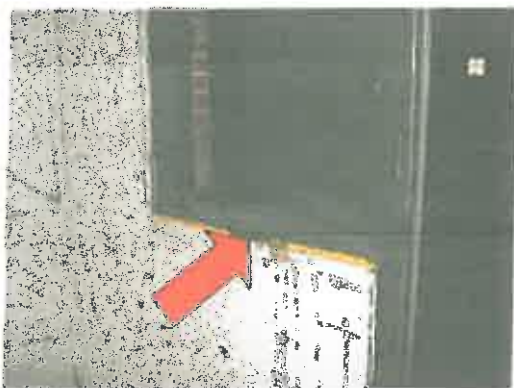
Photo # 5: Black painted pass through window sill in Room 14 - LBP.

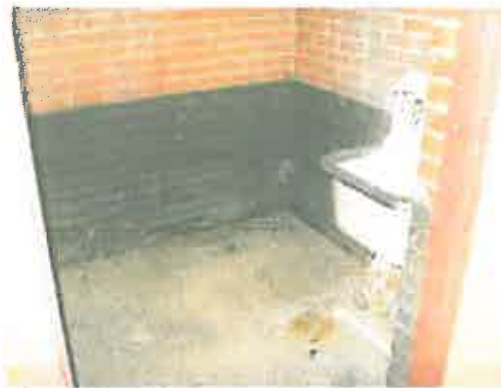
Photo # 6: Green painted brick wall in Room 18 - LBP.

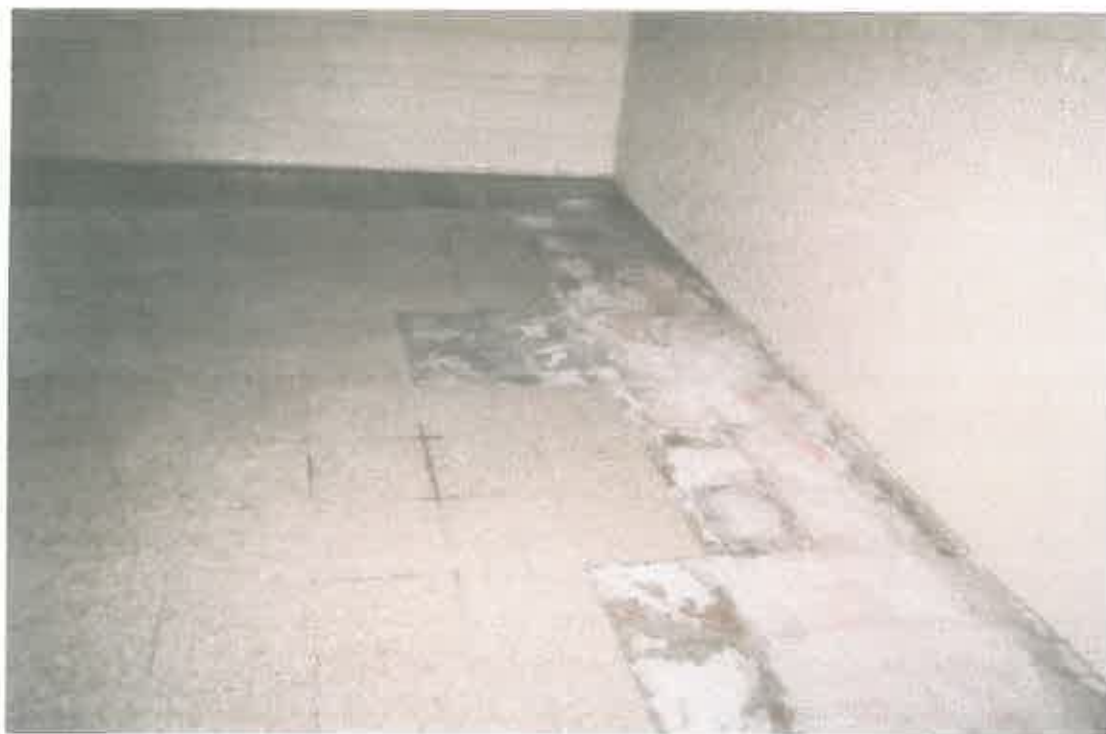
HA #3: 1 x 1 FLOOR TILE
