**Targeted Brownfields Assessment
Oklahoma Army National Guard
Mangum
Mangum, Oklahoma**

**ASTM E 1527-05
Phase I Environmental Site Assessment
All Appropriate Inquiry**

December 18, 2007

**Oklahoma Department of Environmental Quality
Land Protection Division
707 N. Robinson
P.O. Box 1677
Oklahoma City, Oklahoma 73101-1677
(405) 702-5100**

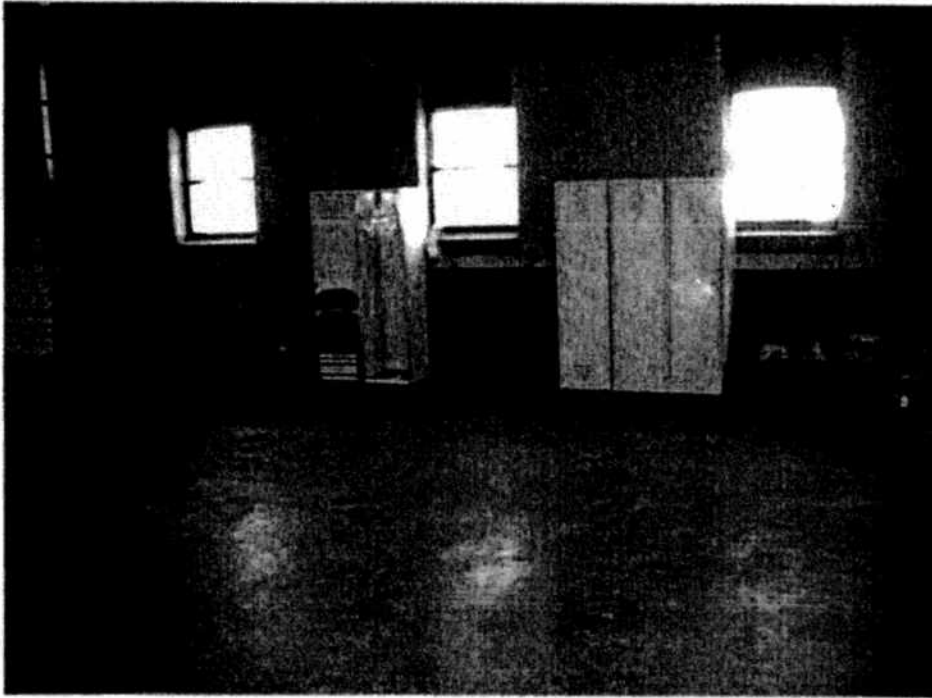
No significant chemical spills were observed at the facility. During the site visit, two or three small oil leaks resulting form the temporary storage of military vehicles on the drill floor were observed. No reports on the property are recorded in the Emergency Response Notification System (ERNS) database (Ref. 13).

Photo 45. Miscellaneous equipment stored near west bay door of the drill floor. Note staining on the floor.
