**Former National Guard Armory  
Oklahoma City SW 44th Street, Oklahoma**

**Remediation Final Report**

**Prepared by:  
Department of Environmental Quality  
707 North Robinson  
Oklahoma City, Oklahoma 73101**

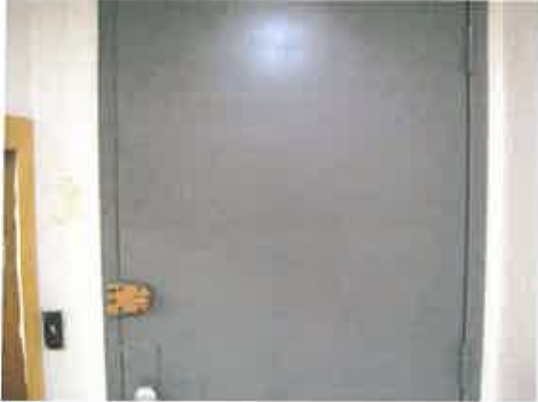
**Photo #1: Gray painted door and door frame Room 14 - LBP.**

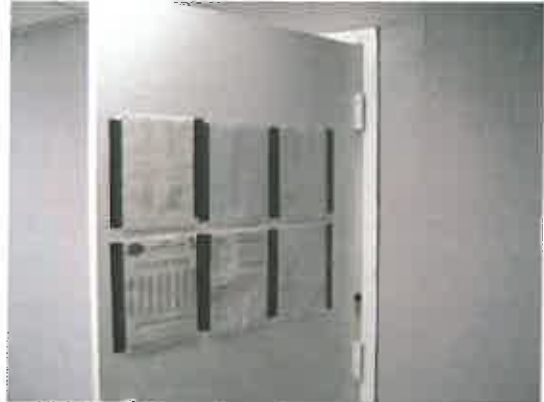
**Photo #2: Blue door frame and white door Room 12 - LBP.**

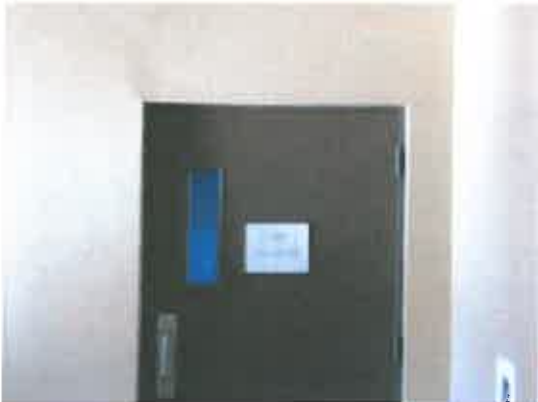
**Photo #3: Brown door frame Room 5 (1) - LBP.**

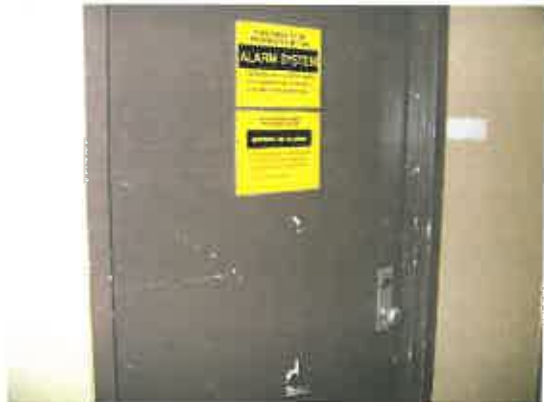
**Photo # 4: Typical brown door and door frame - LBP.**

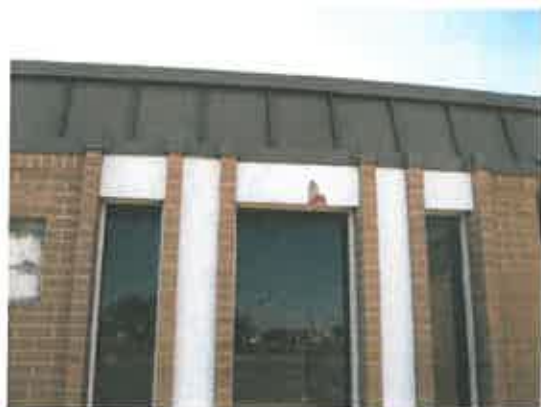
**Photo # 6: White painted trim board above window - LBP.**

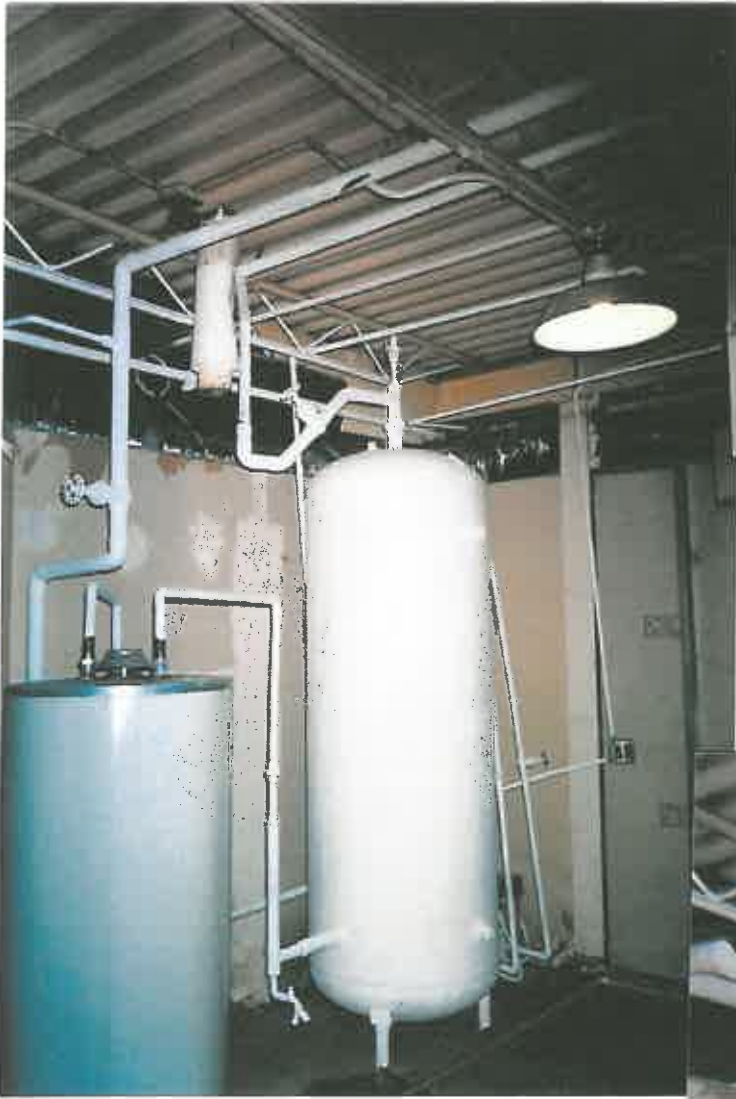
Water tank - abated

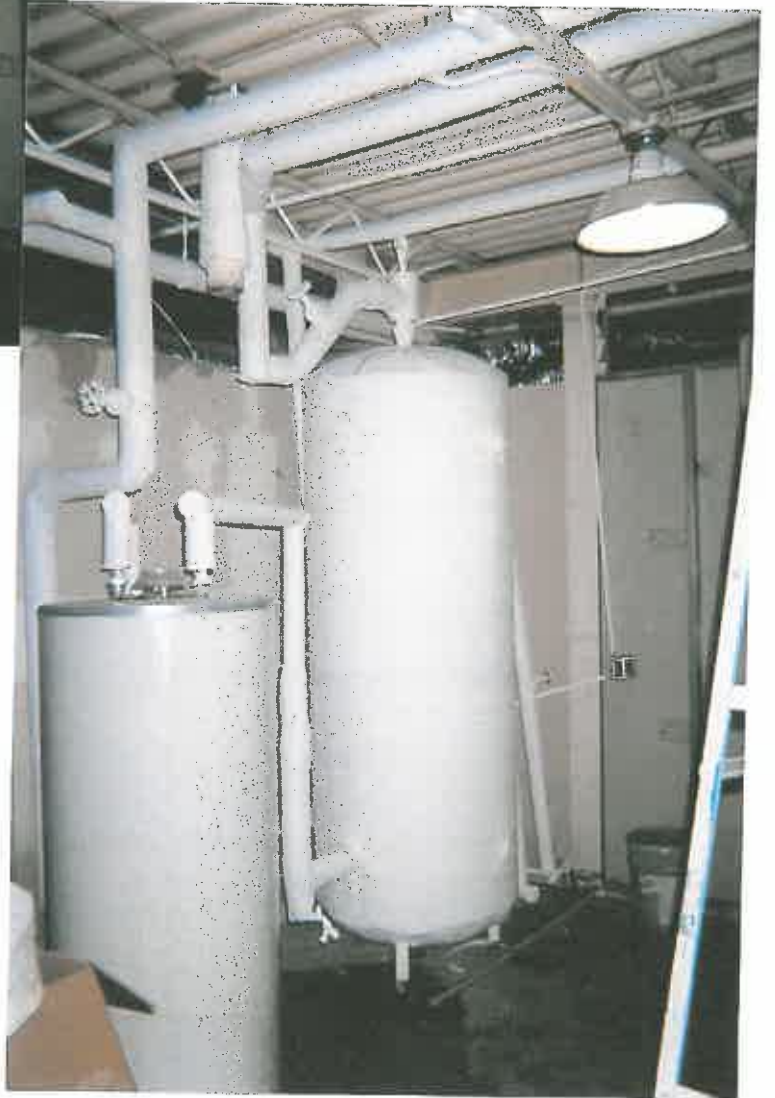
Water tank - reinsulated

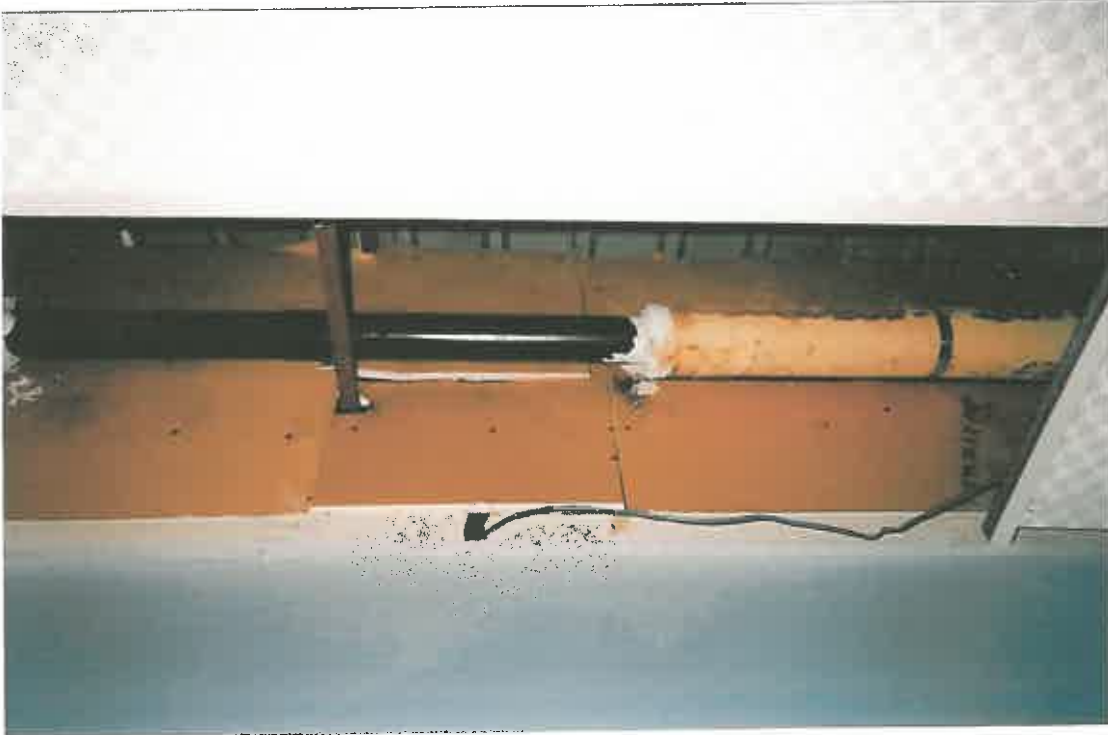
Abated fittings

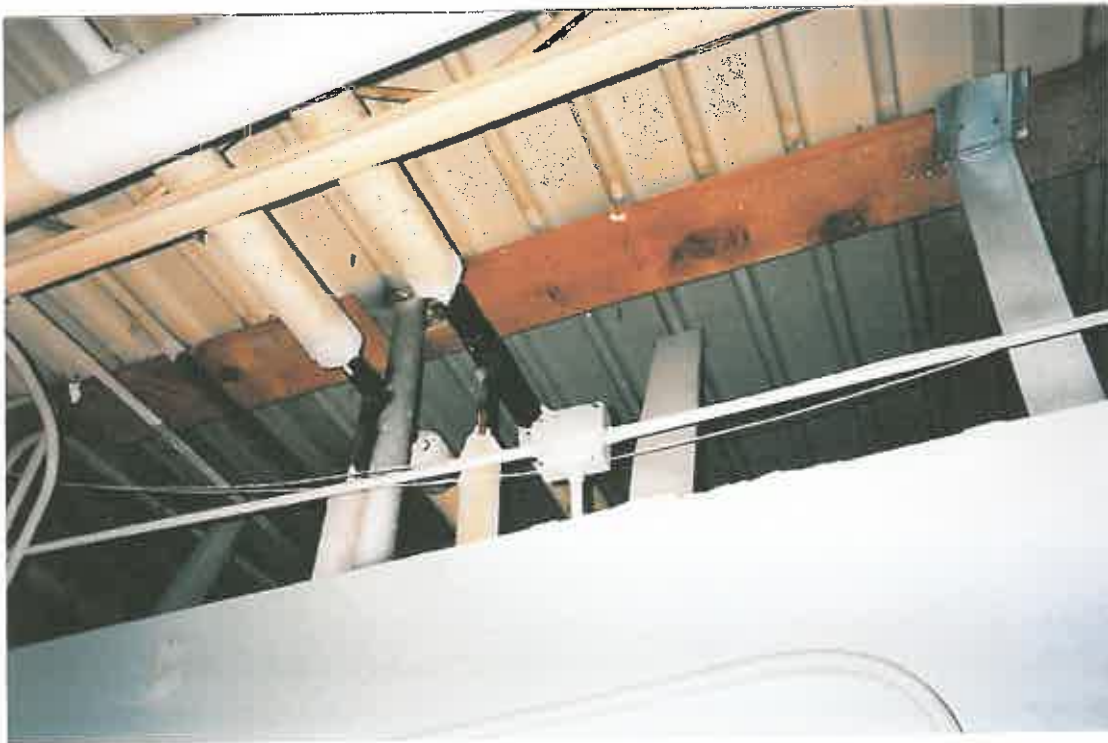
Abated fittings

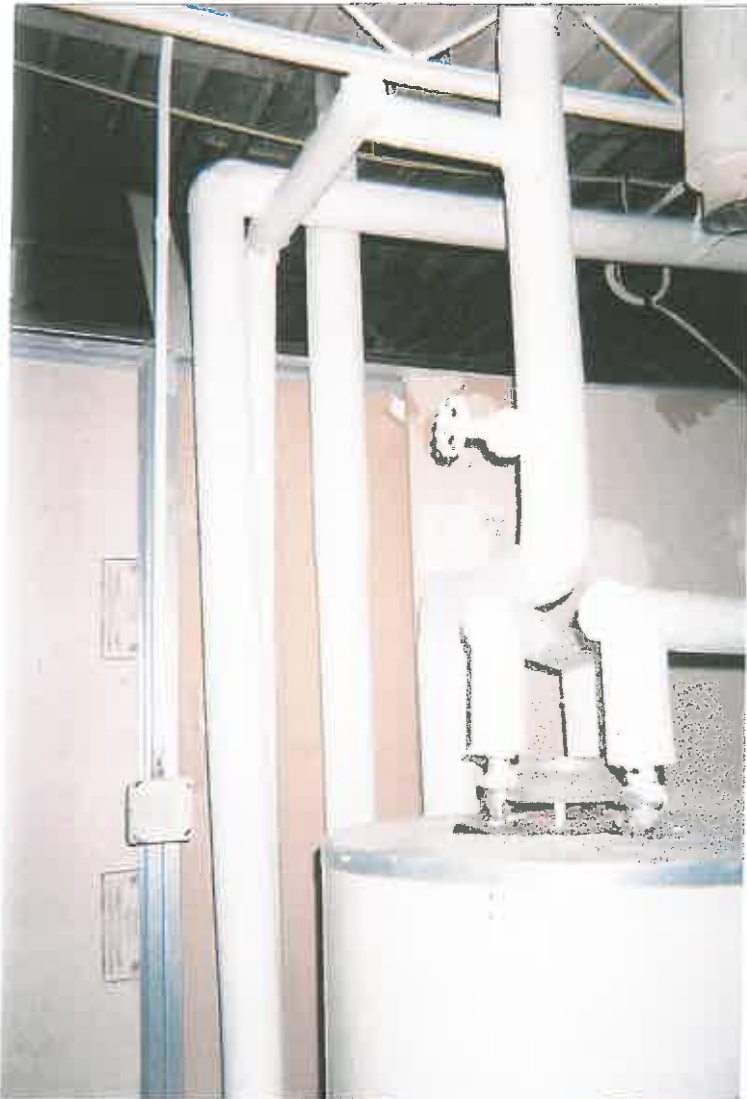
Fittings reinsulated

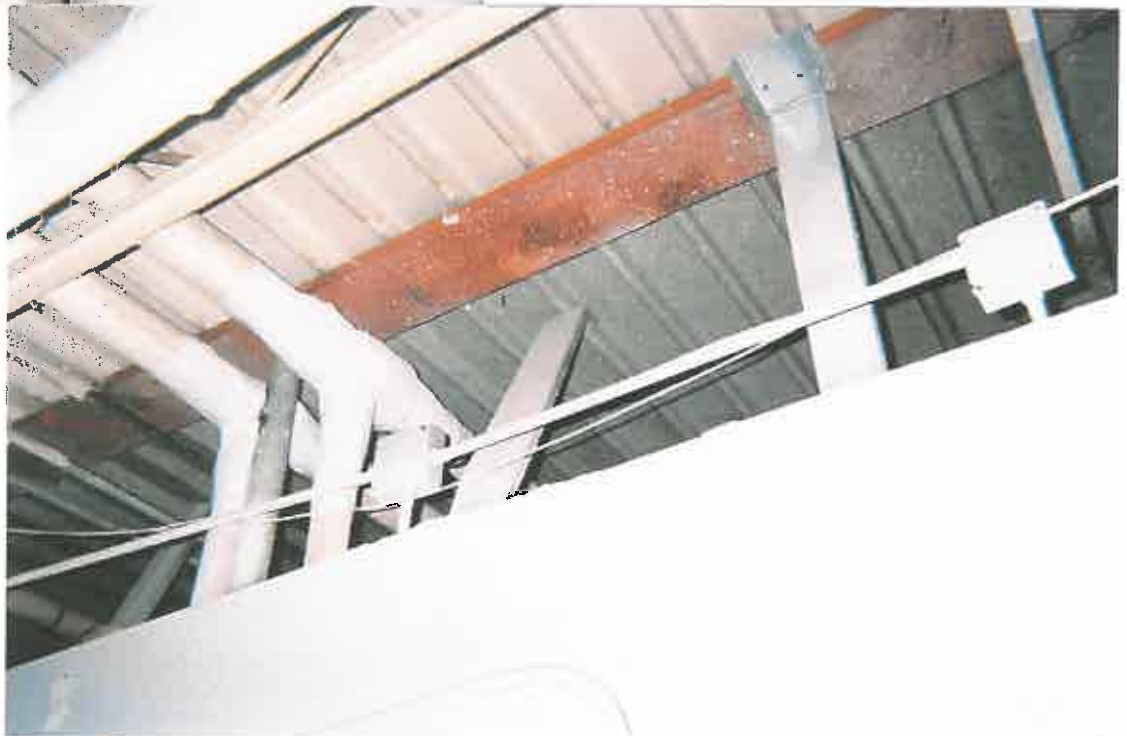
Fittings reinsulated

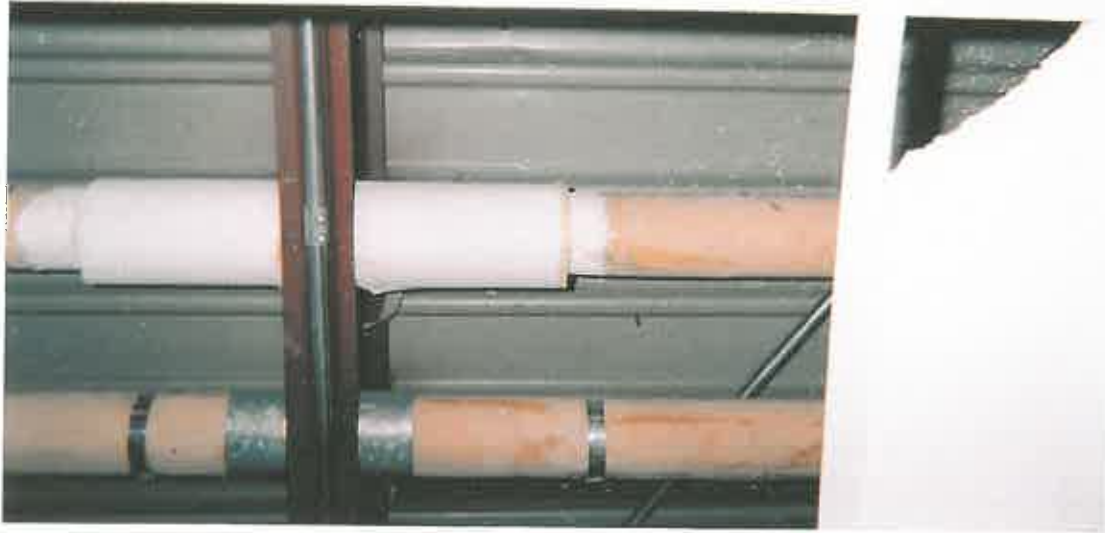
New fitting insulation

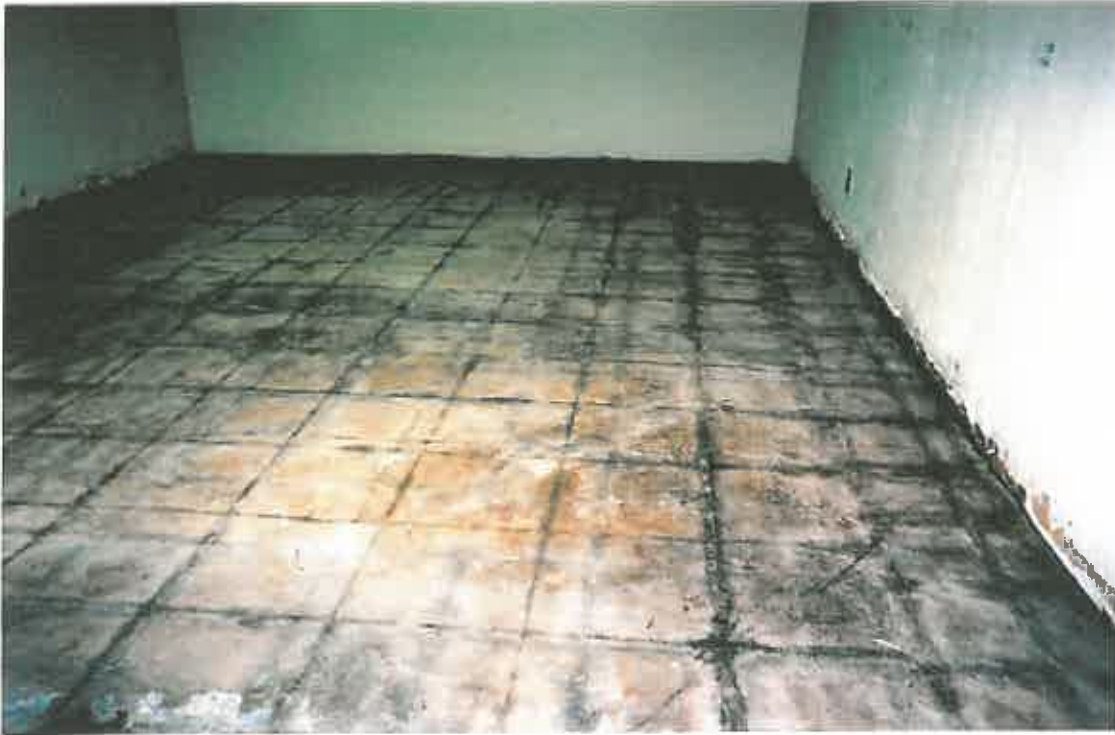
**Floor tile and mastic removed**

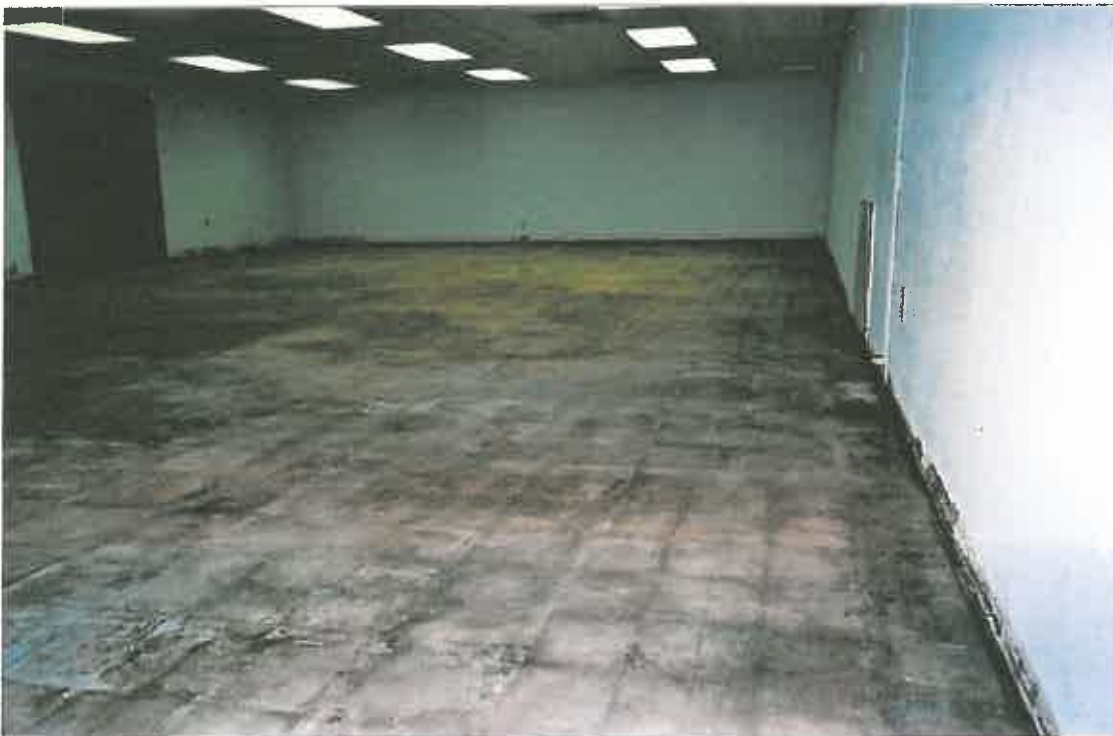
**Floor tile removed**

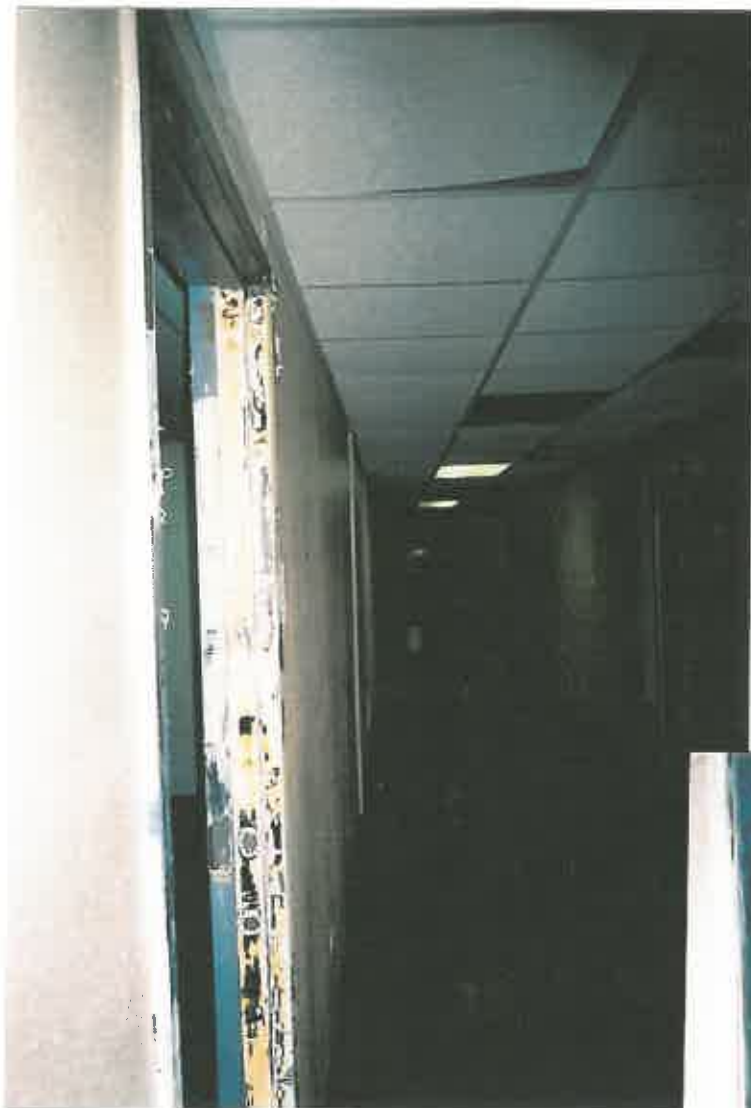
Door frame LBP removed

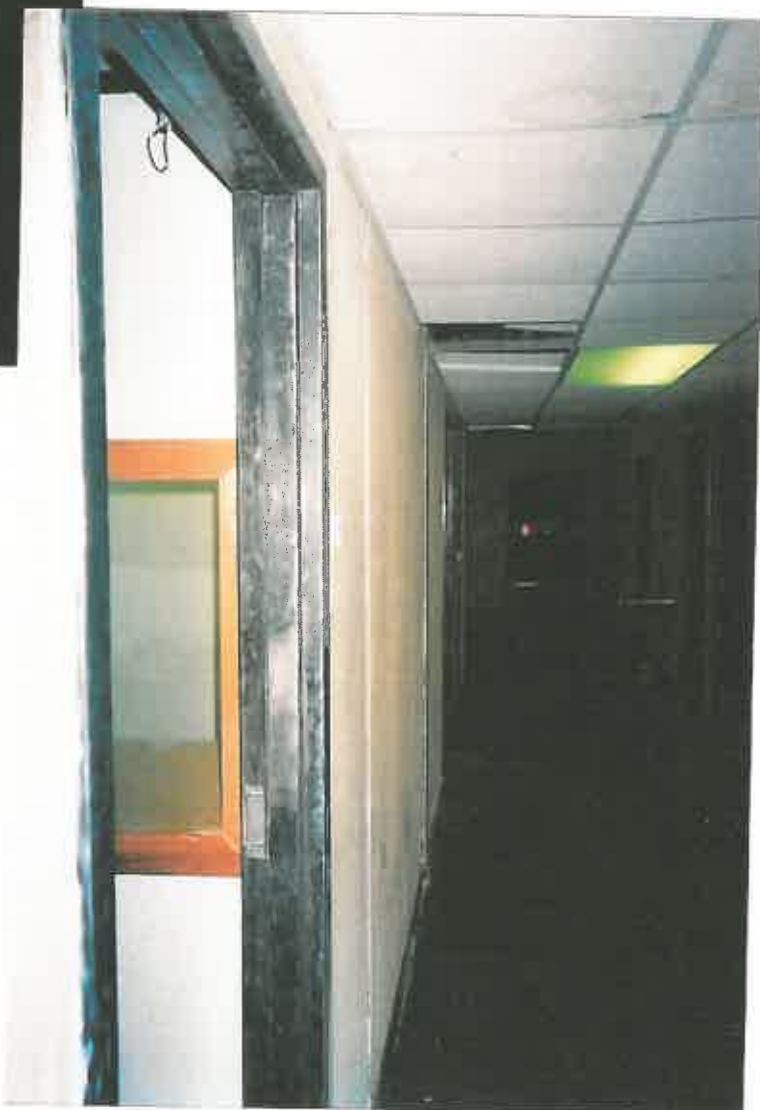
Door frame after  
abatement and sealed

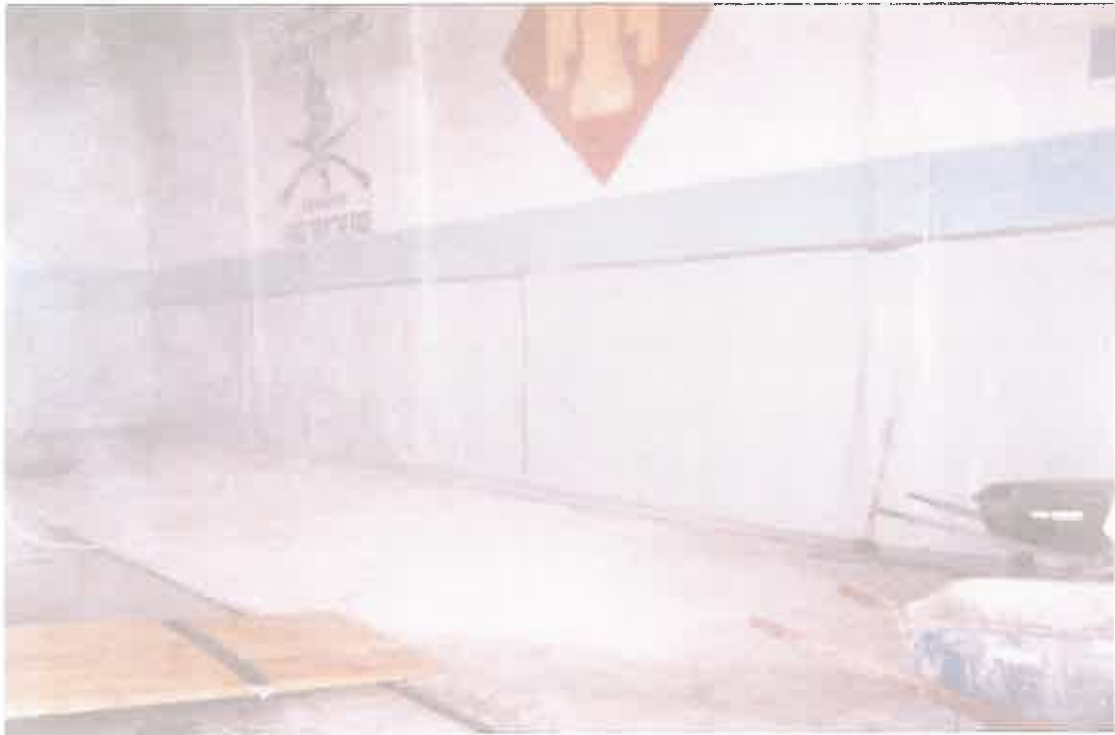
**Sand pit before abatement**

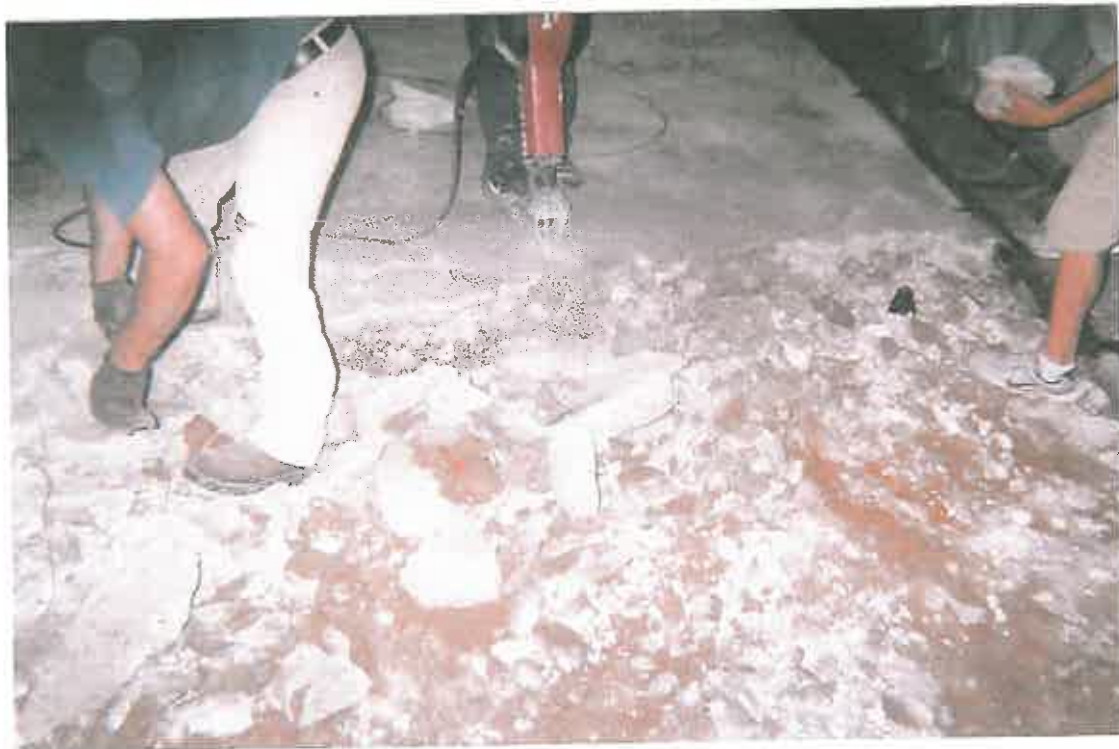
**Concrete layer of sand pit**

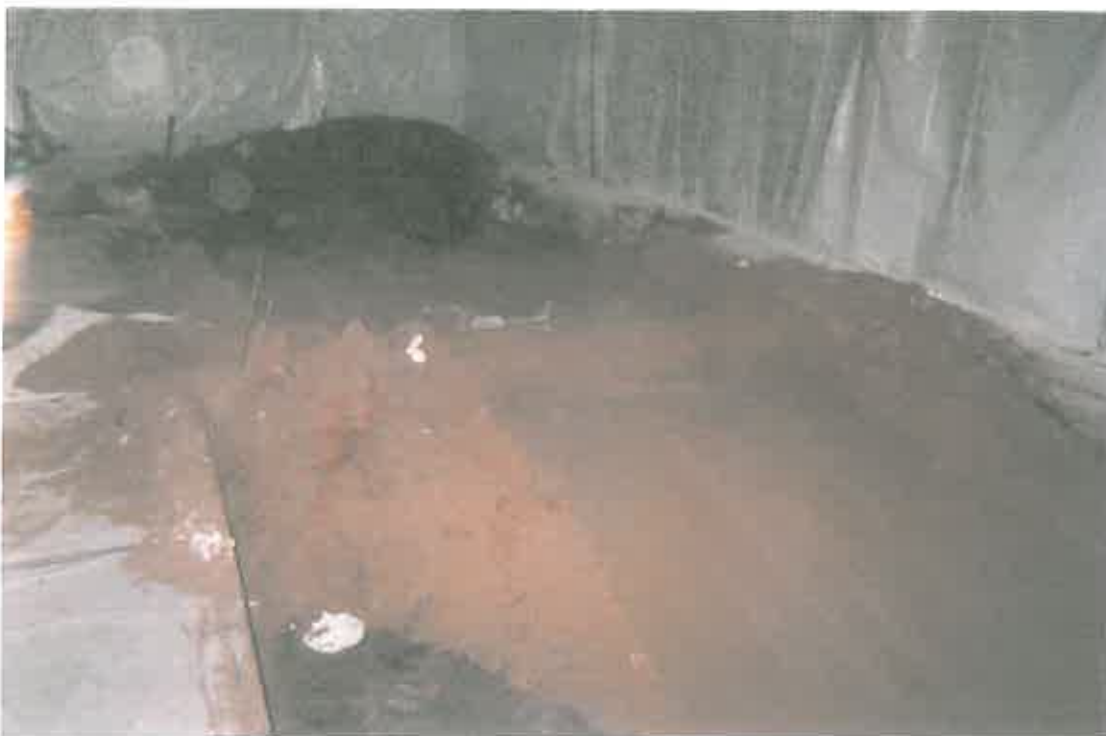
**Sand pit removal**

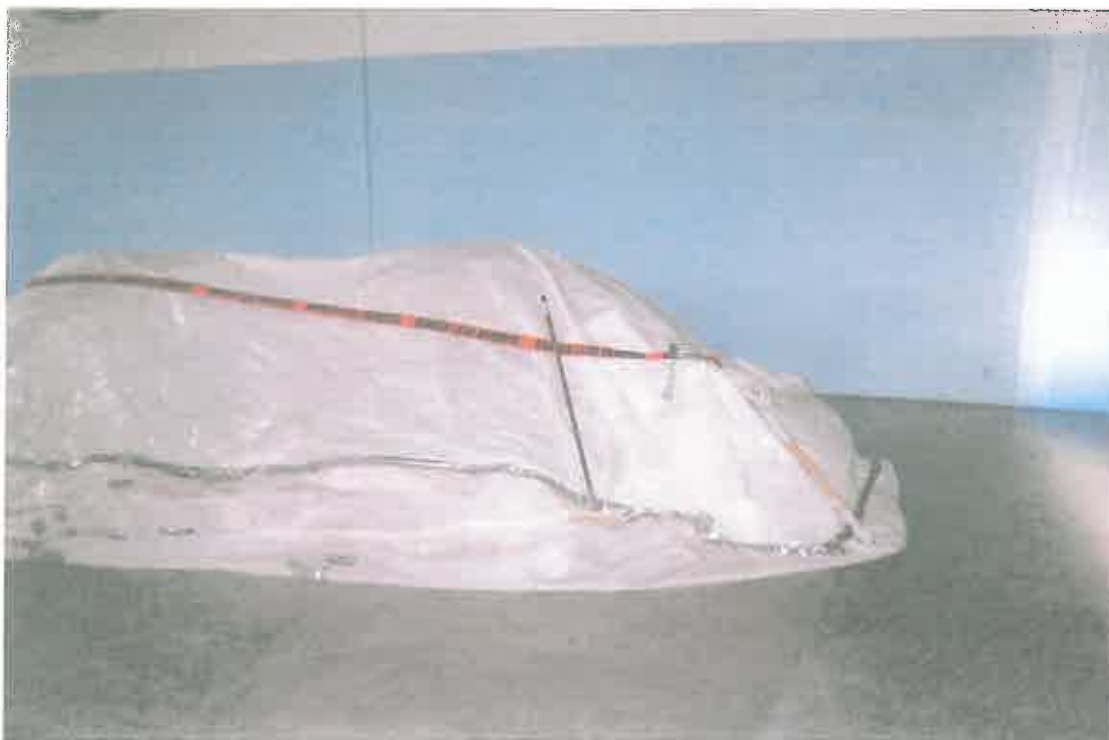
**Stored and covered sand prior to disposal**

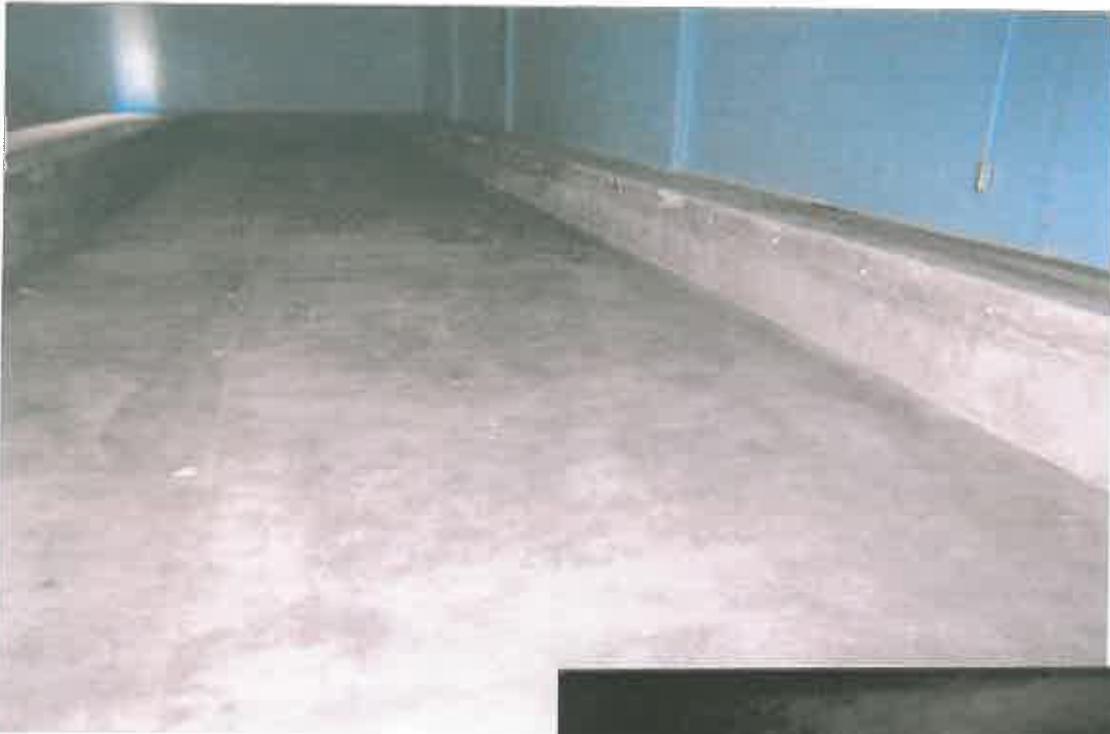
Clean sand pit

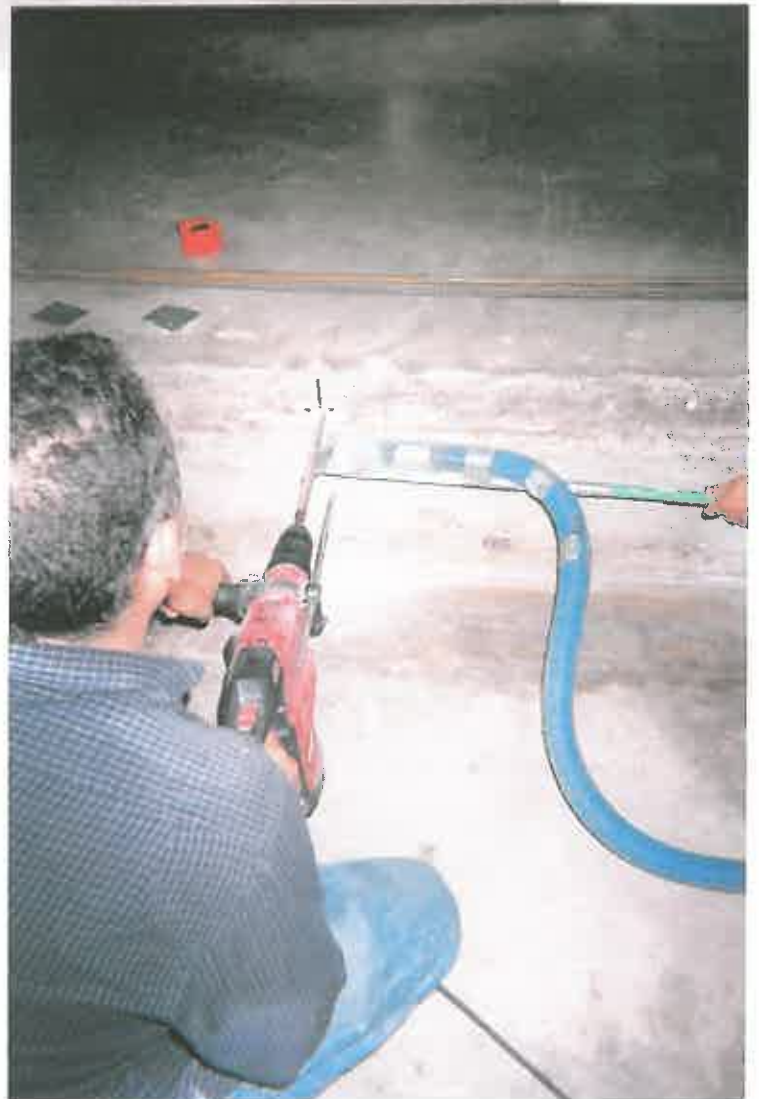
New concrete  
prep work

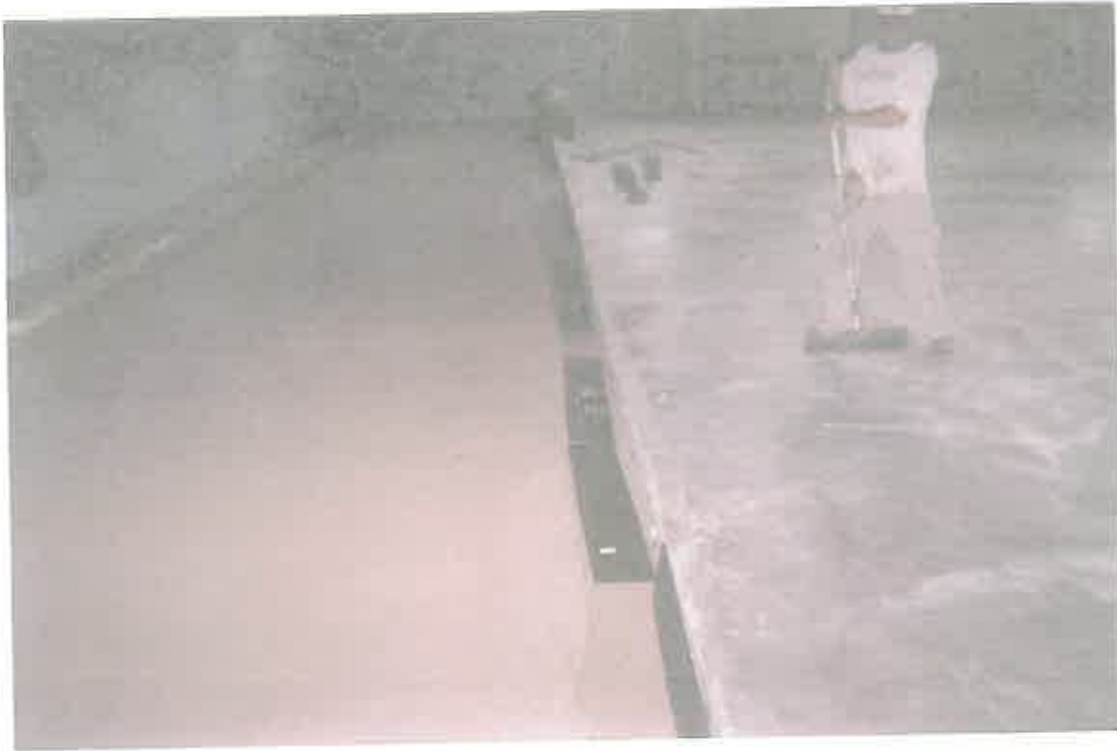
Clean sand and expansion joint

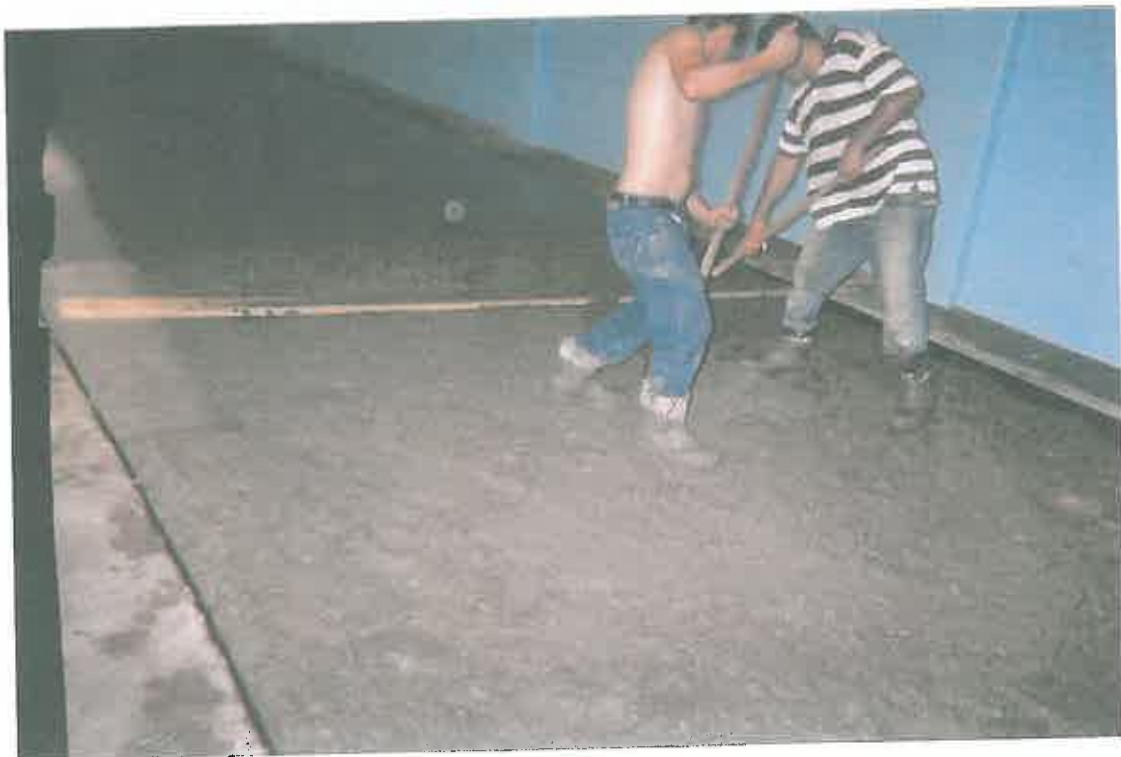
New concrete

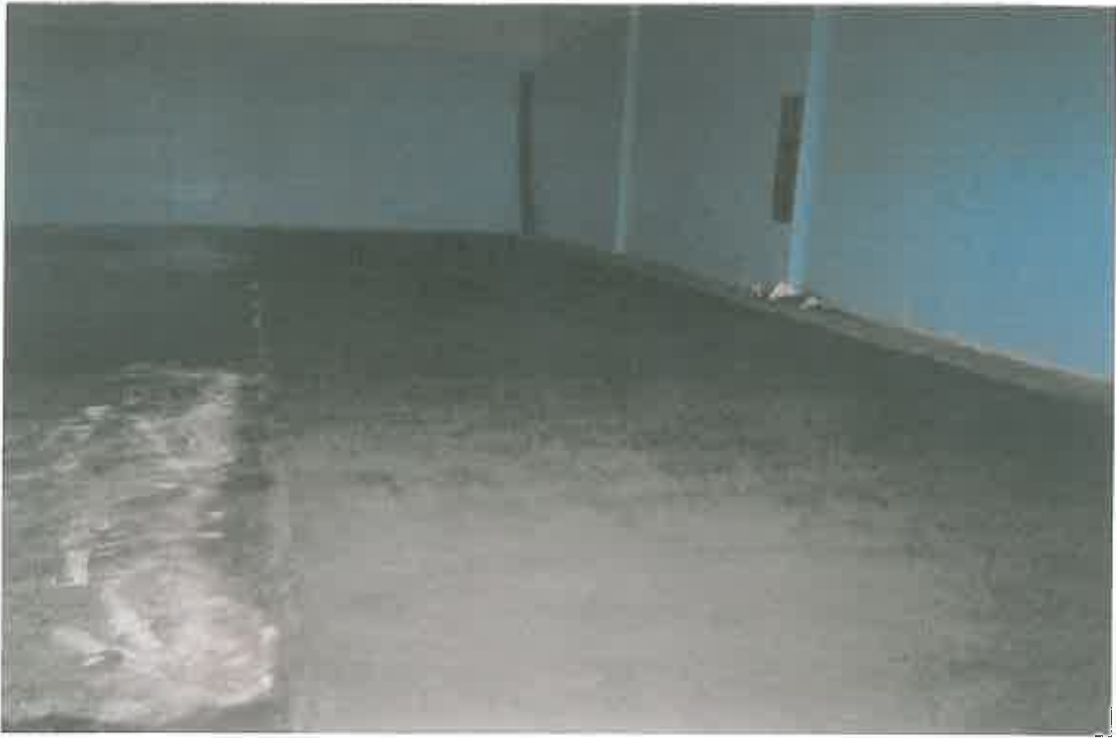
**New concrete cap - final**

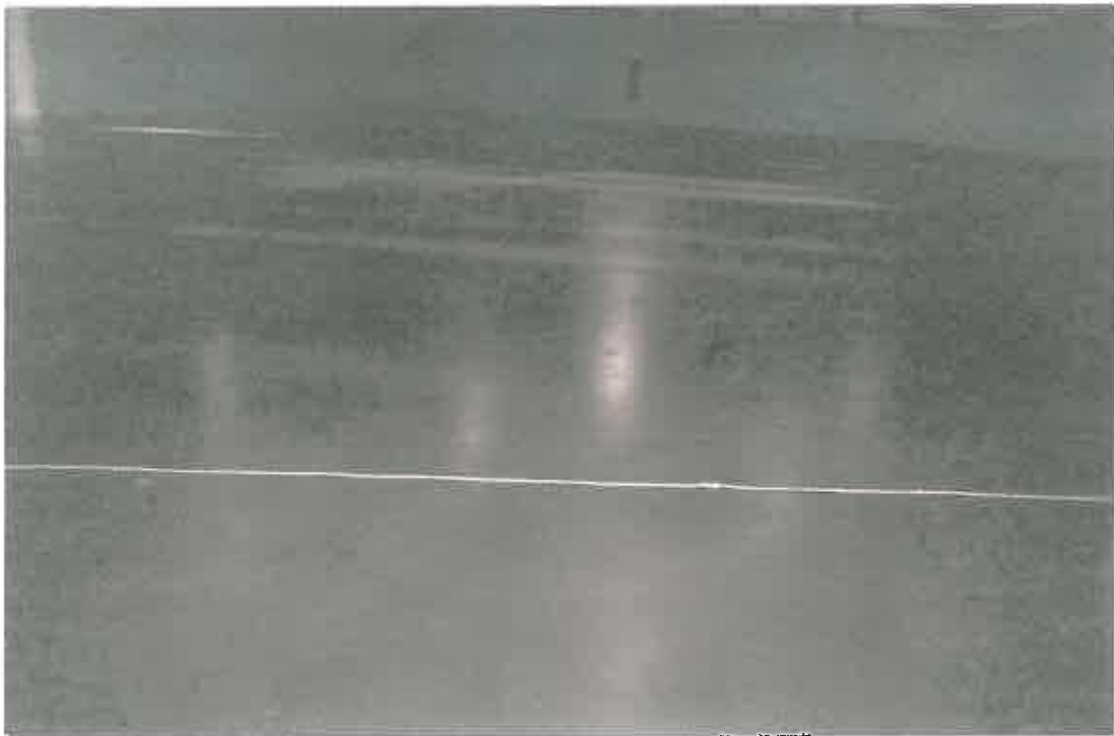
**Clean drill floor**

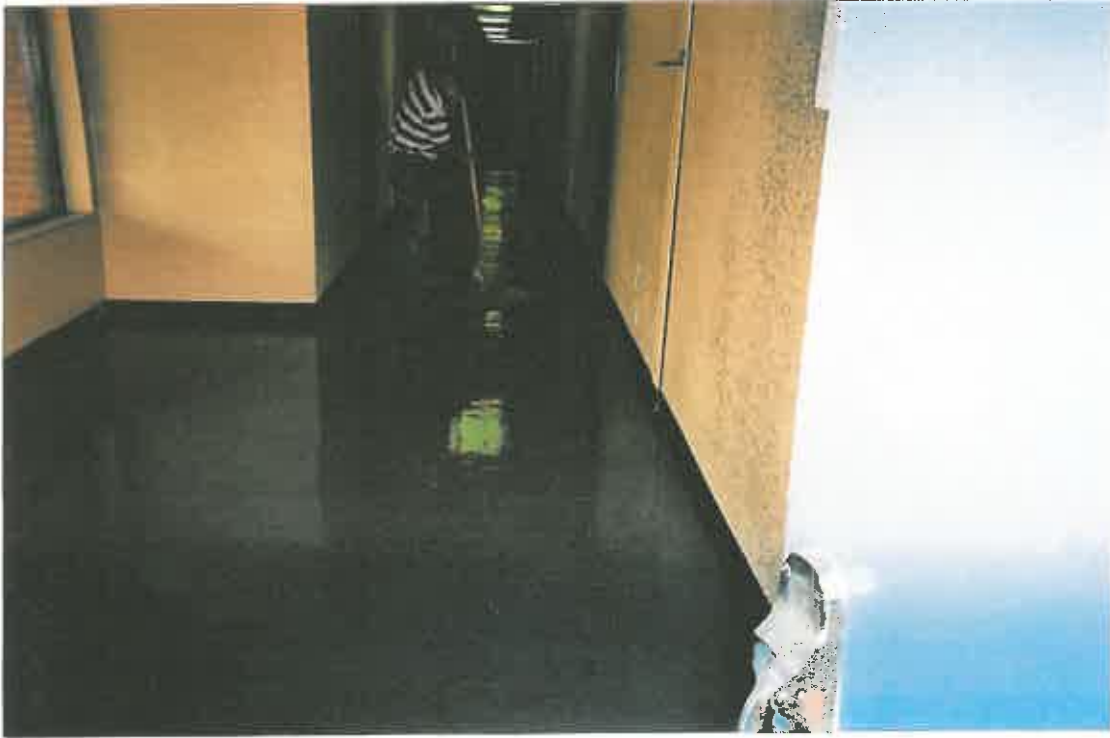
**Clean floors - office/classroom area**

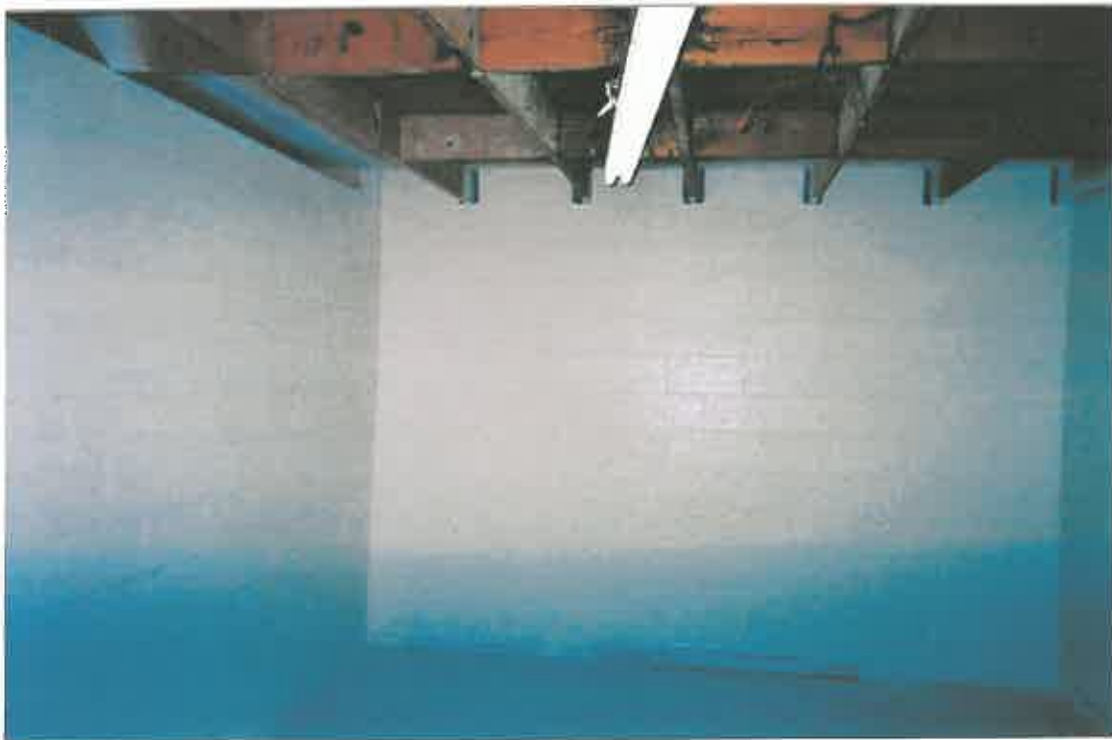
**Removal of loose and peeling paint - wall**
