TARGETED BROWNFIELD ASSESSMENT

PERRY ARMORY

ASTM E 1527-05
Phase I Environmental Site Assessment
All Appropriate Inquiry

March 16, 2010

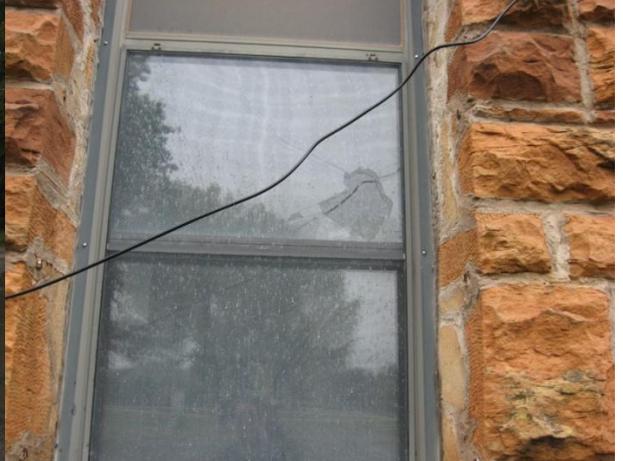
The outside of the Armory is in good to fair condition except for one window. There was extensive paint peeling on wood and metal outside of the Armory. It is unknown when the outside was last painted. The IFR vent is located next to the ground on the west side of the building (Section 3.12). No stressed or stained vegetation was found around the vent or on the subject property. Photographs of the external view of the site can be found in Appendix F.

Broken window on south side.
