**Former National Guard Armory
Sapulpa, Oklahoma**

Remediation Final Report

**Prepared by:
Department of Environmental Quality
707 North Robinson
Oklahoma City, Oklahoma 73101**

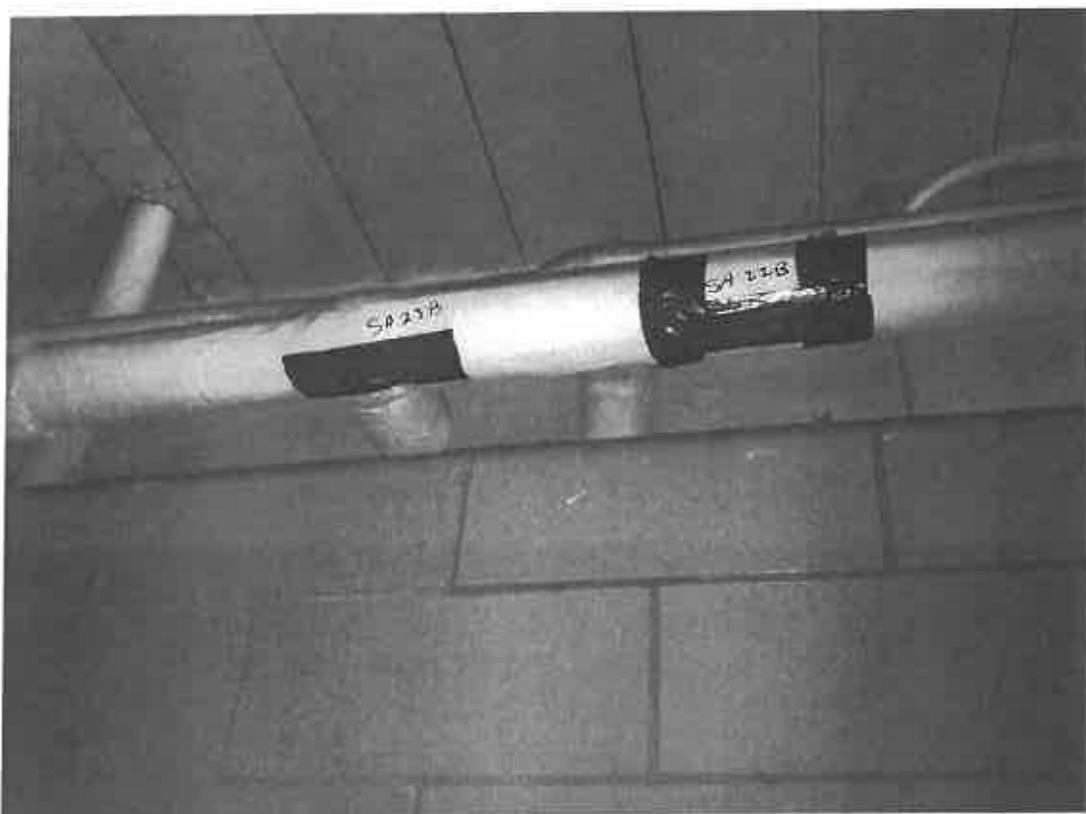
Friable Asbestos Containing Thermal Pipe & Fitting Insulation
(Sample # SA-22B and SA-23B)

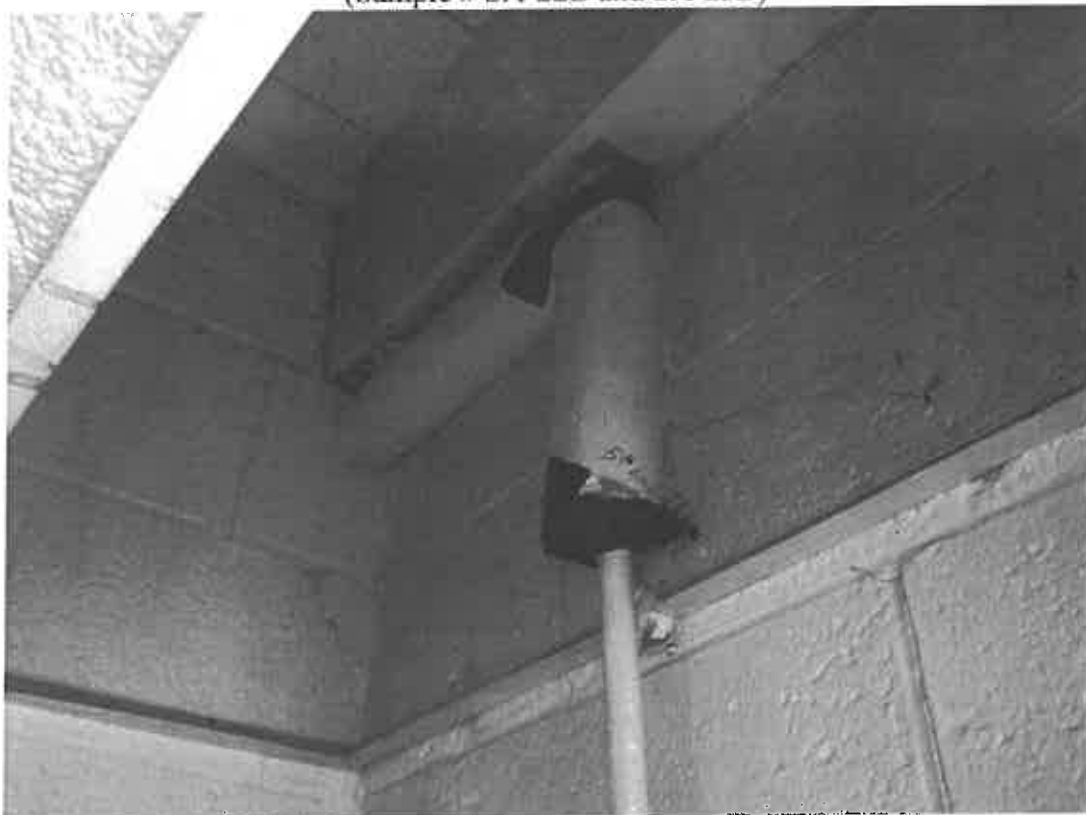
Friable Asbestos Containing Thermal Pipe & Fitting Insulation
(Sample # SA-22C and SA-23C)

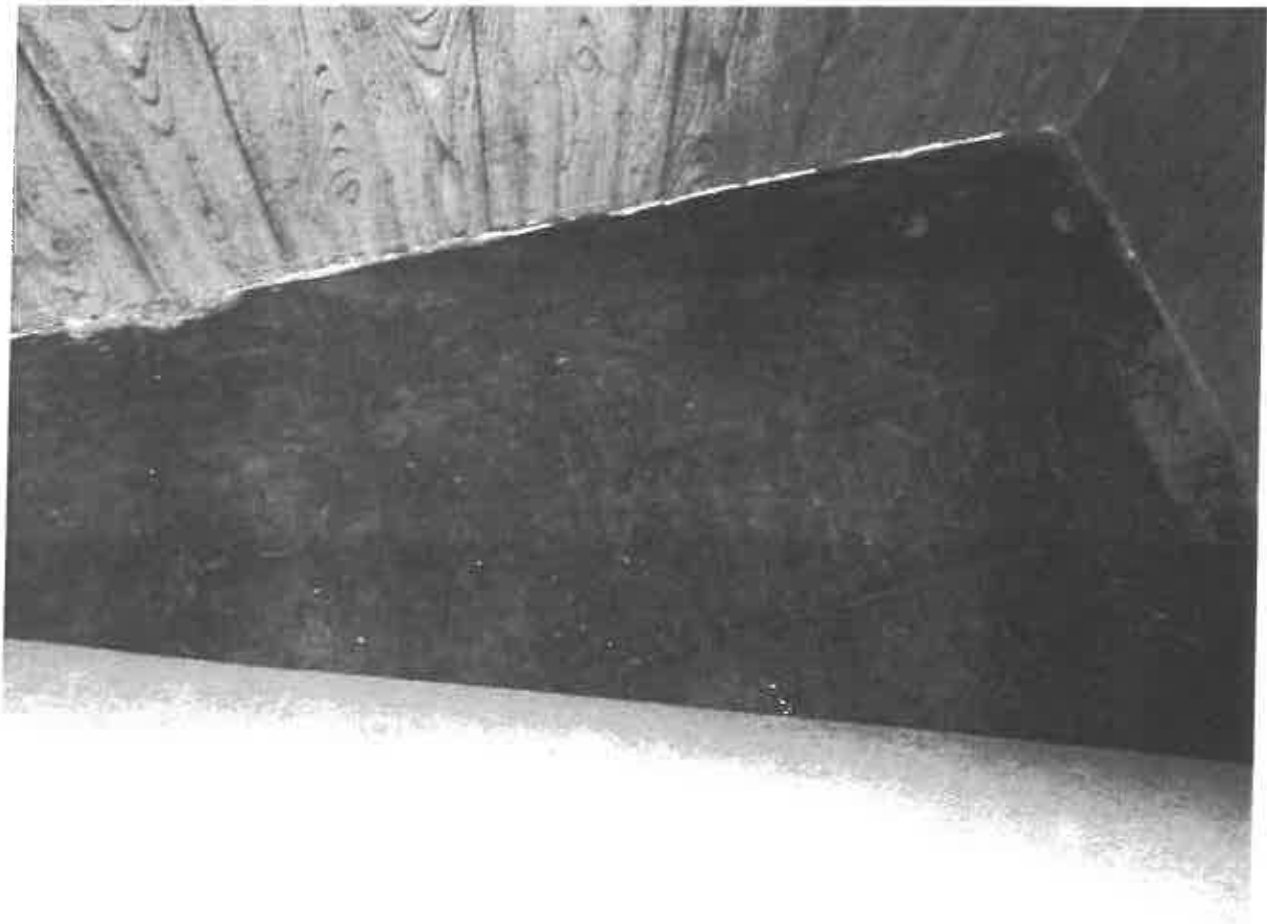
Black Mastic (Under Carpet) in Room 16
(Sample # SA-14A)

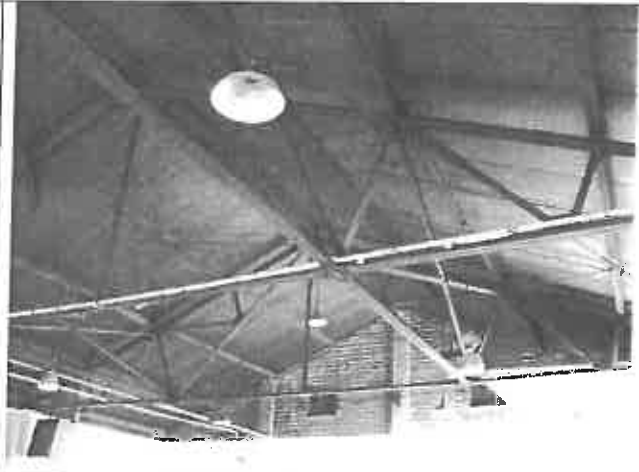
Reading 552, Room 1, Metal Ceiling Beams & Cross Members

- Maintain other lead-based paint present on other ceiling components in intact condition using interim controls (i.e. repainting as necessary)

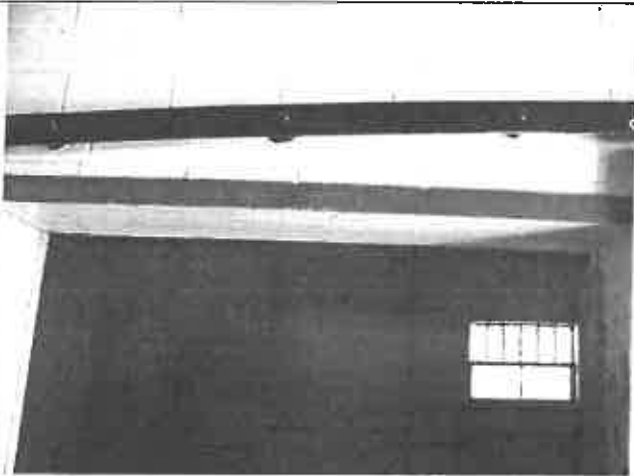
Reading 570, Room 2, Metal Door Header (68")

- Remove and replace metal door header in room 2
- Remove and replace garage door fascia and plinth

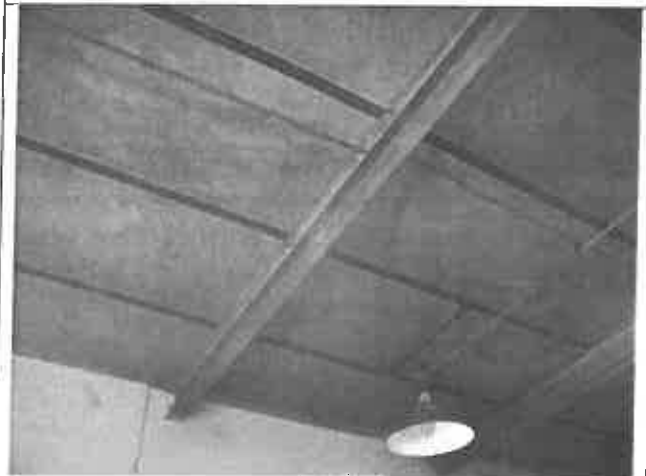
Reading 582, Room 2, Metal Ceiling Beams

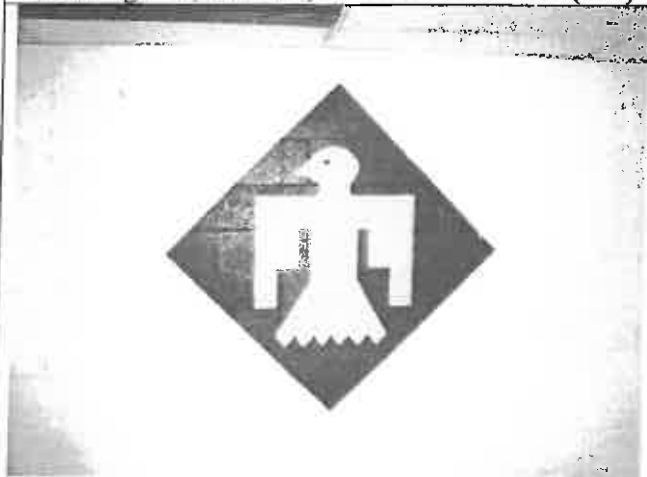
Reading 778, Room 18, Wall Logo (on Concrete)

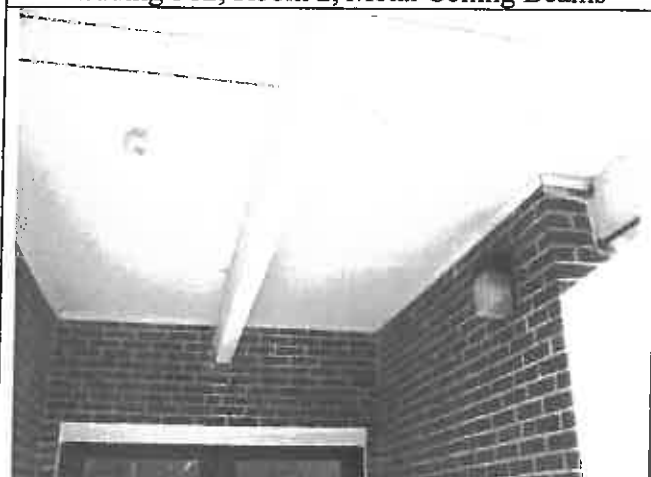
Reading 785, Exterior, Wood Porch Beams
Reading 786, Exterior, Wood Porch Ceiling

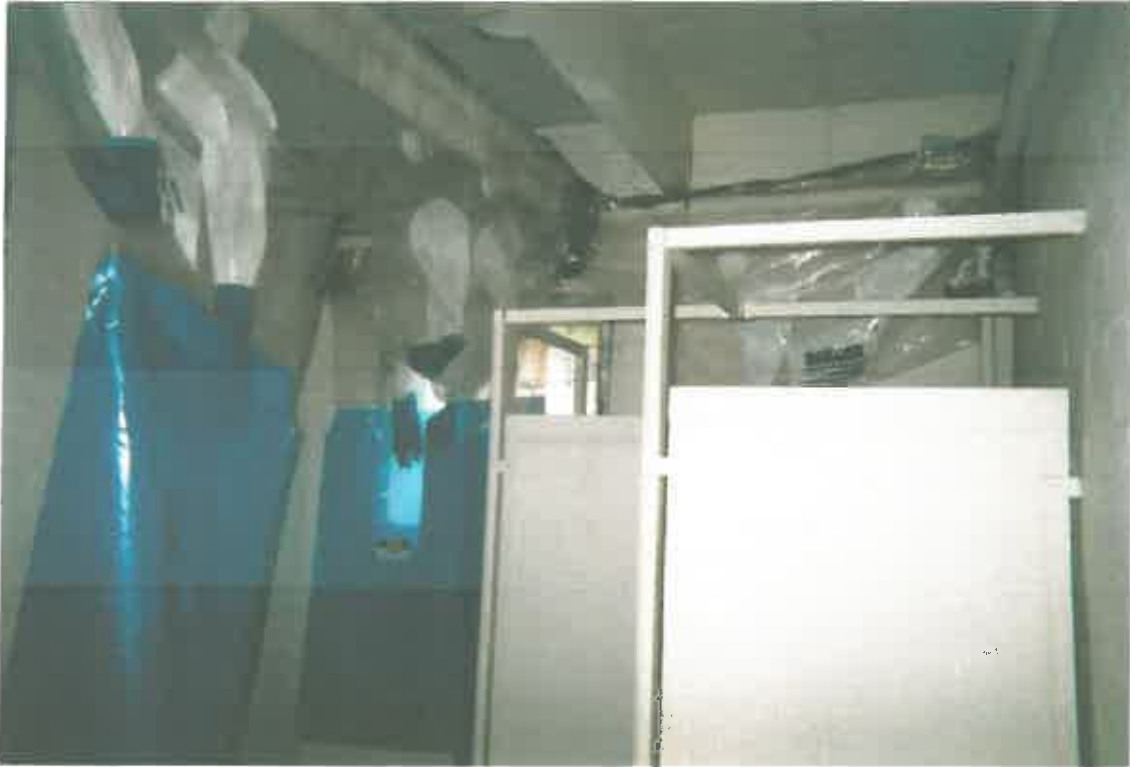
GLOVEBAGS ON ASBESTOS INSULATION

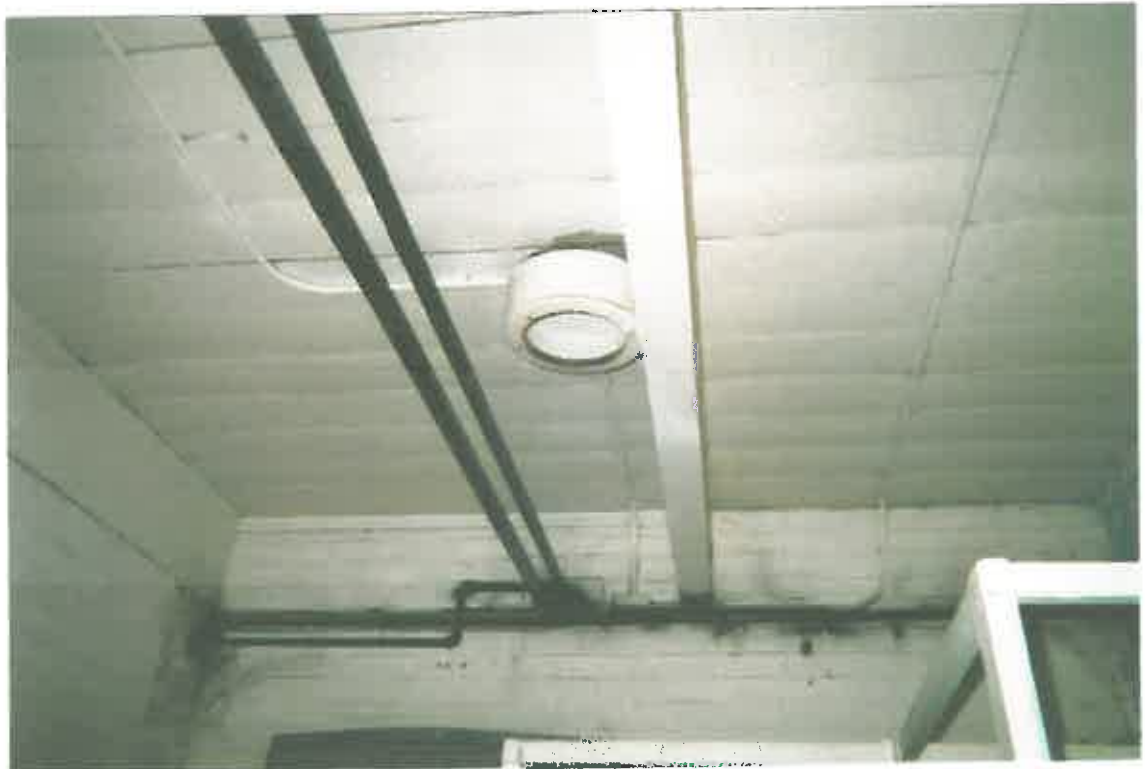
ABATED PIPE INSULATION

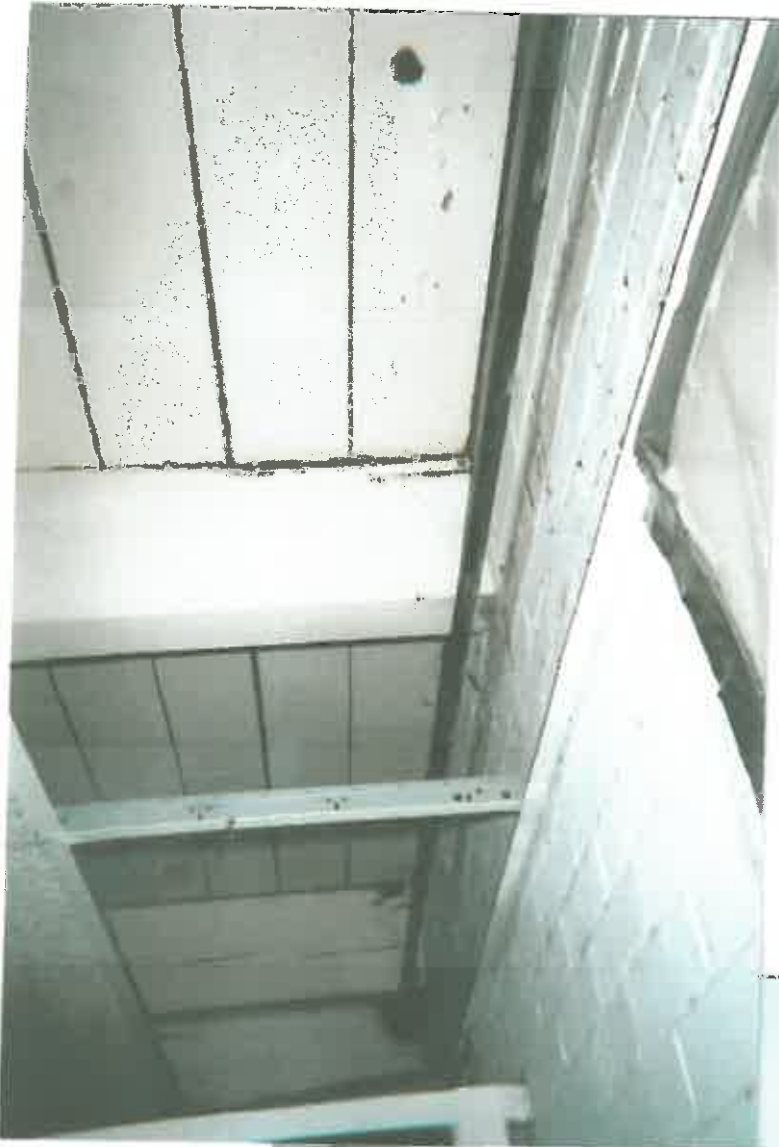
ABATED PIPE INSULATION

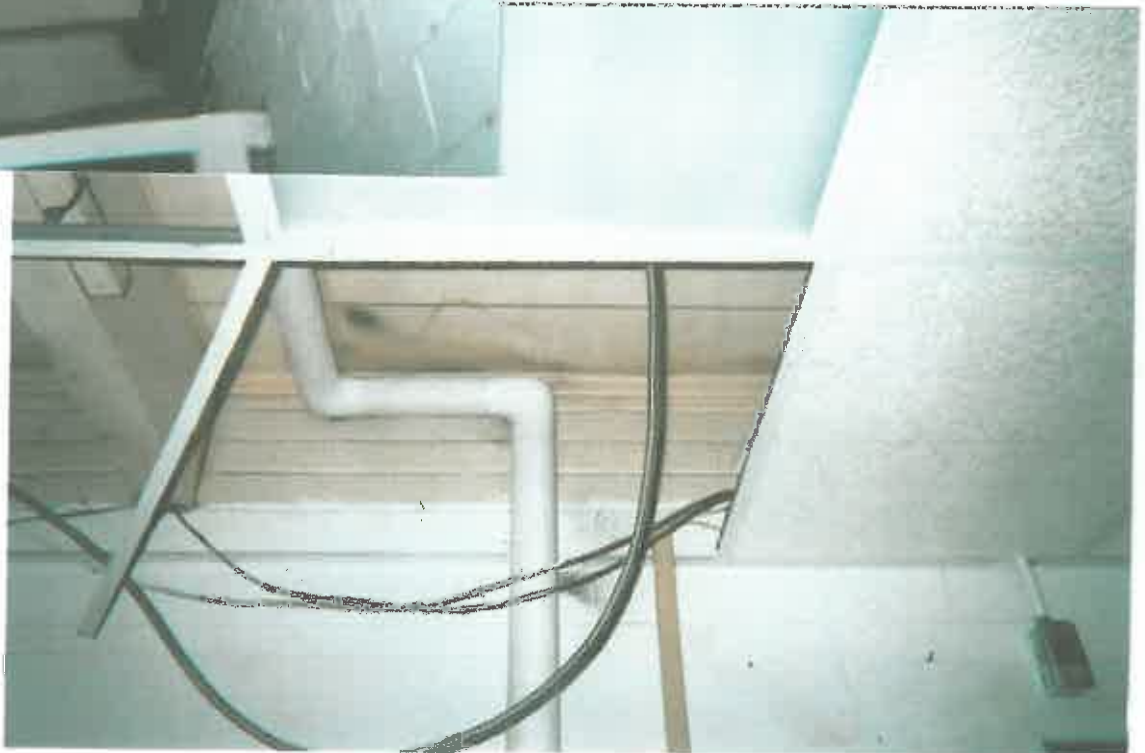
NEW INSULATION ON PIPING

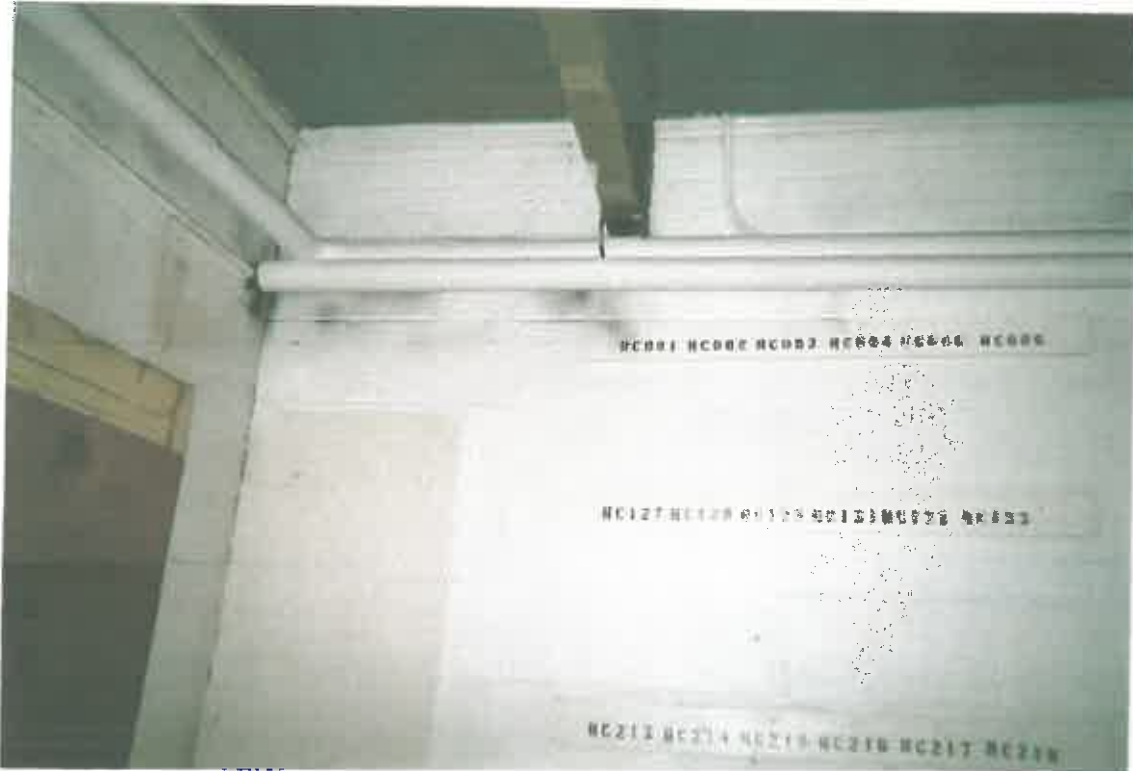
NEW INSULATION ON PIPING

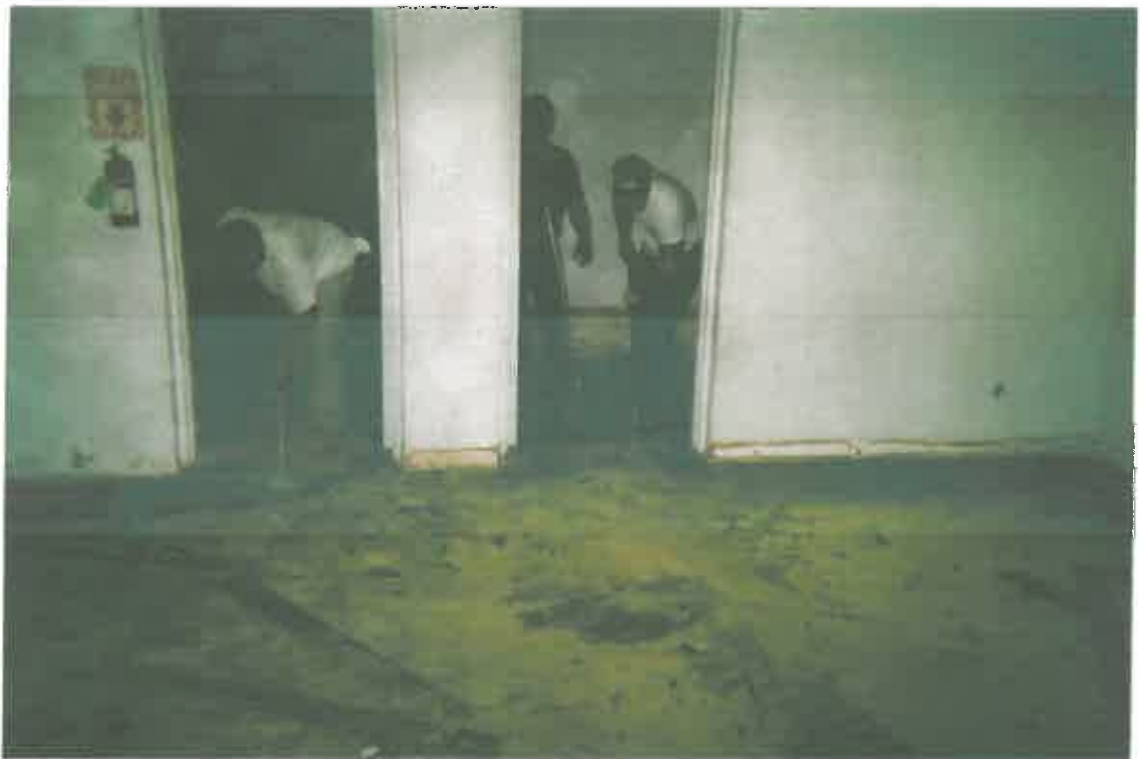
FLOOR TILE REMOVAL

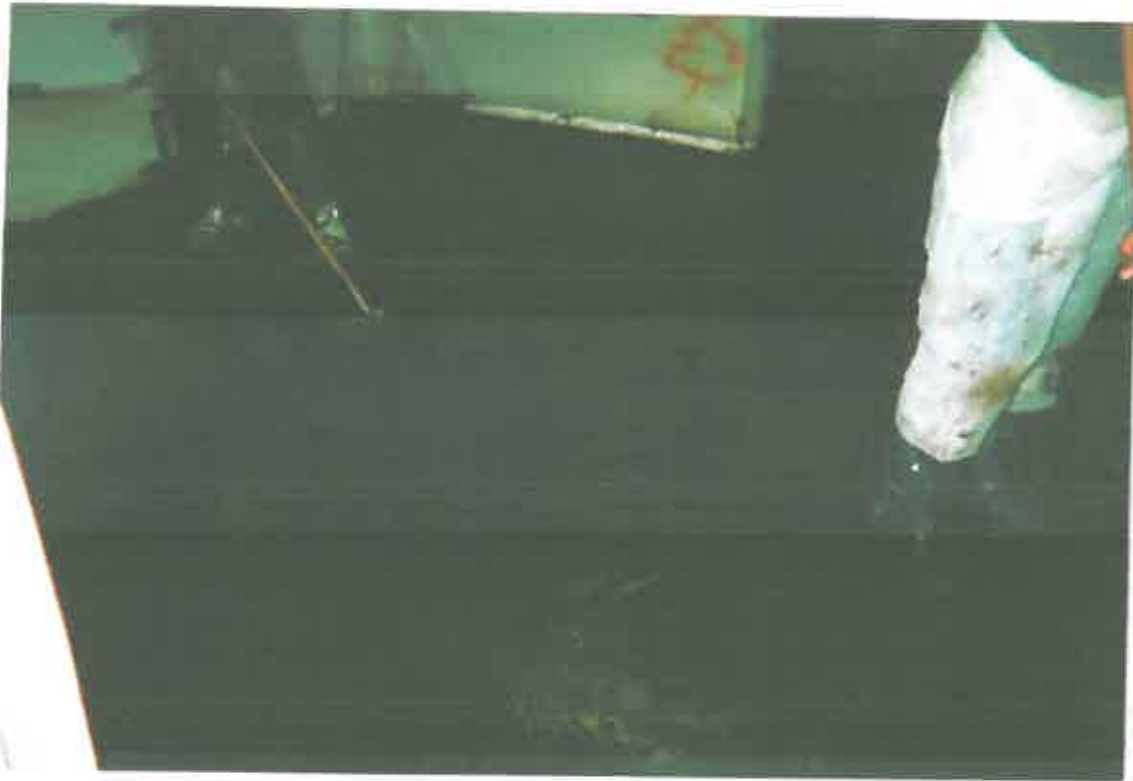
MASTIC REMOVAL

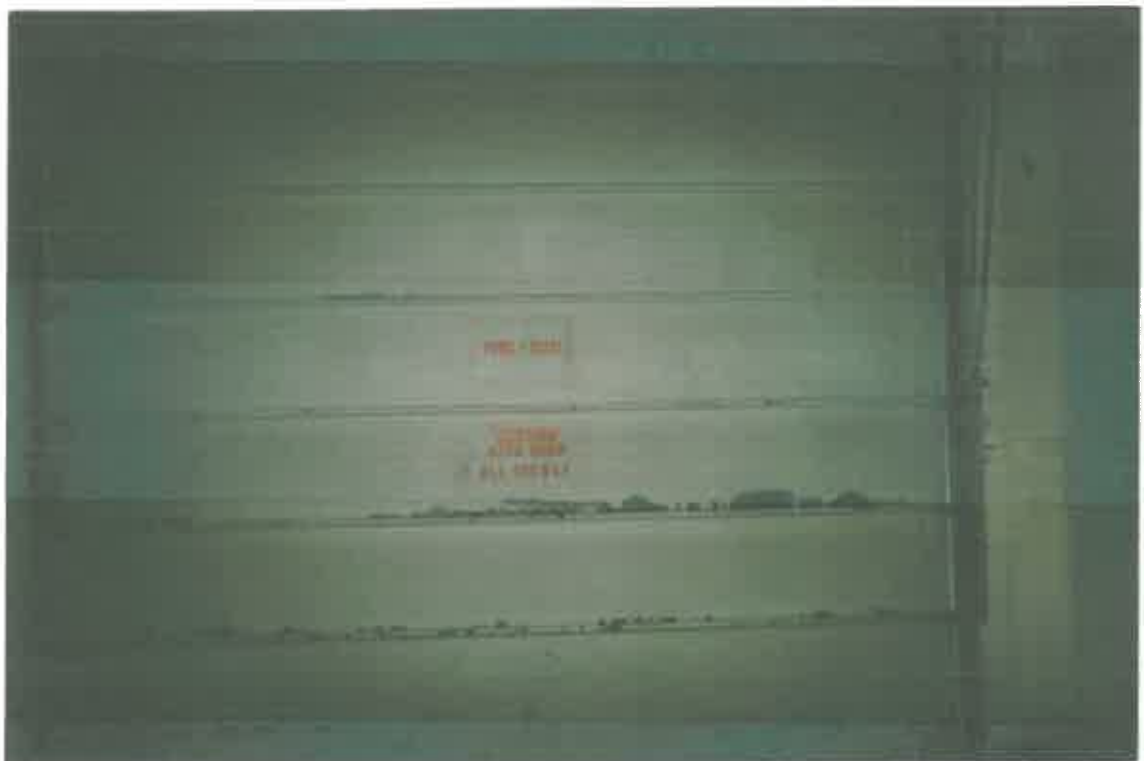
LOOSE AND PEELING PAINT - OVERHEAD DOOR

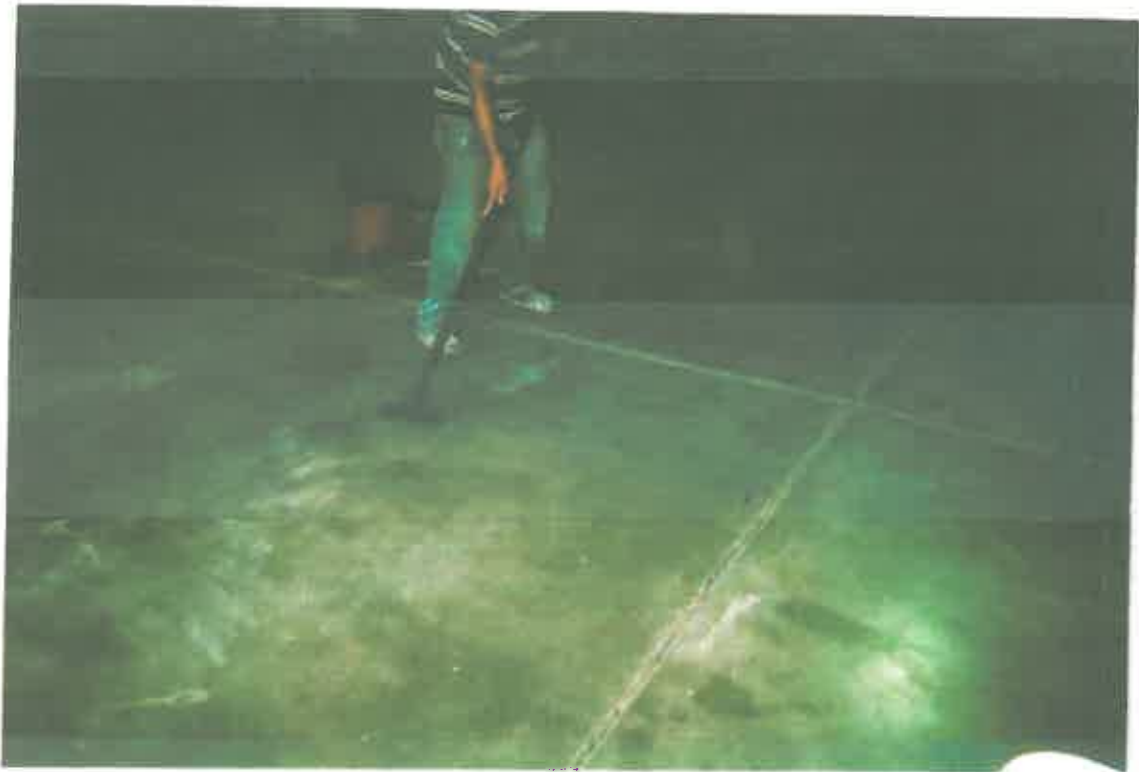
DRILL FLOOR DECONTAMINATION

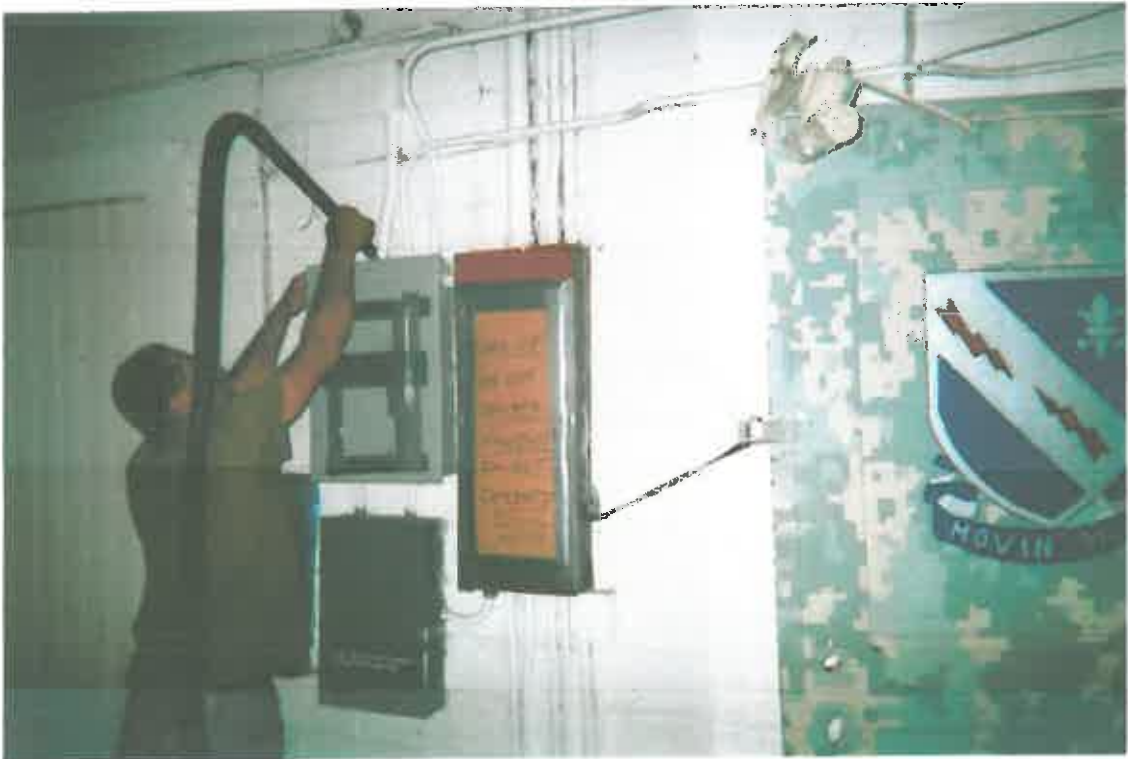
GENERAL DUST CLEANING - DRILL FLOOR AREA

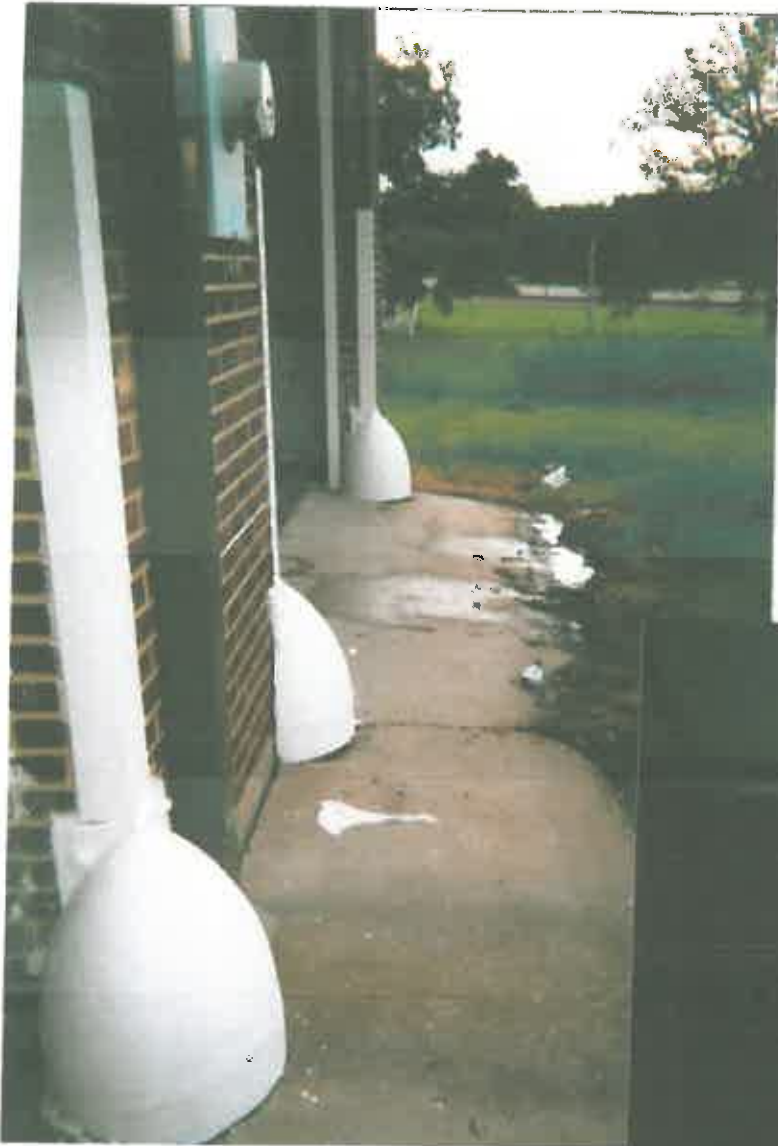
**BOLLARDS - LOOSE AND PEELING
PAINT REMOVED AND SEALED**

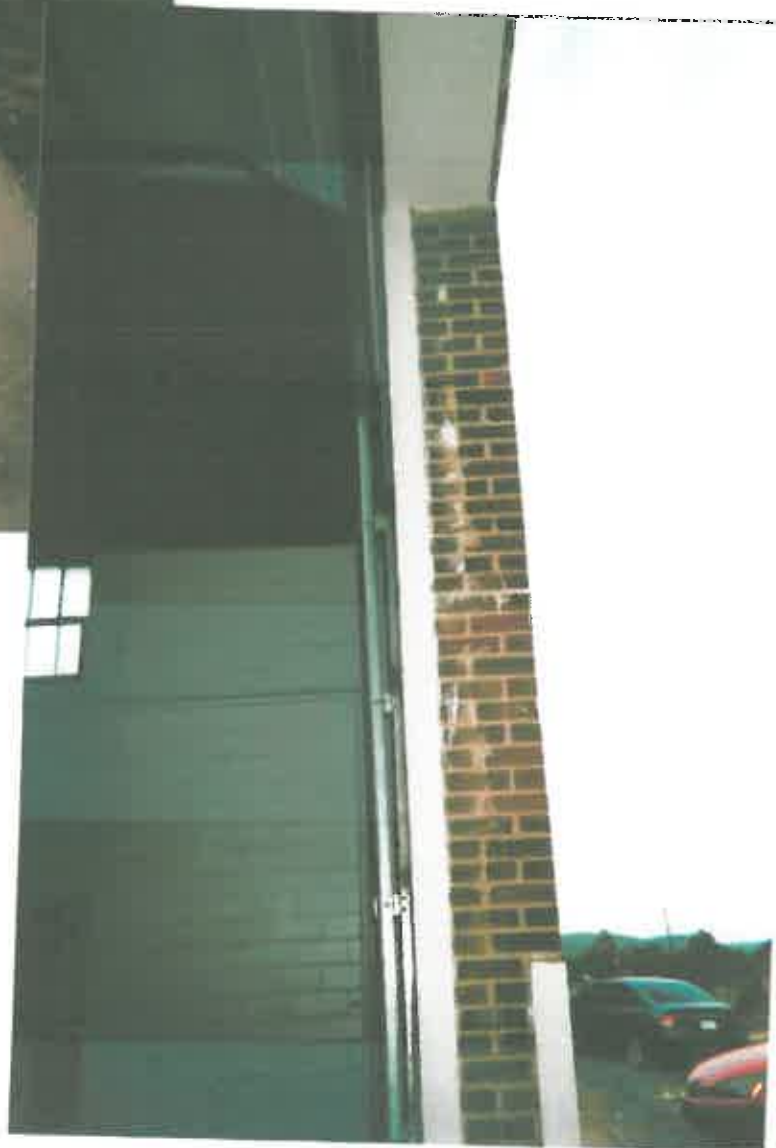
**OVERHEAD DOOR - LOOSE
AND PEELING PAINT REMOVED
AND RE-SEALED**

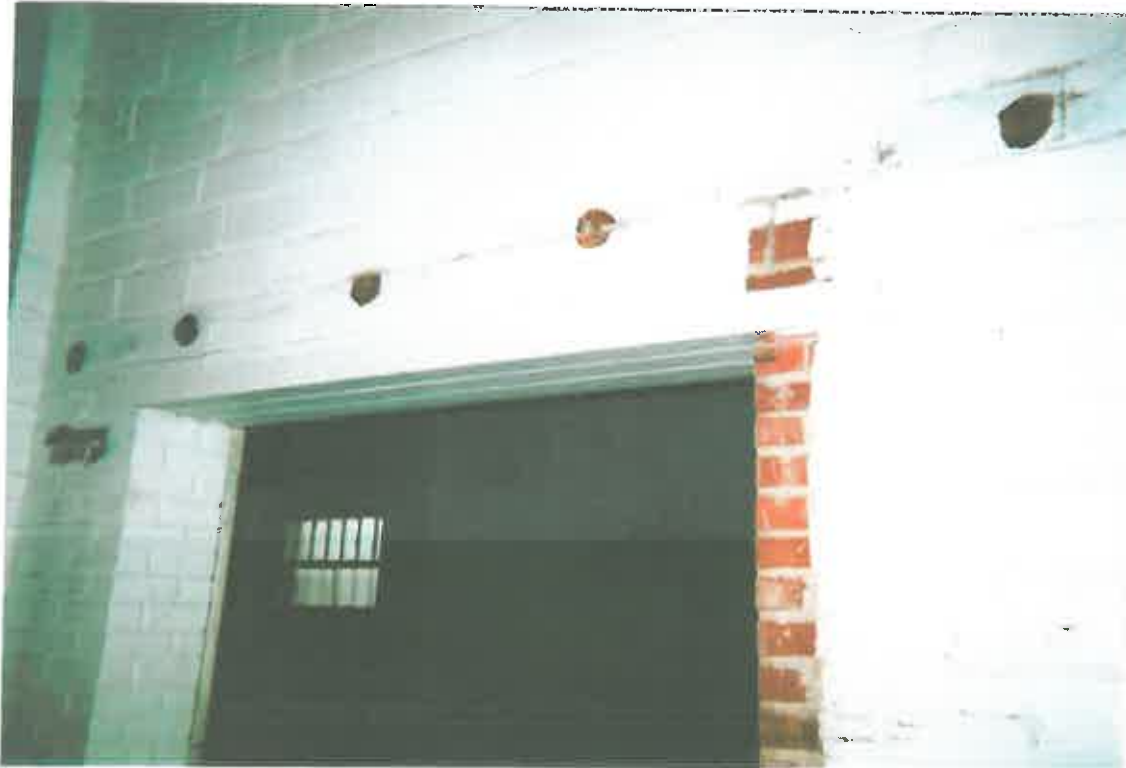
DOOR FRAME - LOOSE AND PEELING PAINT REMOVED AND RE-SEALED

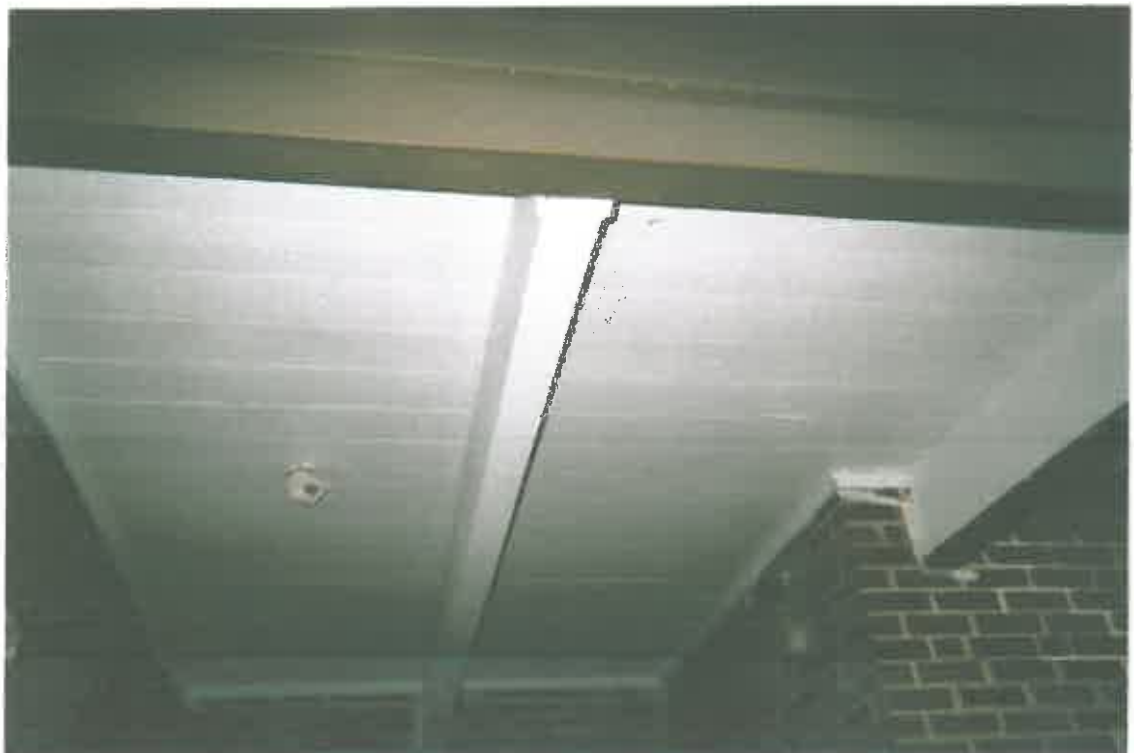
MAIN ENTRANCE - LOOSE AND PEELING PAINT REMOVED AND RE-SEALED
