**Targeted Brownfields Assessment
Oklahoma Army National Guard
Tishomingo Armory
Tishomingo, Oklahoma**

**ASTM E 1527-05
Phase I Environmental Site Assessment
All Appropriate Inquiry**

December 27, 2006

**Oklahoma Department of Environmental Quality
Land Protection Division
707 N. Robinson
P.O. Box 1677
Oklahoma City, Oklahoma 73101-1677
(405) 702-5100**

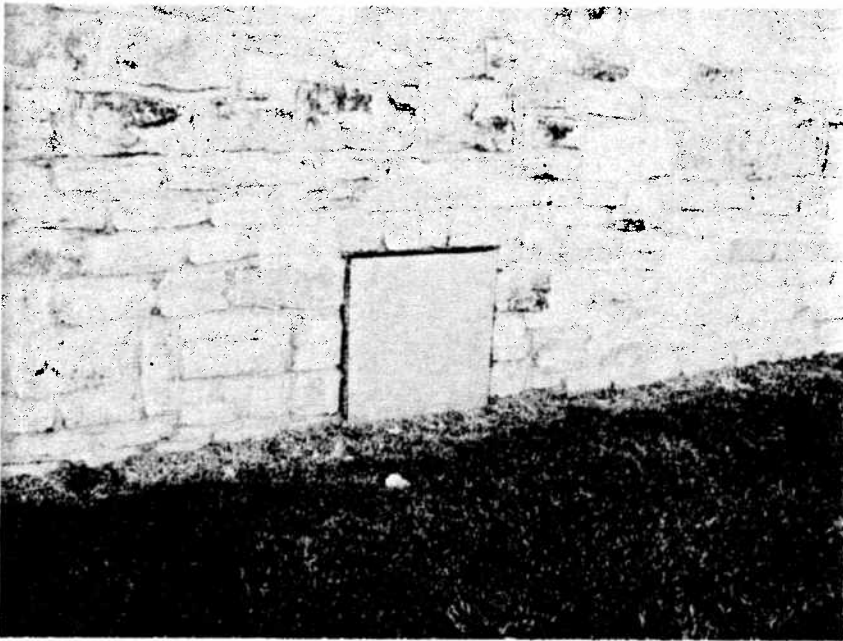
Figure 5: West side of armory showing IFR vent window boarded up.

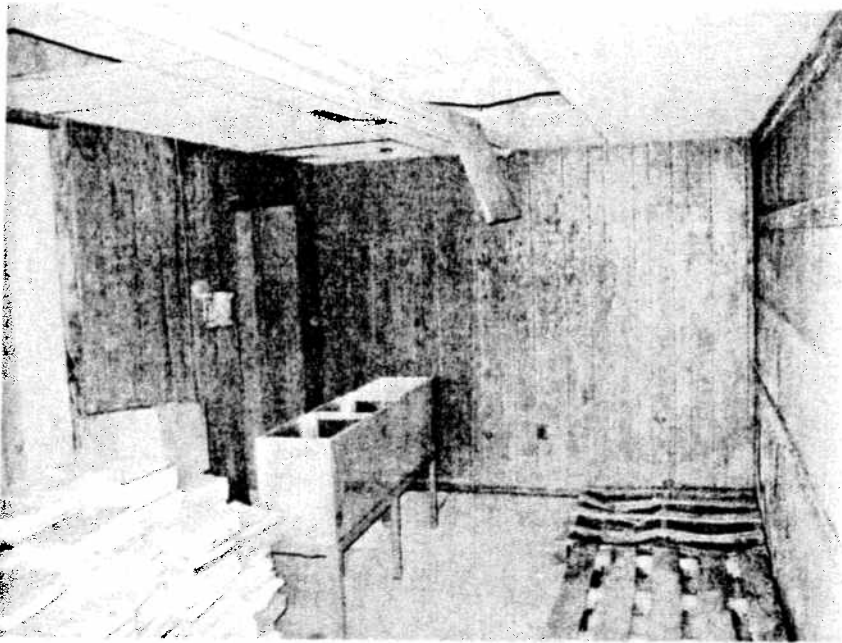
Some rooms inside the building show signs of water damage from a leaking roof. A small room adjacent to the northeast corner of the drill floor shows significant leaking with deteriorated ceiling panels, water staining and mold. The room remains locked to prohibit entry. The drill floor is used to store classroom/office and maintenance

Figure 9: Room off northeast side of the drill floor showing water damage.

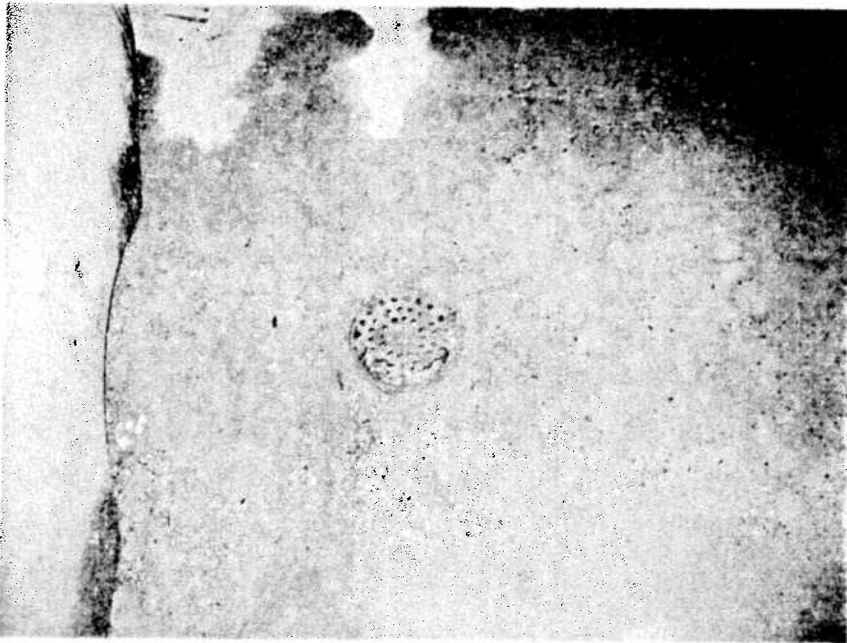
- Water from a seep in the IFR roof may run into the floor drain located in the middle of the firing range (IFR). The drain may discharge lead contaminated water from the IFR into the sanitary sewer system.

Figure 13: Floor drain at north end of IFR clogged with sand.

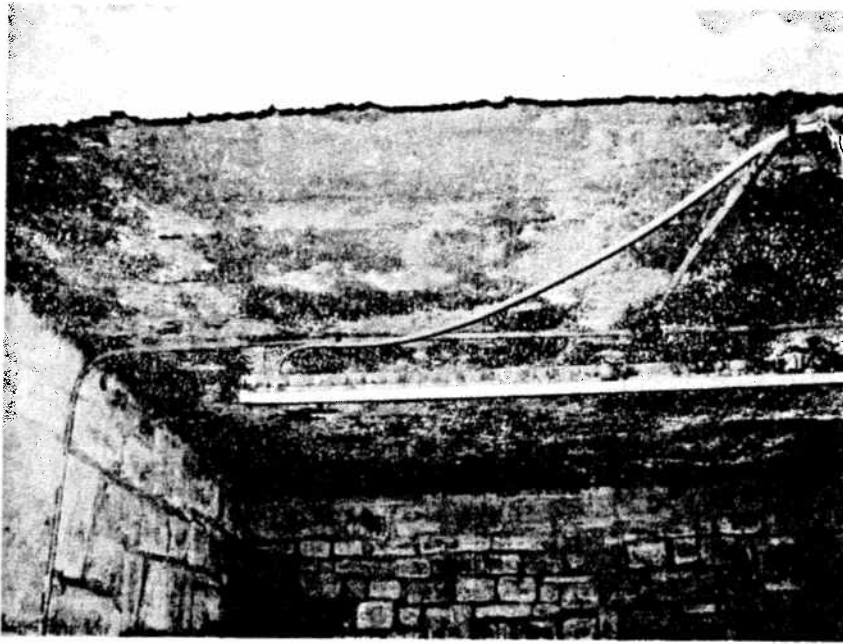
- Water infiltration into the IFR has seeped through the concrete roof on the north side as well as various rooms throughout the armory. This has caused the room to become humid and may potentially cause the growth of mold.

Figure 15: Water seep from roof of IFR at north end.

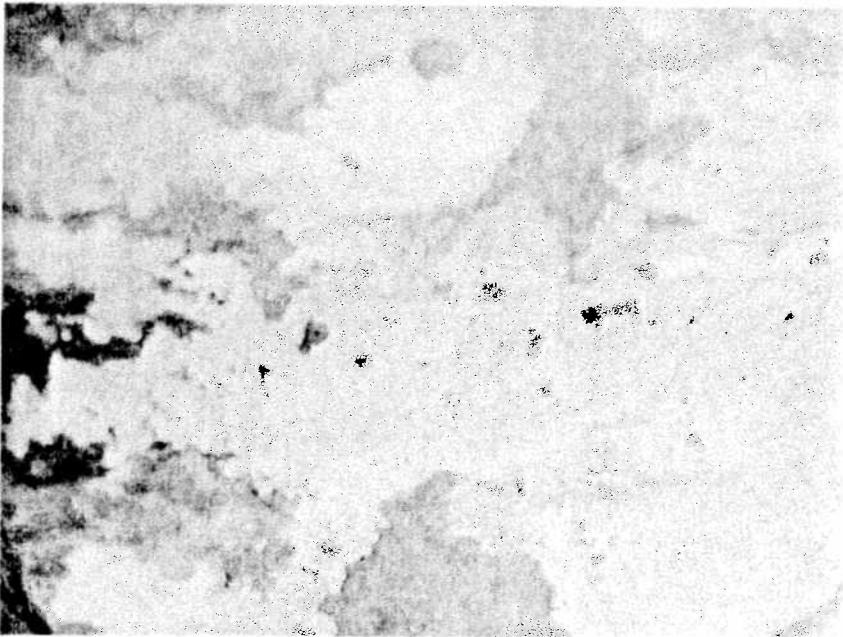
Figure 16: Flaked paint-like surface at north end of IFR.

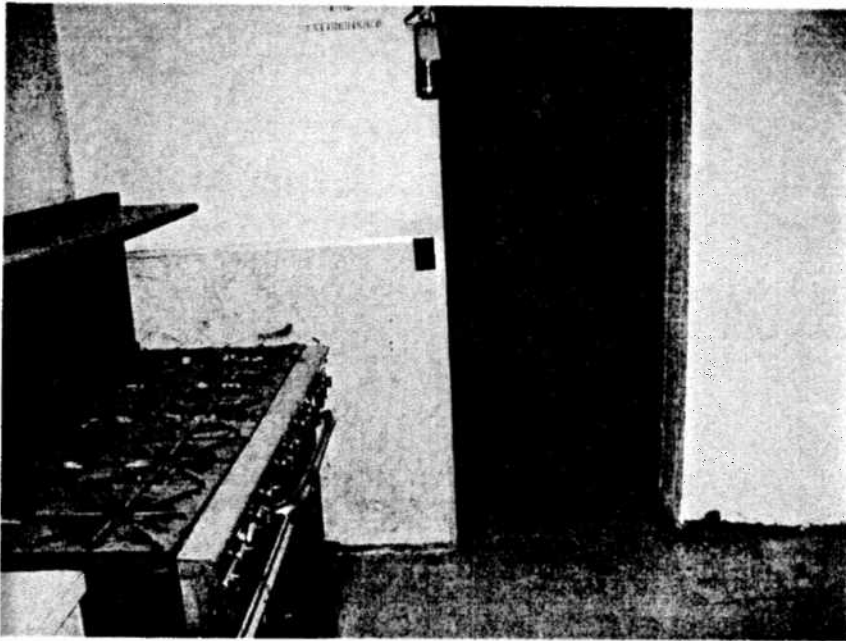
Figure 18: Kitchen area of mess hall showing 12" x 12" floor tile.

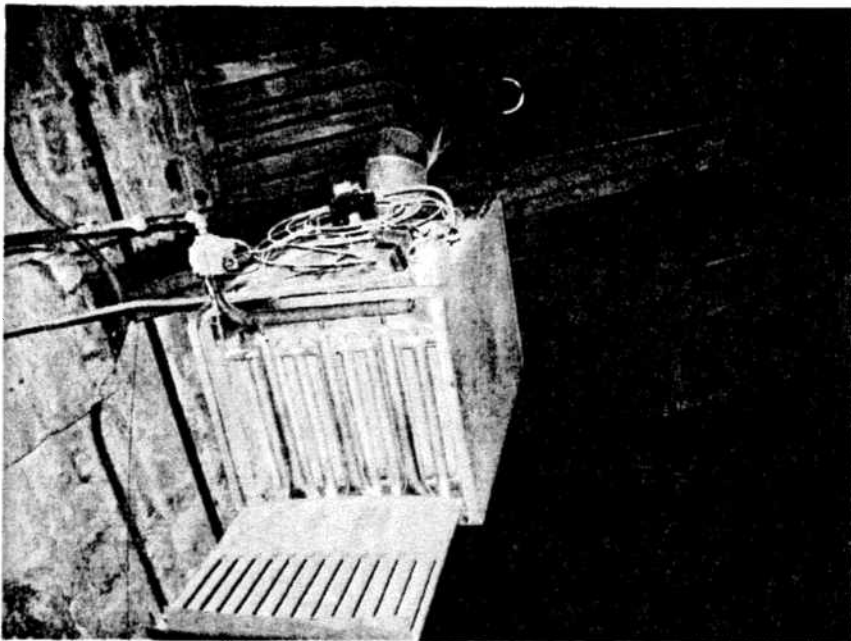
Figure 21: Bracket mounted space heater in the drill floor area showing access panel open.

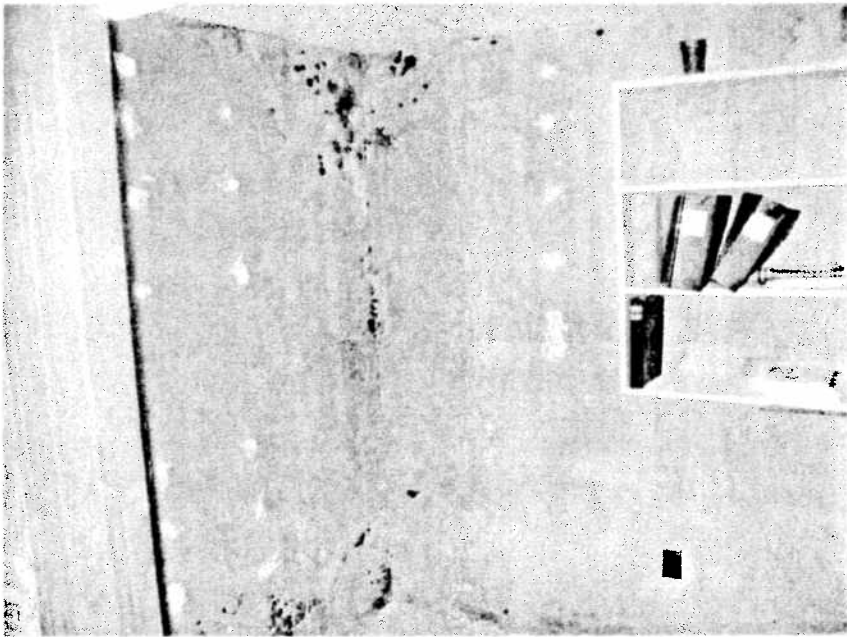
Figure 24: Water and mold damage in the west side office area.

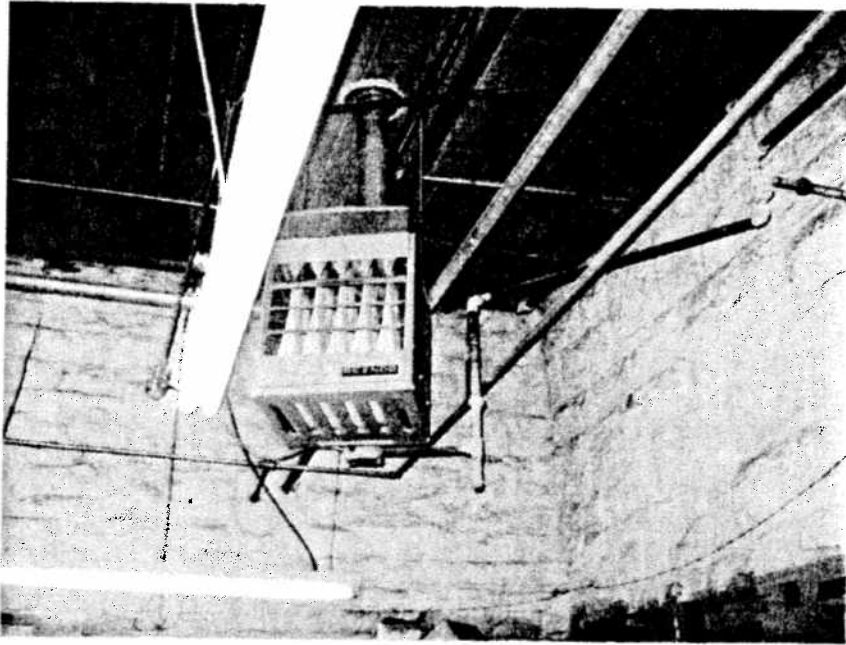
Figure 25: Bracket mounted heater in the garage bay area.
