# **Targeted Brownfields Assessment**

**Oklahoma Army National Guard Armory  
Sulphur, Oklahoma**

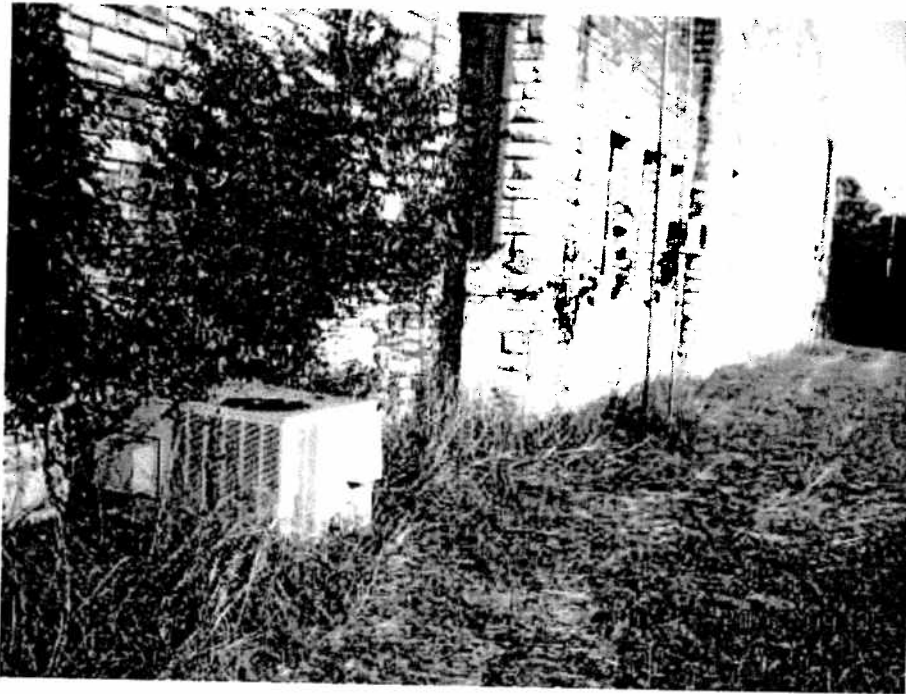
Figure 7. Central air-conditioner for offices in south part of the armory. Located near the southeast corner of the armory.

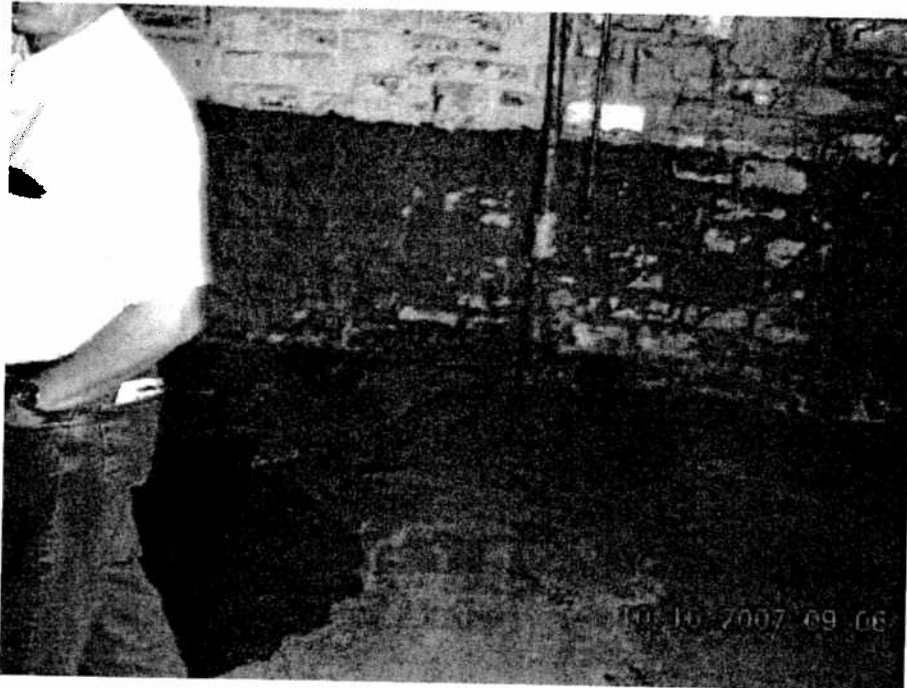
Figure 8. Minor rust stain from water faucet located on the south wall of the vehicle service bay in the southwest corner of the building.

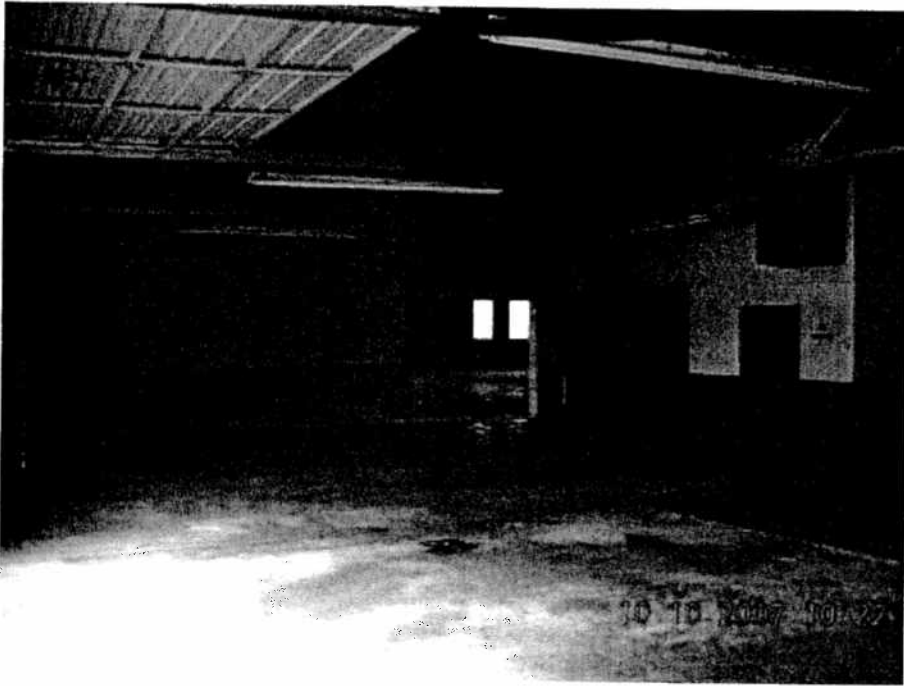
Figure 9. View from the vehicle service bay in the southwest corner of the armory looking northeast. Note minor oil stain on the floor (bottom center).

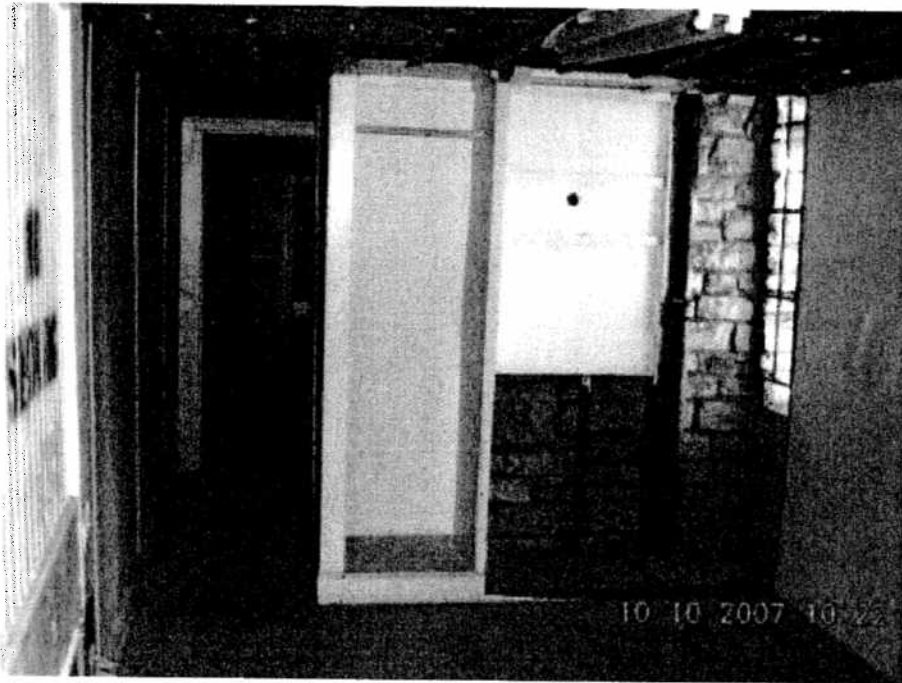
Figure 10. Hallway on the Southside of the building looking from the vehicle service bay leading the central hallway and offices.

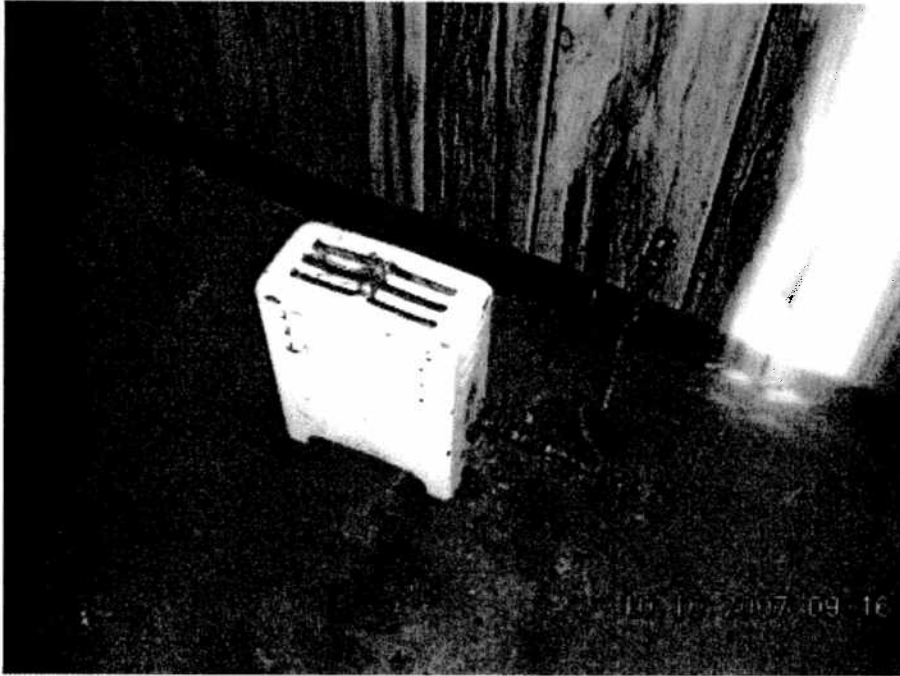
Figure 15. Small gas floor heater typical of heating units found in the office spaces.

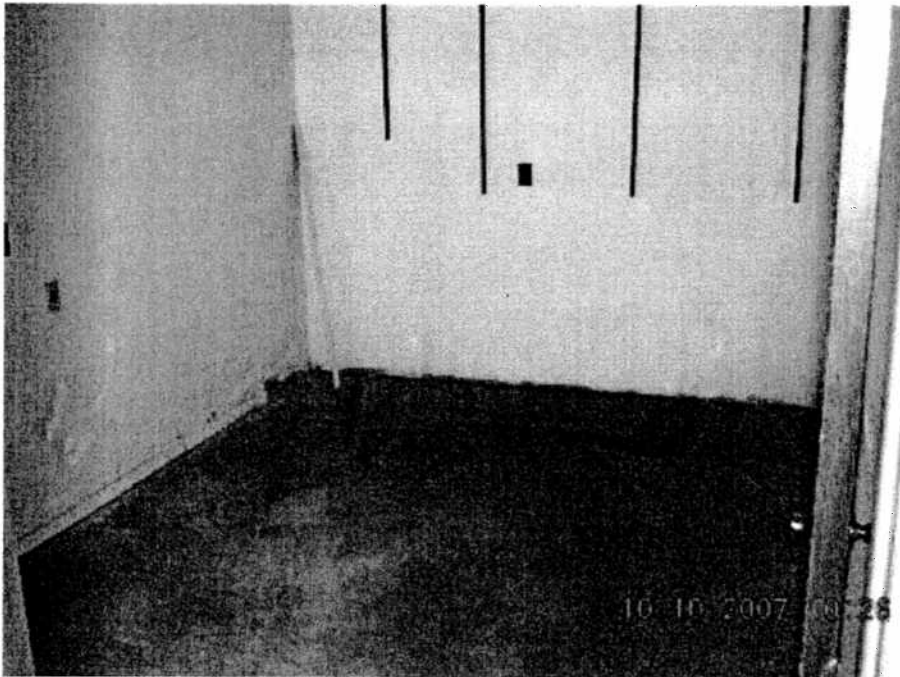
Figure 16. Storage area located off the main hallway in the south side of the building.

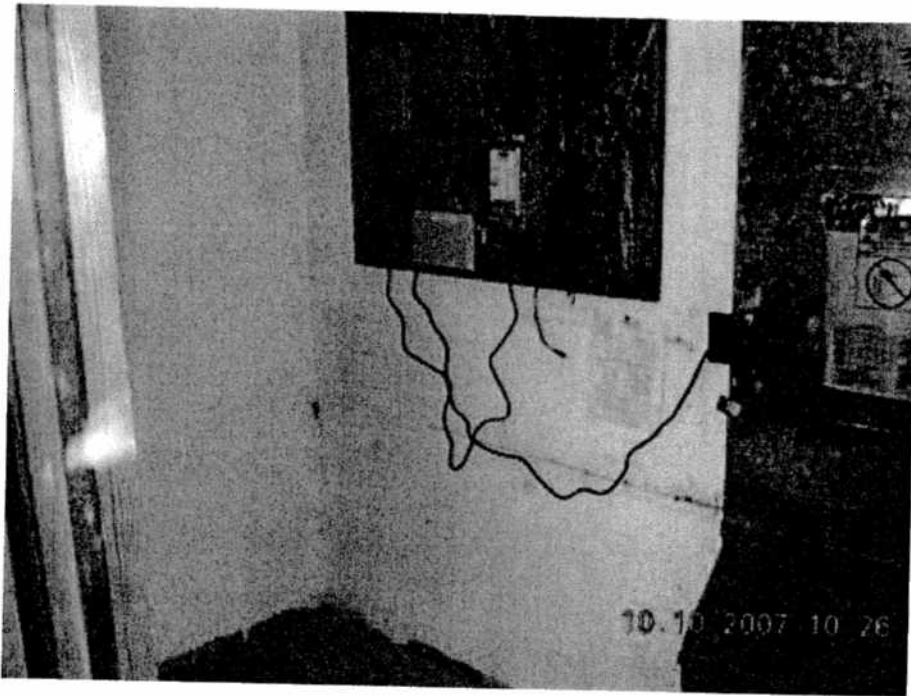
Figure 17. The utility closet off of the main hallway with air conditioning plenum.

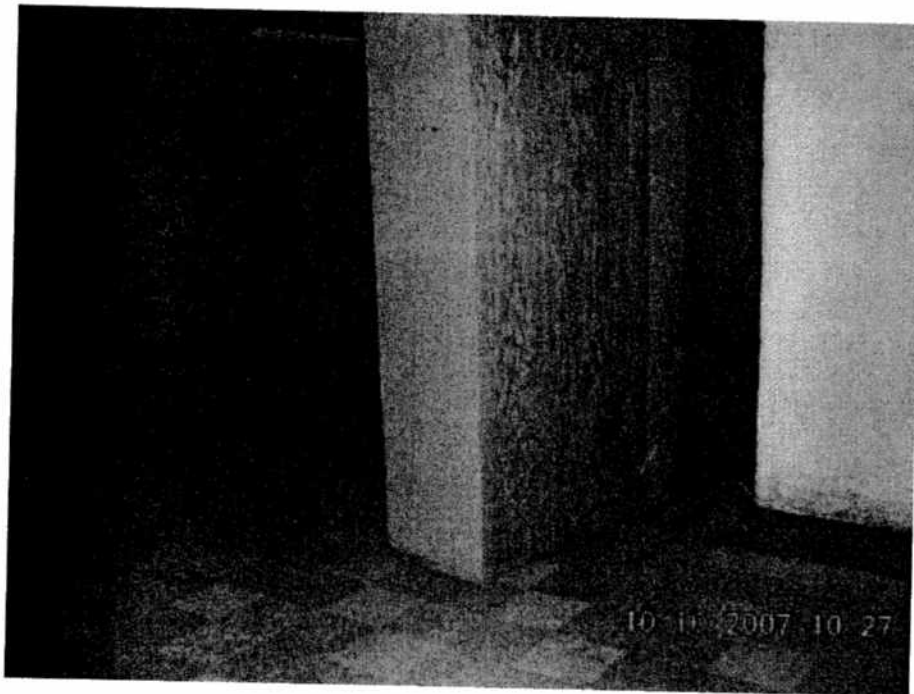
Figure 18. Room located off the main hallway on the west side. Tiles shown are 12”.

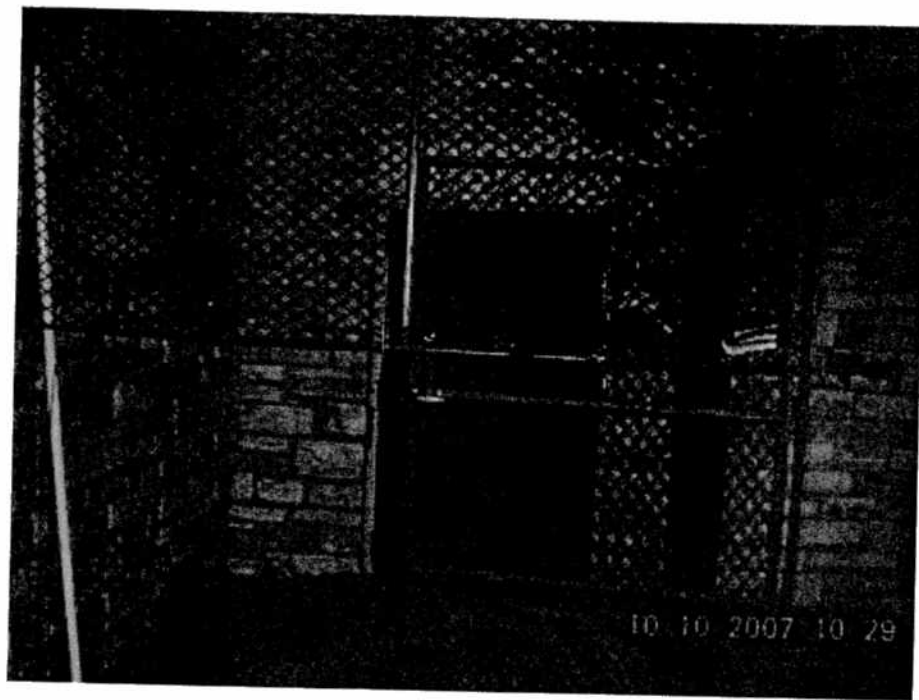
Figure 19. Unlocked caged area located in the room noted in figure 18.

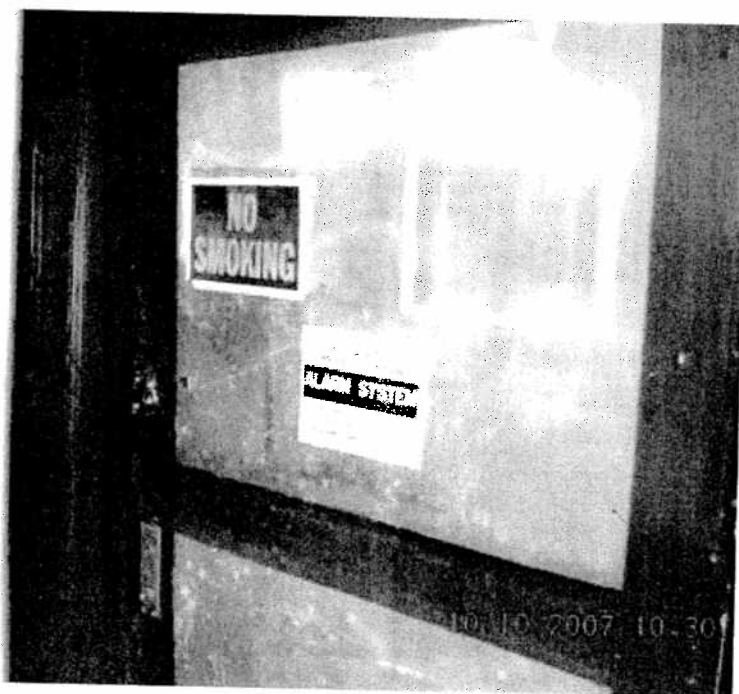
Figure 20. Fire door entrance to the "Commo" room west of the main hallway.

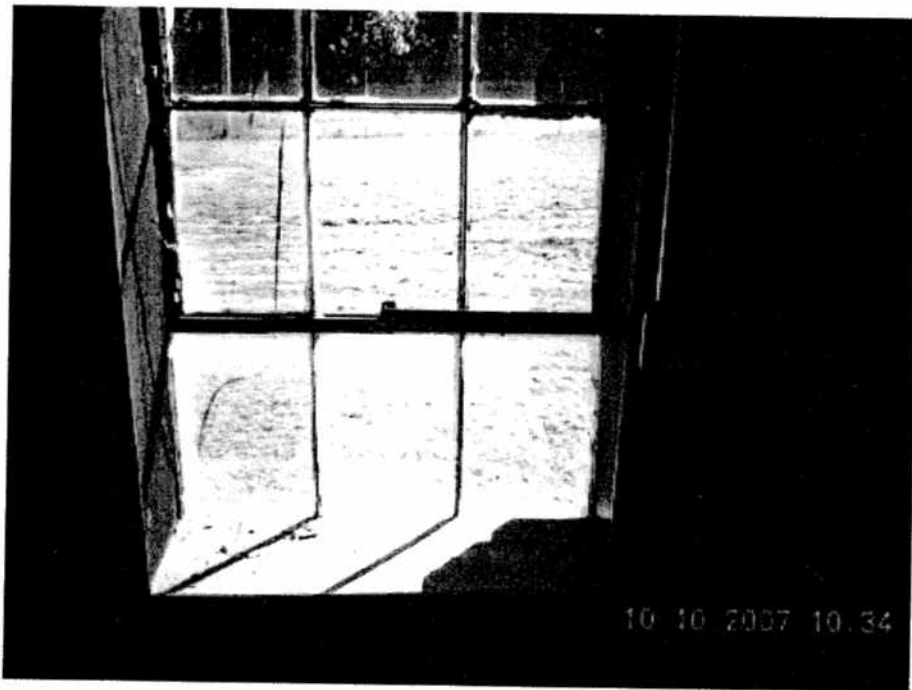
Figure 29. Window looking east from the office south of the kitchen area. Note the cracking and peeling paint typical of most of the Sulphur Armory windows.

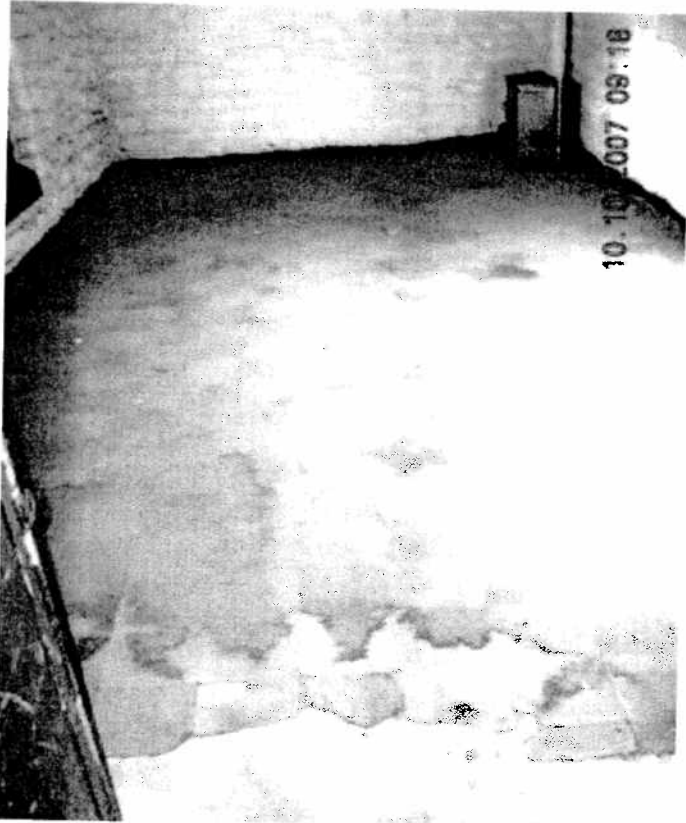
Figure 30. Office south of the kitchen and east of the drill floor. Note 9-inch floor tiles.
