**Targeted Brownfield Assessment  
Oklahoma Army National Guard  
Cherokee Armory  
Cherokee, Oklahoma**

**ASTM E 1527-05  
Phase I Environmental Site Assessment  
All Appropriate Inquiry**

**December 11, 2006**

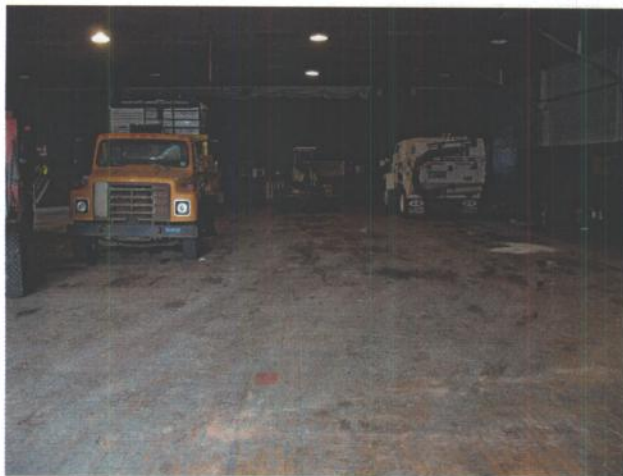
**Photo #1:** Drill Hall where vehicles are stationed.

- 9 (nine) 55-gallon drums of hydraulic oil were found in the northwest corner of the Battalion Supply Room.
- Oil and grease spots were found throughout the Battallion Supply Room, the Motor Pool Room, and the Drill Hall from the servicing of vehicles.

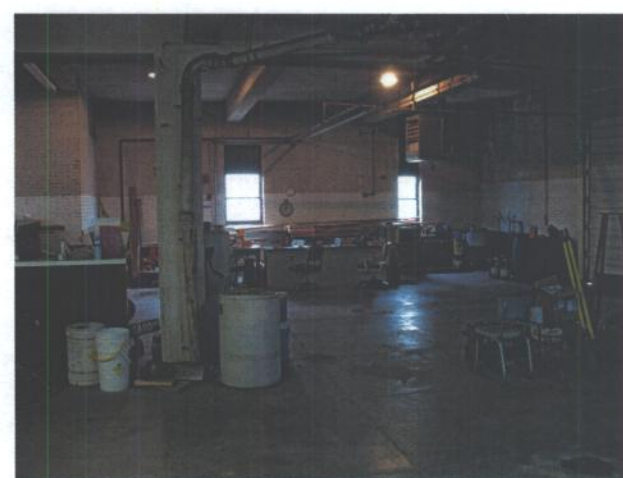
**Photo #6:** West side of the Battalion Supply Room. 55-gallon drums located on the northwest corner.

- 9 (nine) 55-gallon drums of hydraulic oil were found in the northwest corner of the Battalion Supply Room. These drums could present a potential for improper disposal and could result in undesirable consequences if released into the environment.

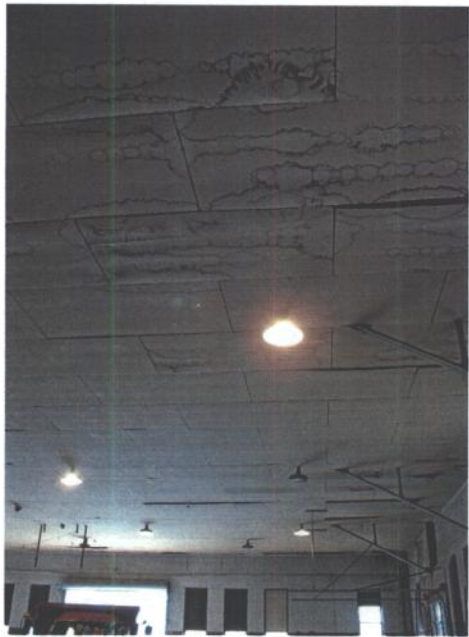
**Photo #13:** Ceiling in the Drill Hall.

Mold growth may be developing in areas where there is water damage. This is most relevant on the ceilings of the Drill Hall and potentially inside the IFR. This may be harmful to future occupants.

Inside the building, there was water damage on the ceilings of the Drill Floor, Stage area, Rental Area, and Storage Rooms on each side of the Stage. Some parts of the ceiling in these areas had enough damage that some of the ceiling was missing. Throughout the floor area of the Drill Floor, Battalion Supply Room, and the Motor Pool area there were oil and grease spots from the servicing of street maintenance vehicles and other kinds of equipment. Nine 55-gallon drums of hydraulic oil were found on the northwest corner of the first floor. Buckets of paint and paint thinner were observed in the Oil Room. These materials all belong to the Street and Water Departments. Piping was found throughout the first floor especially in the Battalion Supply Room Motor Pool areas. No insulation was noticed on any of the piping that may be suspect for ACM. However, some of the piping had white paint in areas, which may contain lead. The rest of the first floor mainly contained vehicles, tools, signs, and street maintenance equipment.

Suspect ACM potentially in the drop ceilings of the rooms described earlier and the friable wallboard in the FDC Room should be sampled for asbestos. If ACM is found, proper remediation should be conducted. Other areas that should be evaluated further are the drums of hydraulic oil, paint and paint thinner in the Oil Room, adhesives and lubricants in the Supply Room, and mold growth that may be found where there is water damage.

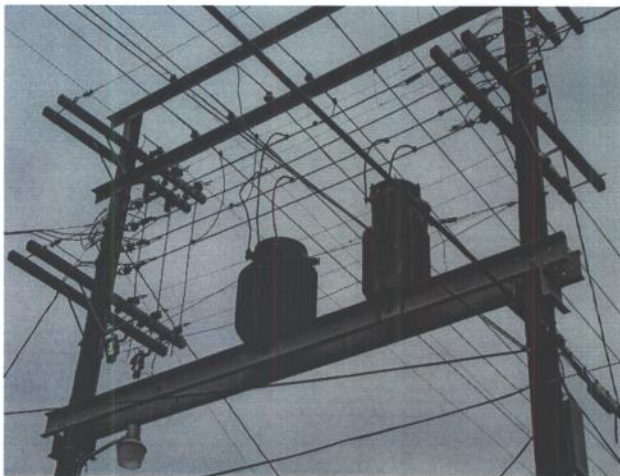
**Photo #15:** Close-up view of the pole-mounted transformers.

Two pole-mounted transformers were found next to each other located on the southwest corner of the armory building in the alley. These transformers appeared to be very old and rusted from years of weathering. No leakage of PCBs was noticed from the transformers. Photographs #15, #16, and #17 provided in Appendix B, show the two pole-mounted transformers. Other materials found that may have PCBs and possibly mercury were the fluorescent ballast light bulbs located throughout the facility.

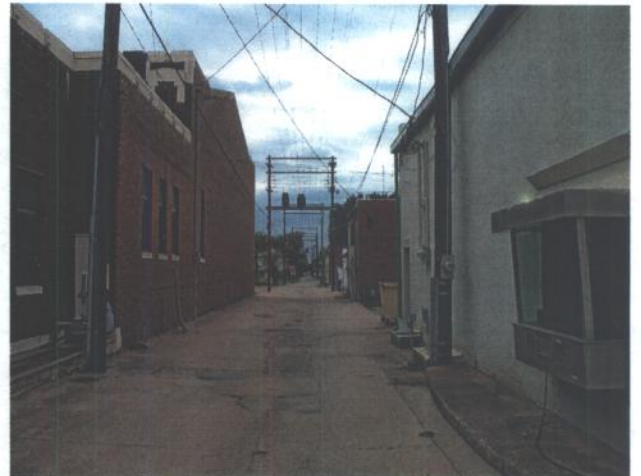
**Photo #16:** Pole-mounted transformers located southwest of the armory building.

- The Drill Hall and rooms (Rental Area, Stage, and Storage Room) directly west of the Drill Hall have water damage on the ceilings.
- Two pole-mounted transformers were found next to each other located on the southwest corner of the armory building in the alley. These transformers appeared to be very old and rusted from years of weathering. No leakage of PCBs was noticed from the transformers.

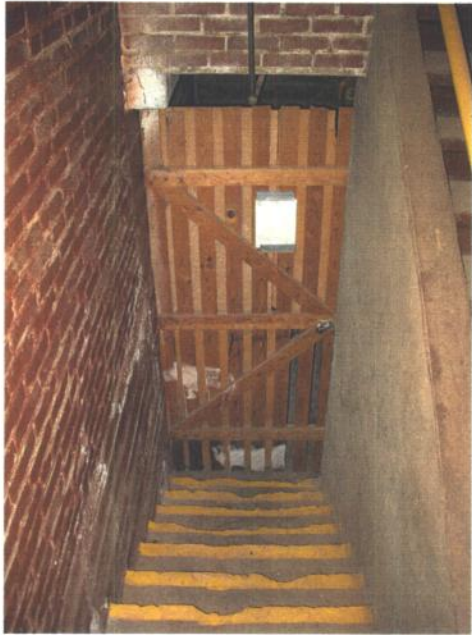
**Photo #19:** Entrance door to the IFR with the OMD notice prohibiting entrance.

The IFR was observed when Major Merkle of the OMD arrived to unlock the entry door. The entry door had a notice duct-taped on it that prohibited the use of the room. The IFR had a few gun shells lying around. Dust was apparent throughout the range from past gunshot activity and the sand trap on the north end of the range. The DEQ collected two sand samples from the sand trap for disposal analysis of lead. The metal backstop above the sand trap was found to have holes in it from guns not supposed to be used on the 0.22 caliber rated metal backstop (Ref 18).

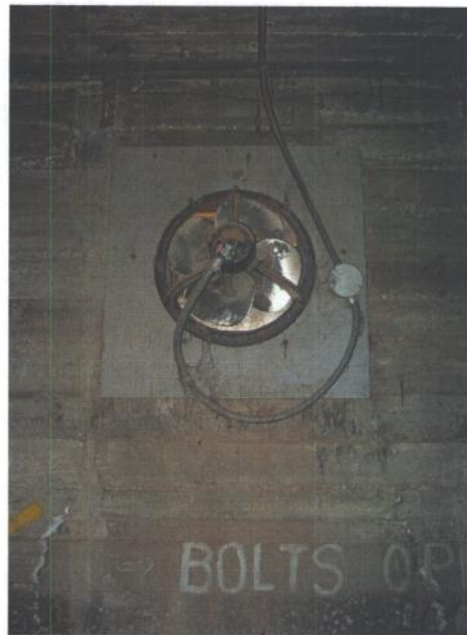
**Photo #20:** IFR vent fan.

- 58,880.0 ug/ft<sup>2</sup> of lead was found on the east side floor of the IFR.
- 183,900.0 ug/ft<sup>2</sup> of lead was found in the center of the IFR.
- 6,765.0 ug/ft<sup>2</sup> of lead was found next to the ventilation fan.
- 3,398.50 ug/ft<sup>2</sup> of lead was found at the stairs.

The IFR needs additional evaluation and remediation efforts on the sand trap and dust residue for lead. The vent area of the IFR, which allows indoor air to escape to the outside air into a concrete surfaced alley, should be investigated for dust residue of lead as well. Other suspected lead issues that should be further investigated include the piping on the first floor. The white paint on some of the piping may or may not have lead-based paint, but it is recommended that it be tested and controlled if the paint is positive for lead.

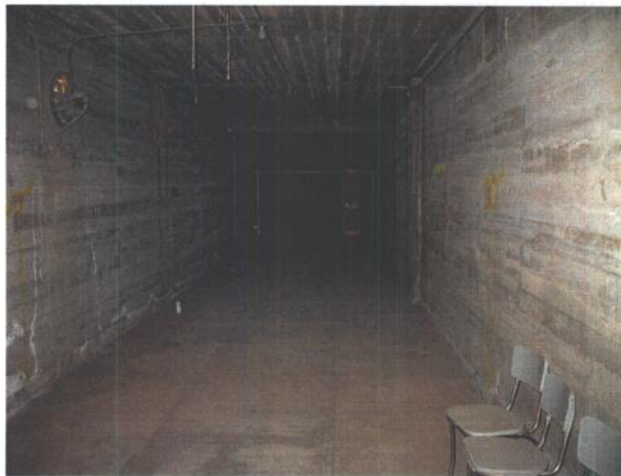
**Photo #21:** IFR looking north towards the sand trap.

The Indoor Firing Range (IFR) sand trap and dust residue is contaminated by lead. Past sampling has been conducted to characterize the lead concentration of this room. A statewide sampling event for lead was conducted by C.H. Guernsey & Company for the Oklahoma Army National Guard on all armories containing indoor firing ranges. This report is called the "Indoor Firing Range Lead Issues Report" (Ref. 11). Five samples were collected inside the IFR. The following are the locations and concentrations of lead found in the room.

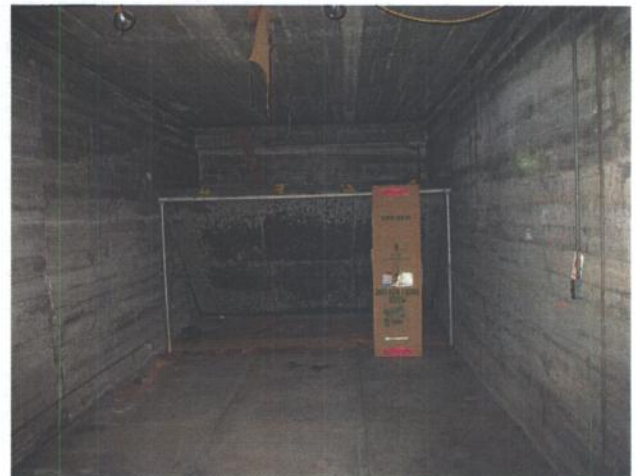
**Photo #22:** IFR sand trap with makeshift target.

- The sand trap and dust residue within the Indoor Firing Range (IFR) was found to have lead contamination. Past sampling of the sand trap and the rest of the IFR show results of lead concentrations in need of remediation. The IFR constitutes a recognized environmental condition (REC) based on the lead concentrations and its leachability.

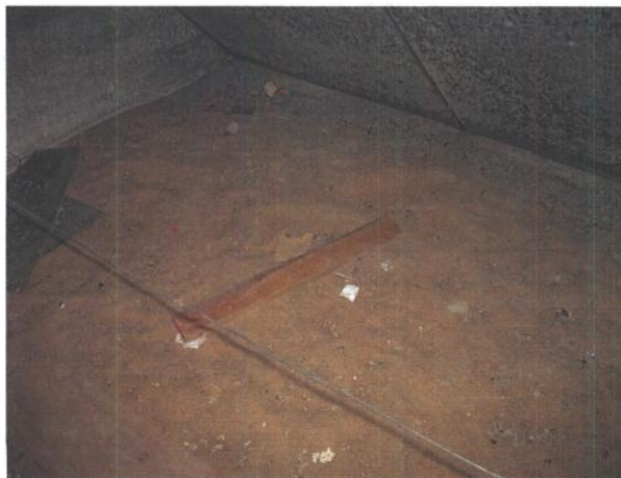
**Photo #23:** Close-up view of the IFR sand trap.

- The sand trap and dust residue within the Indoor Firing Range (IFR) was found to have lead contamination. Past sampling of the sand trap and the rest of the IFR show results of lead concentrations in need of remediation. The IFR constitutes a recognized environmental condition (REC) based on the lead concentrations and its leachability.

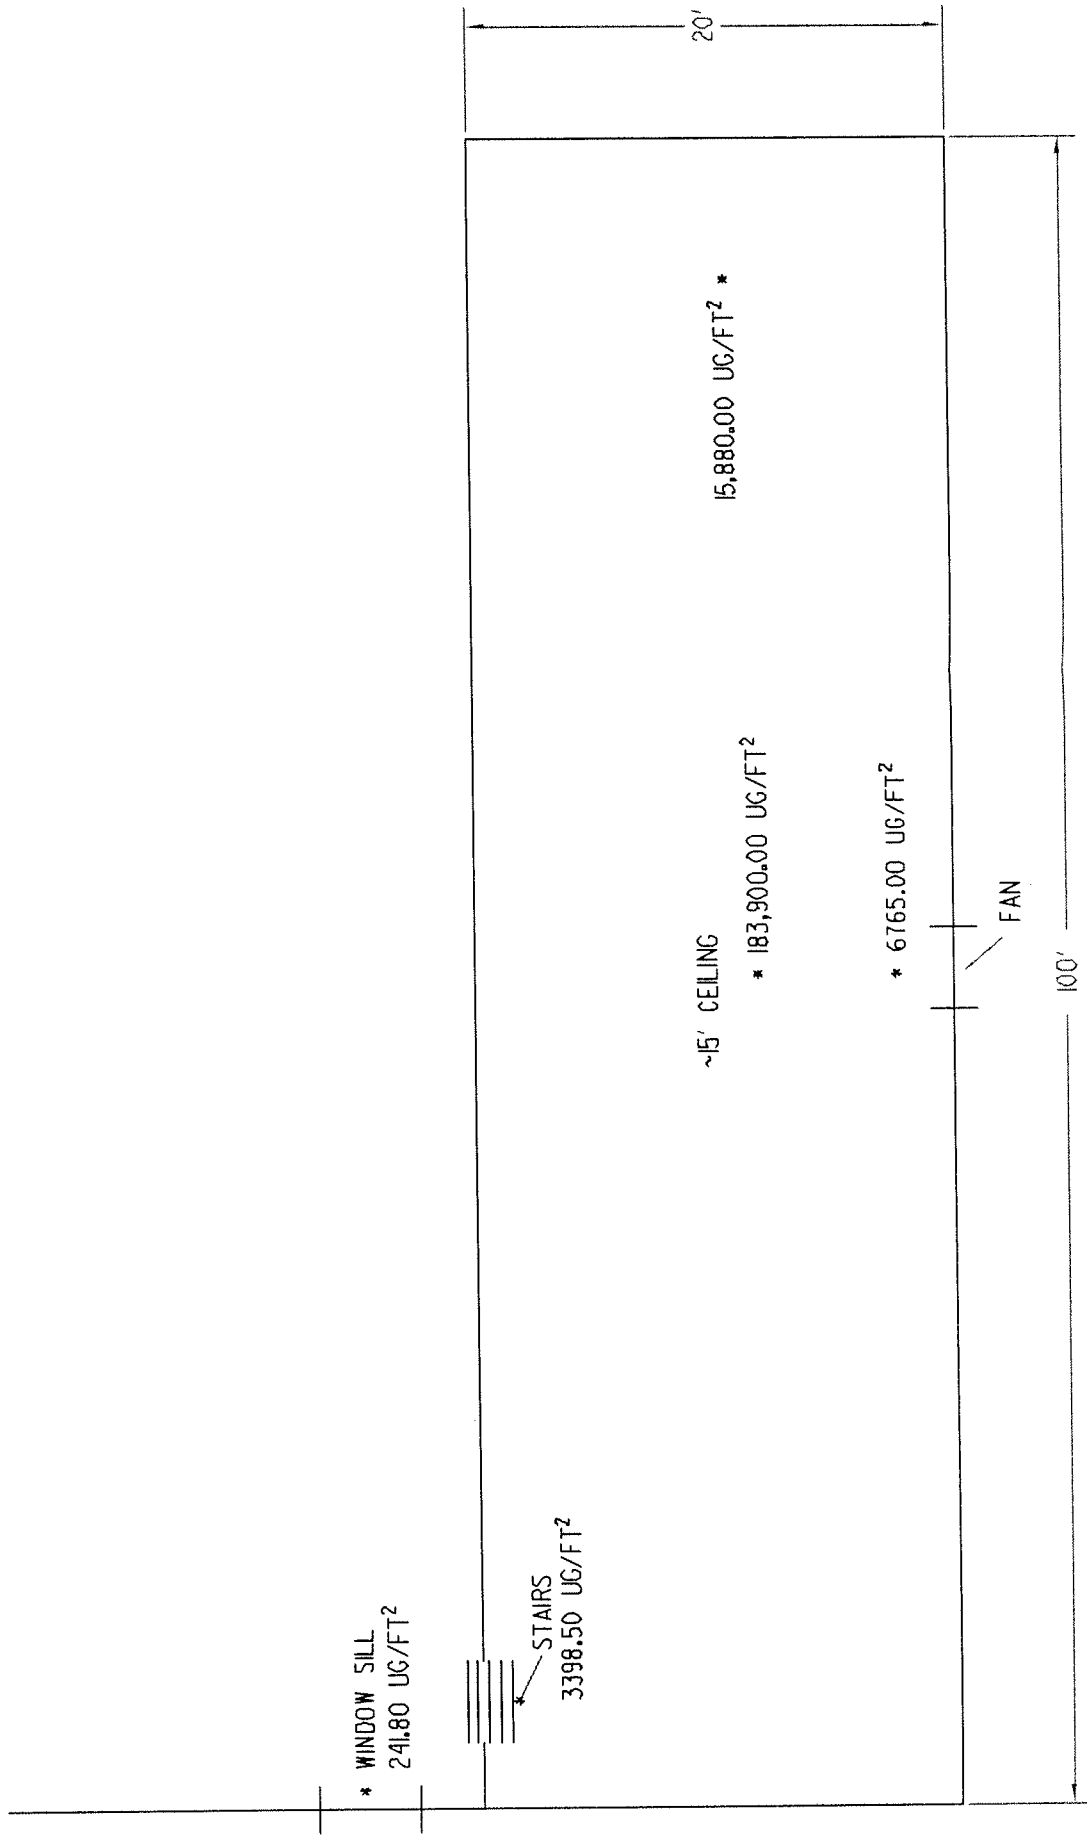
CHEROKEE FIRING RANGE NOTES:

- 241.80 ug/ft<sup>2</sup> of lead was found at the window sill northwest of the stairs of the IFR.

1. ALL MEASUREMENTS ARE APPROX.
2. SAMPLE LOCATIONS ARE APPROX. & IDENTIFIED BY "\*"
3. SAMPLE CONCENTRATIONS ARE IN MICROGRAMS PER SQUARE
4. SAMPLES COLLECTED BY OMD PERSONNEL 29-APR-04
5. SEE PHOTOGRAPHS FOR REFERENCE
6. SEE INVENTORY LIST FOR DESCRIPTION OF EQUIPMENT TO E
