TARGETED BROWNFIELD ASSESSMENT

Oklahoma Army National Guard
Former 44th Street Oklahoma City Armory
Oklahoma City, Oklahoma

ASTM E 1527-05
Phase I Environmental Site Assessment
All Appropriate Inquiry

December 16, 2010

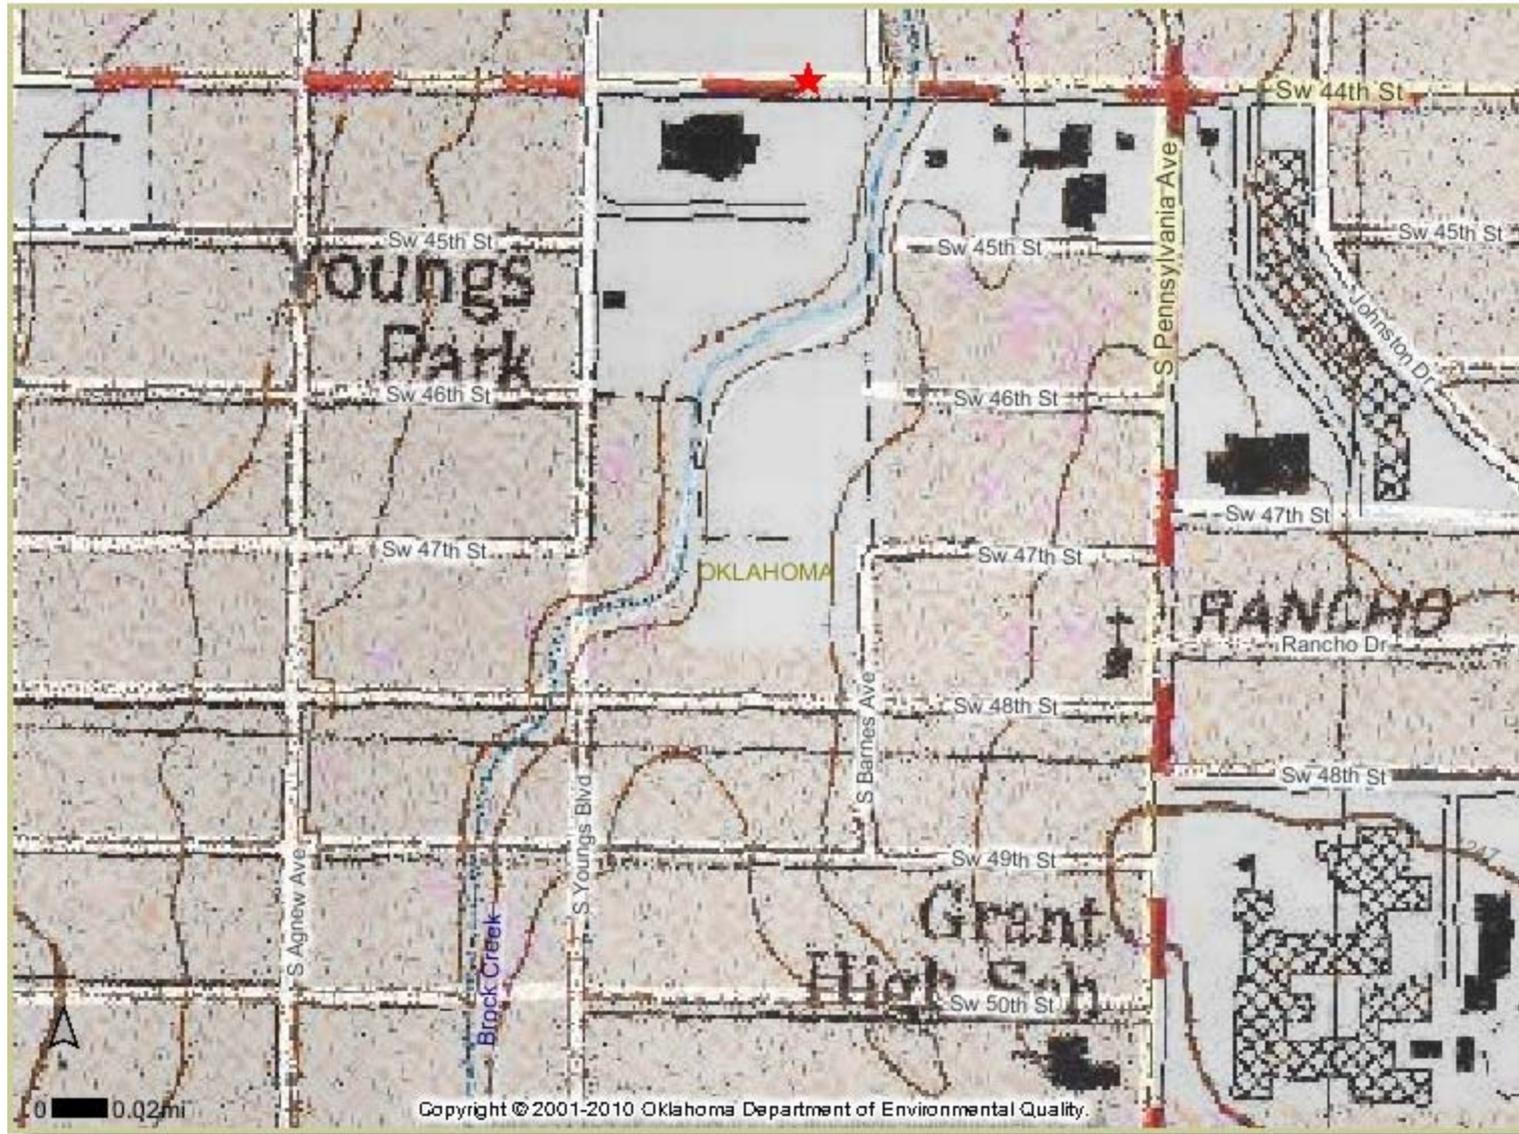
Topographic Map from DEQ Dataviewer

A review of the topographical map indicated that the surface elevation of the site is approximately 1230 feet above mean sea level. The topographical gradient is to the southeast, toward Brock Creek. Brock Creek is located on the eastern edge of the subject property. The topographical map can be found in Appendix B.

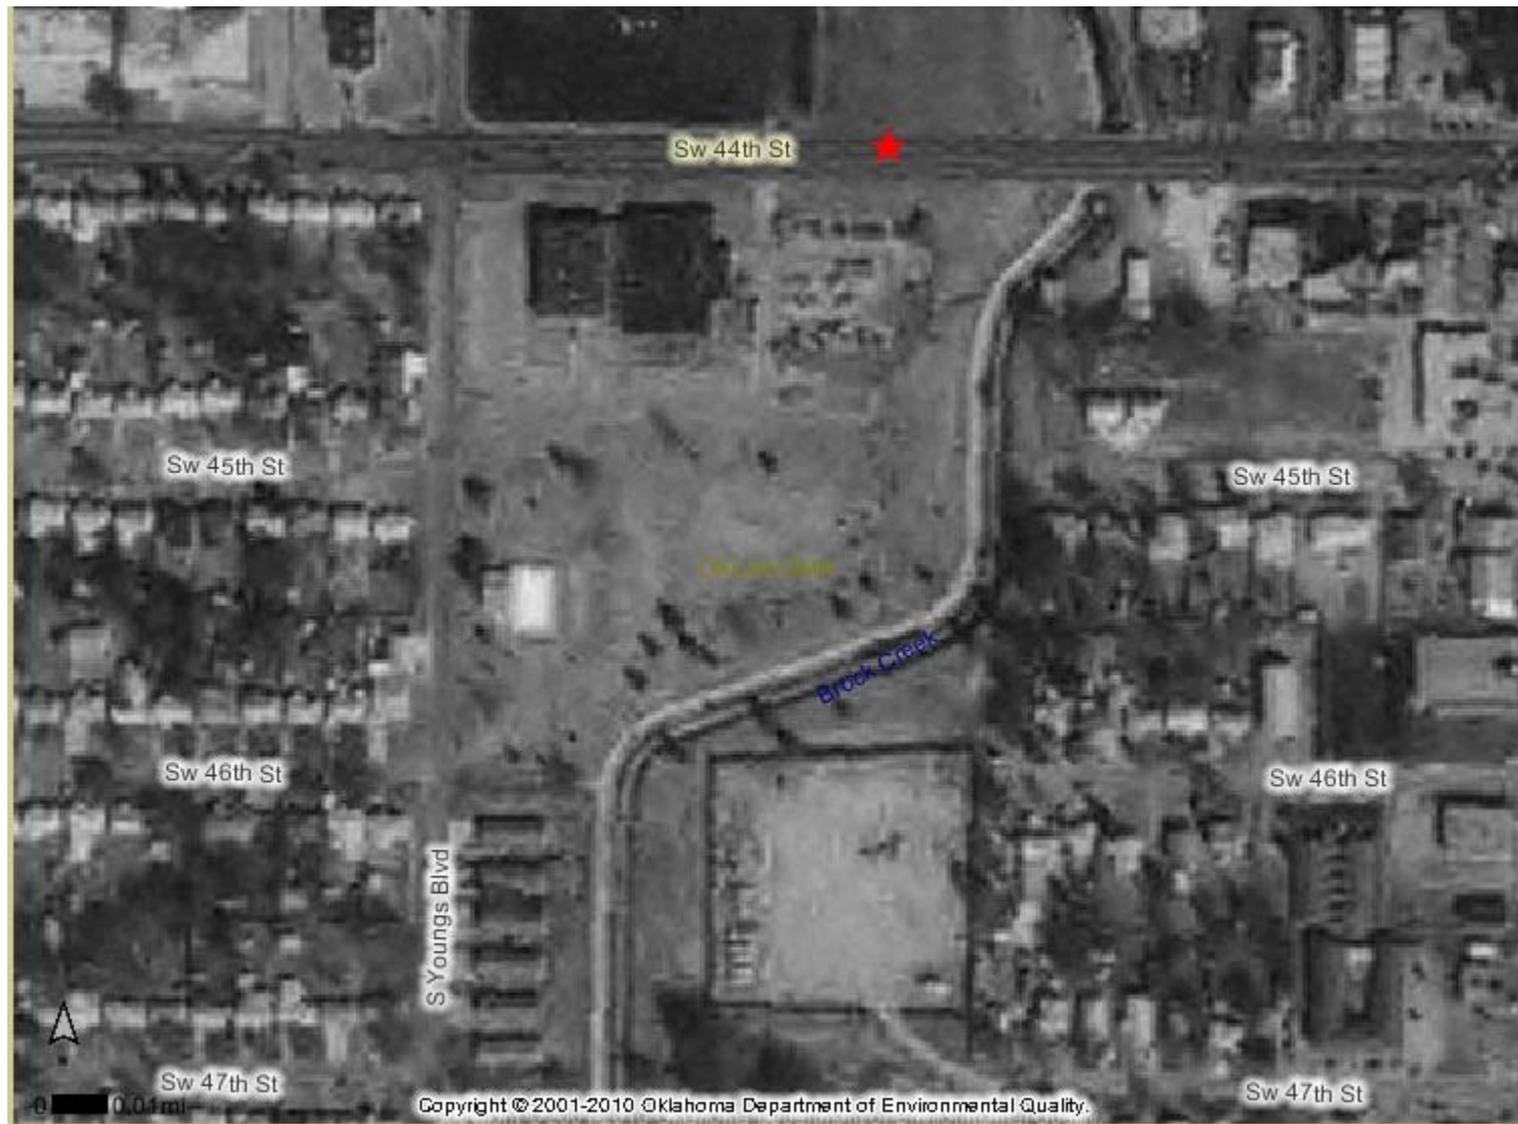
1995 Aerial from DEQ Dataviewer

- The aerial photographs from 1995 to 2010 show an area of oil and gas development to the south of the armory building, south of Brock Creek. Several oil and/or gas tanks are observed in these photographs. The Oklahoma Corporation Commission's (OCC) Oil and Gas Well database shows four wells listed for Young's Park. The OCC oil and gas database indicates that oil exploration was attempted in the past. However all of these wells have been abandoned or plugged. Since this area of oil and gas development is located on an adjacent property, it is considered a REC. One gas well is currently operating onsite. Three oil or gas wells are listed as being near the subject property. These do not appear to be located on adjacent properties. One of these wells has been plugged and the other two are listed as active and probably producing.

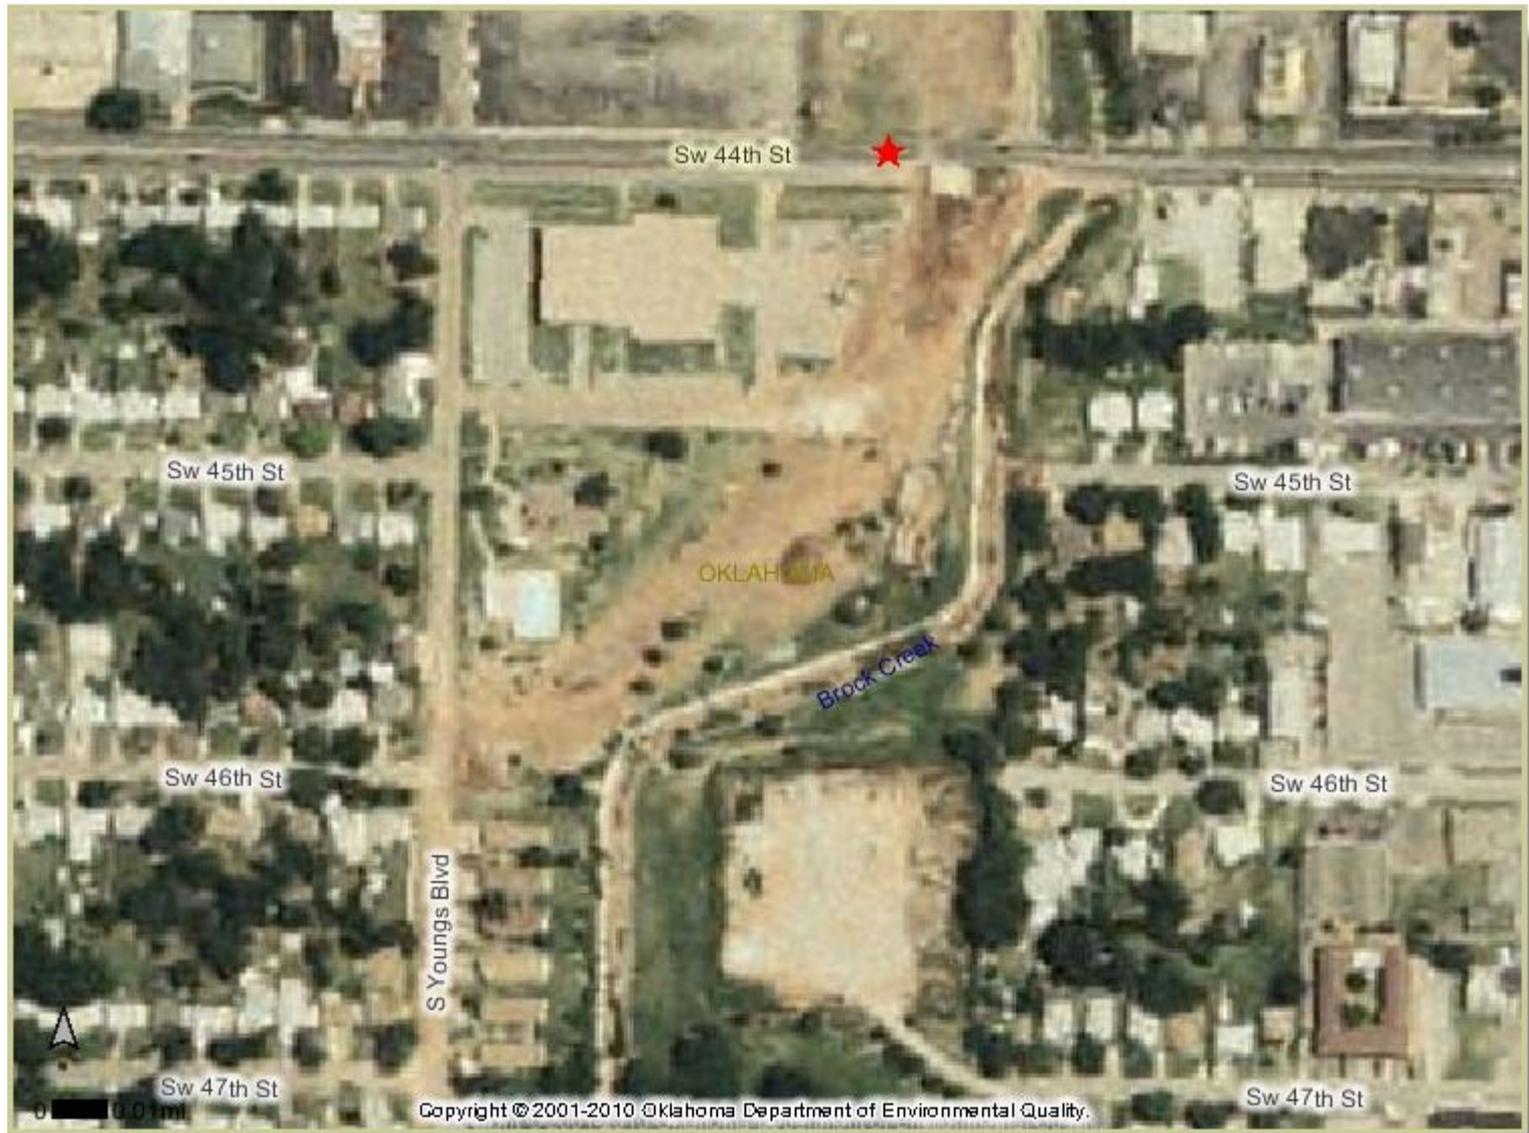
2003 Aerial from DEQ Dataviewer

The 2003 aerial photograph shows some dirt work along Brock Creek on the subject property and across the street to the north. Most adjoining properties appear to be the same as in 1995. A few buildings have been added to the west of the subject property. The only environmental condition noted from the photograph is the area of oil and gas development.

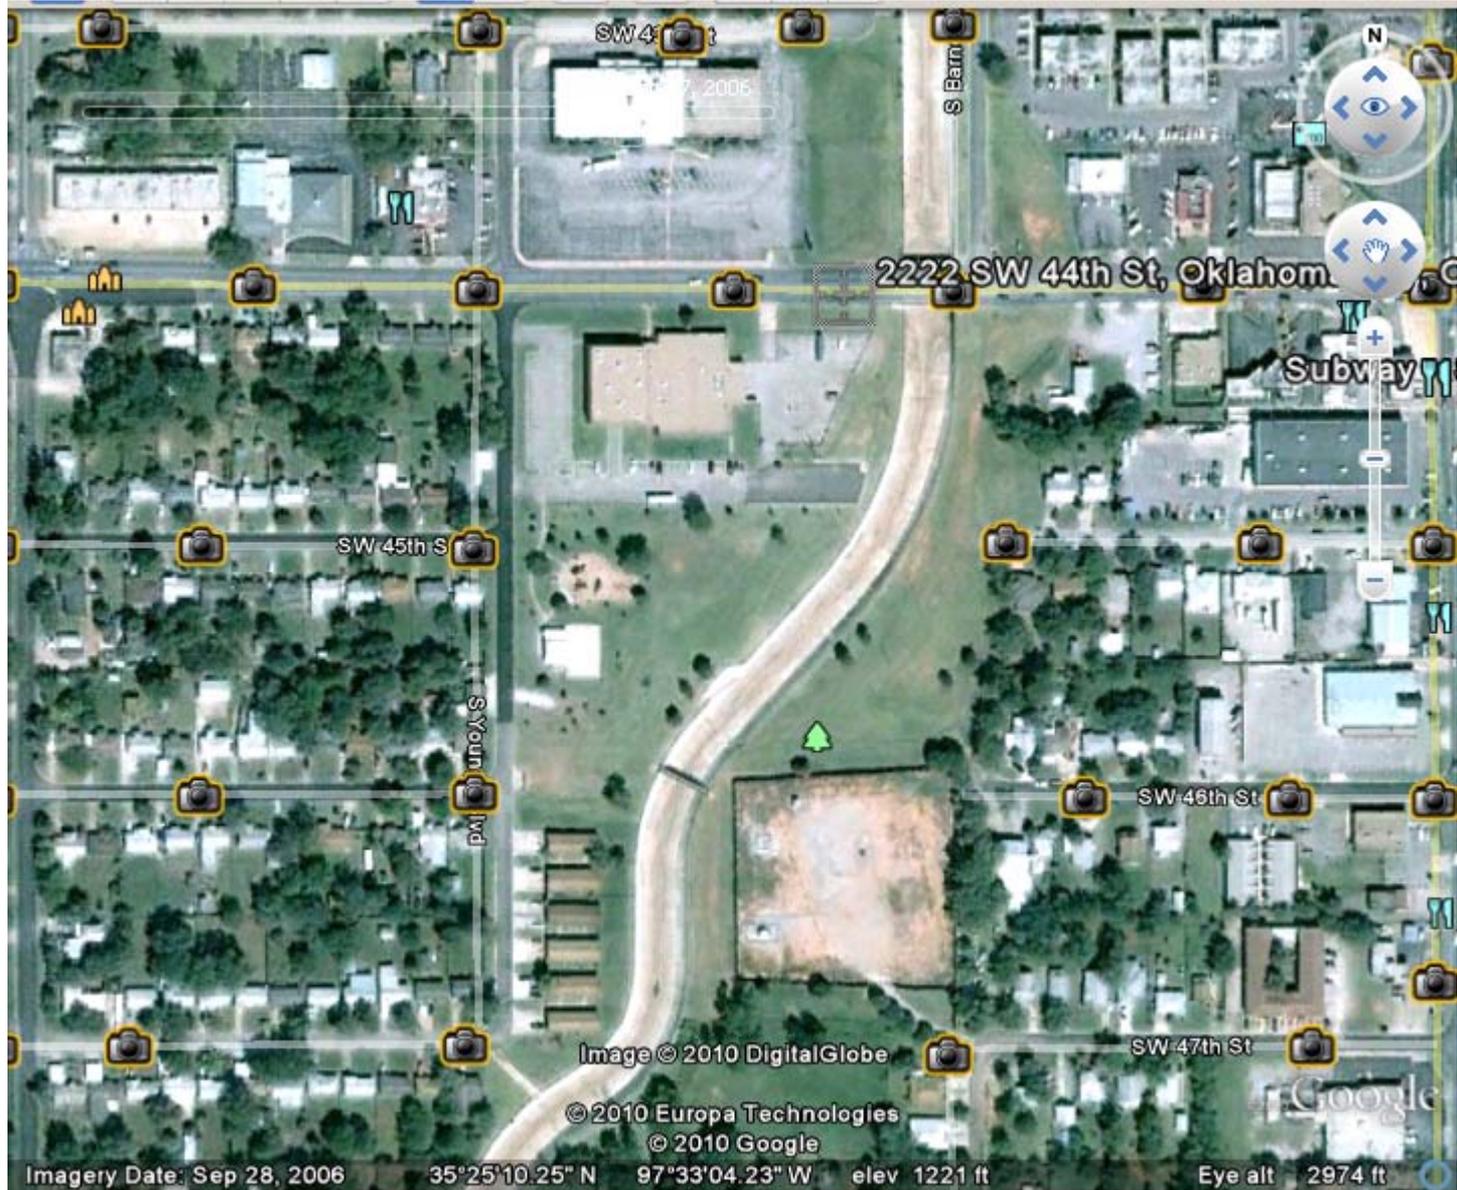
September 28, 2006 Aerial from Google Earth

The 2006 aerial photograph shows a concrete channel for Brock Creek that was not shown in the 2003 aerial photograph. Other than the absence of dirt work and new creek channel, the subject property did not change in appearance from the 2003 aerial photograph. Adjoining properties have not changed much either. The only environmental condition noted from the photograph is the area of oil and gas development.

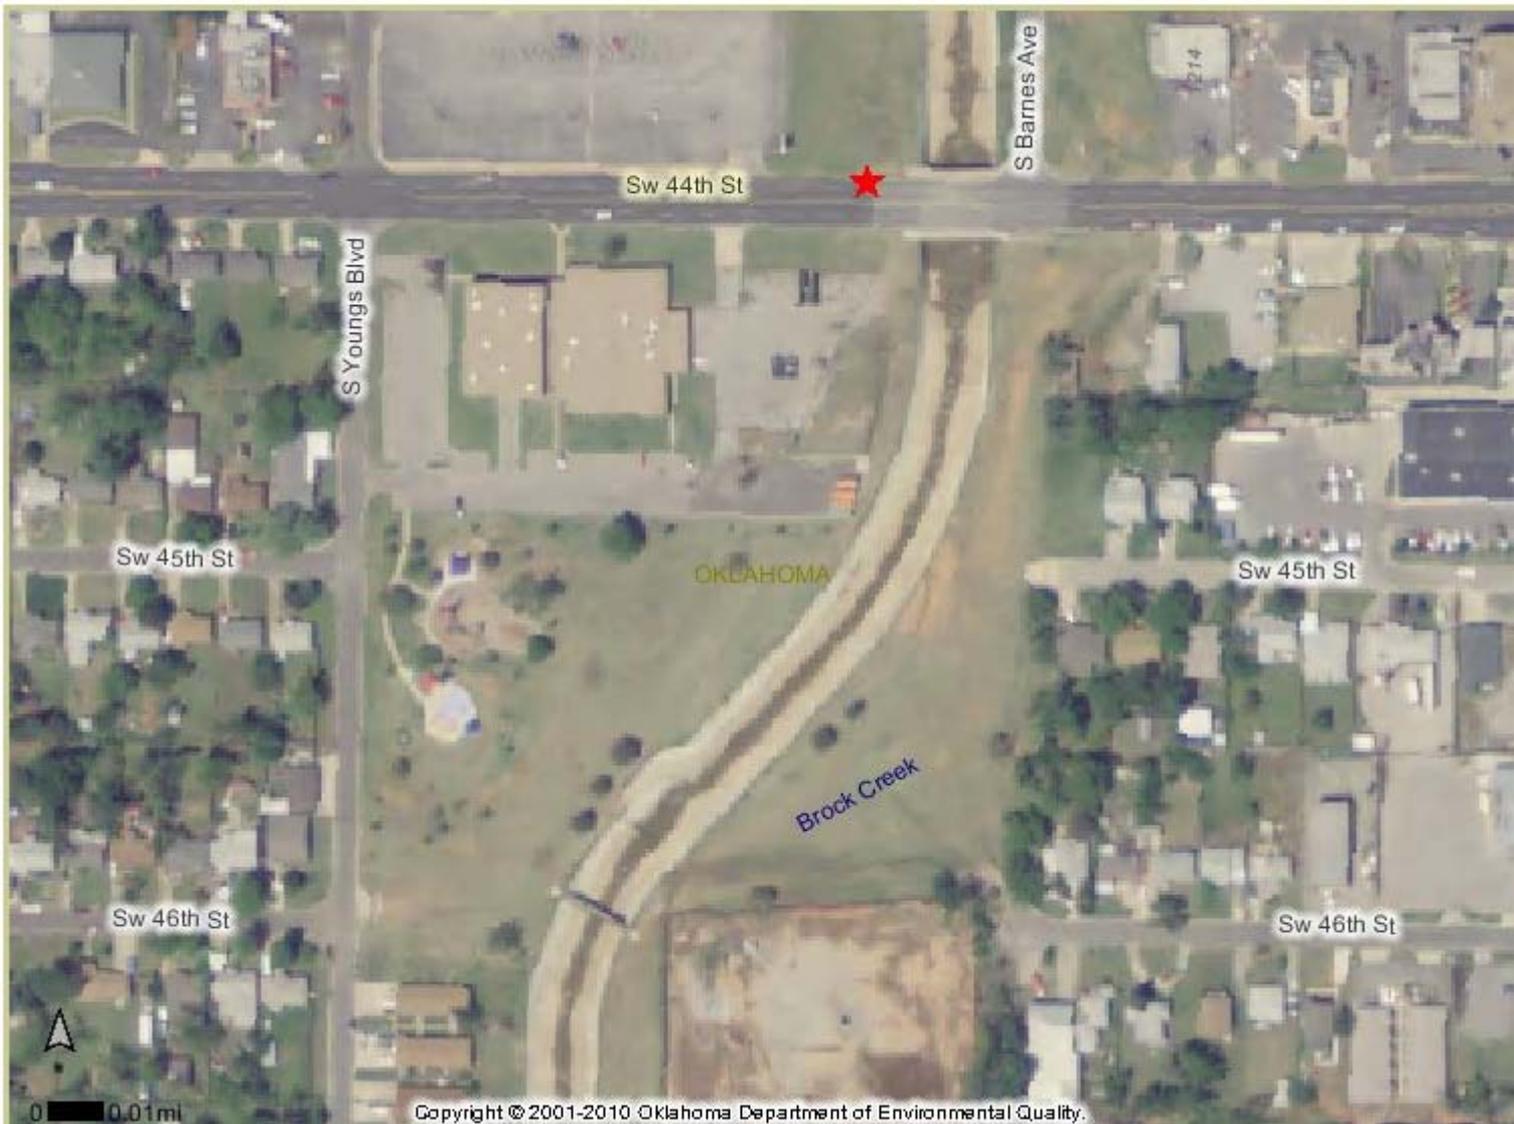
2008 Aerial from DEQ Dataviewer

The 2008 aerial photograph shows the building to the south as being removed. It appears that a round concrete pad has been poured in place of the building. Not much has changed on the subject property other than four metal storage containers being added to the southeast corner of the armory parking lot, near Brock Creek. Adjacent properties have not changed much either. The only environmental condition noted from the photograph is the area of oil and gas development.

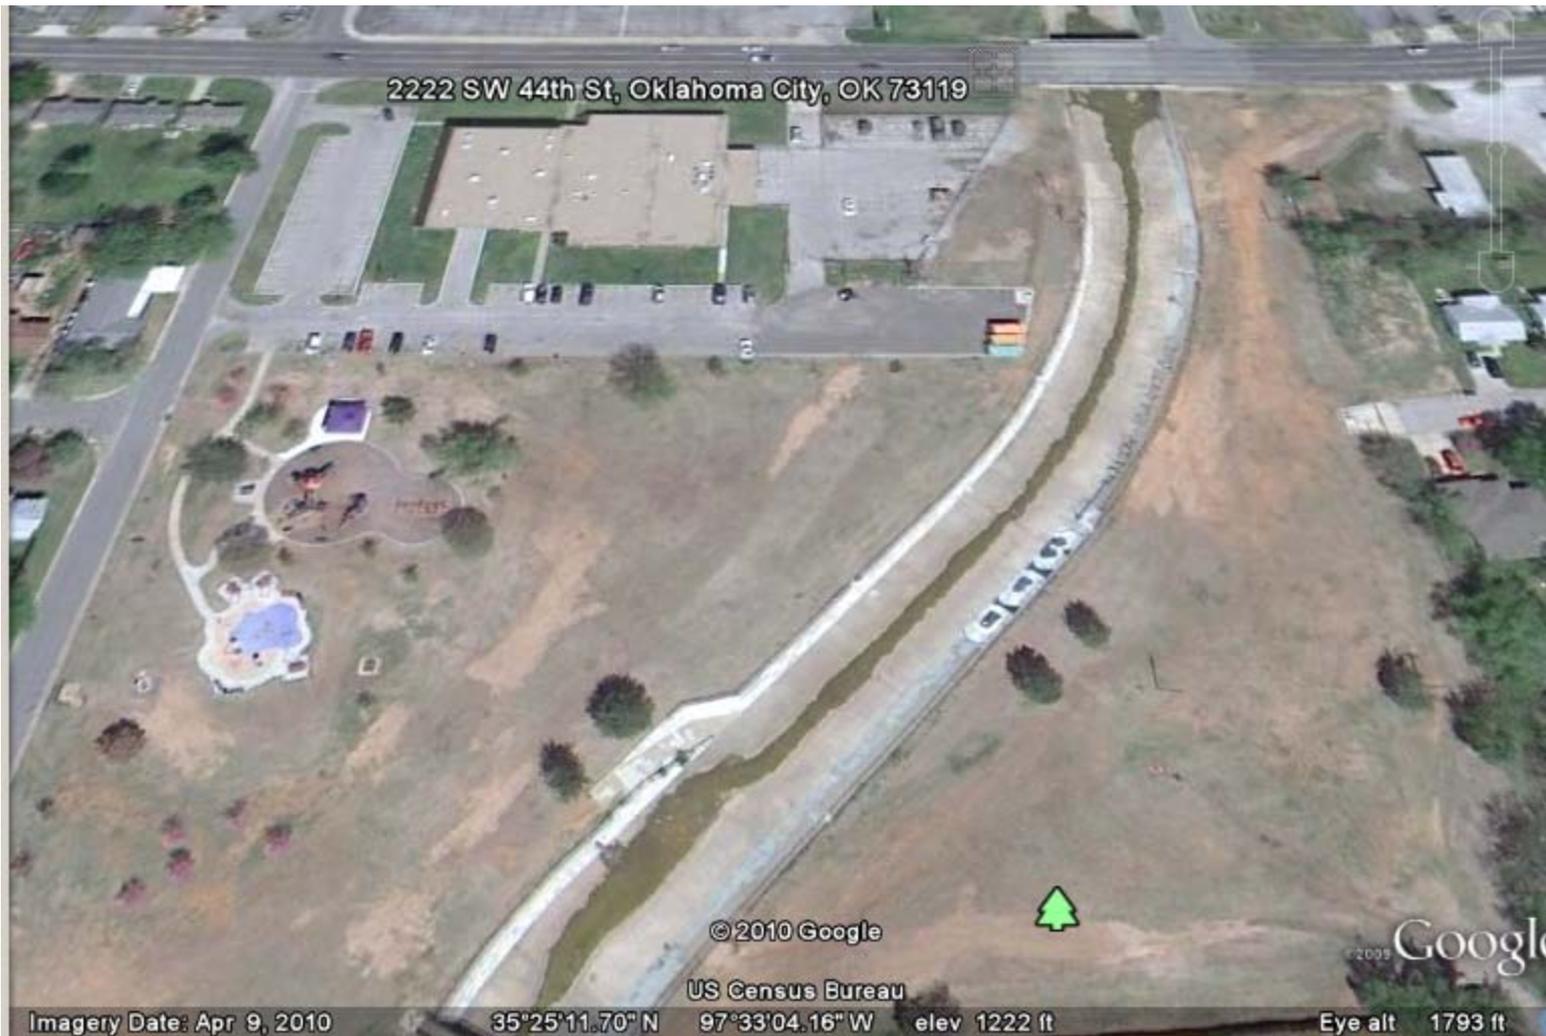
April 9, 2010 Aerial from Google Earth

The 2010 aerial photograph shows a water spray park on the round concrete slab and playground equipment located south the subject property. The subject property has not changed much from the 2008 aerial photograph. It appears that three metal storage containers are now located in the southeast corner of the armory parking lot, near Brock Creek. The only environmental condition noted from the photograph is the area of oil and gas development.

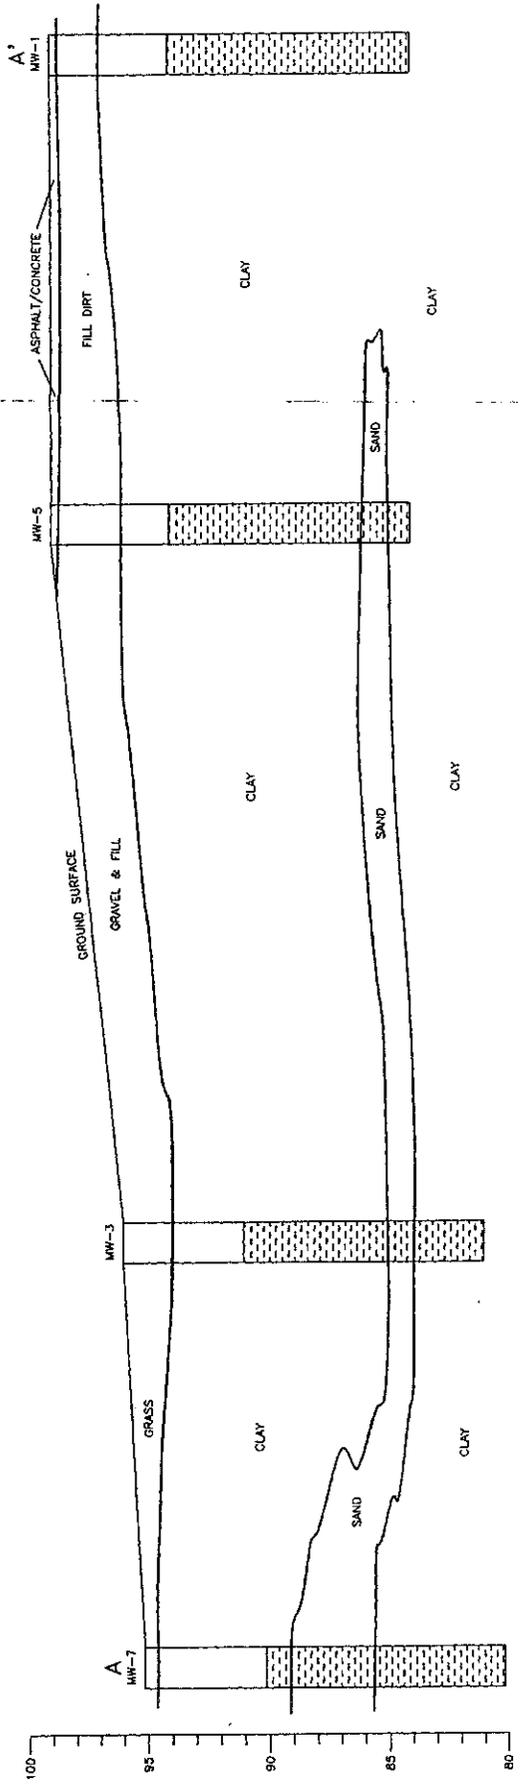
The soils in the tank pit area consist of red-brown or gray clay to 12 - 14 feet. A fine-grained, gray sand was encountered at approximately 13 feet, followed by a red-brown, hard, dry clay to total depth drilled. The maximum depth of investigation was 20 feet. Groundwater was encountered at approximately 12 feet in MW-3, but the water zone was not readily apparent in most wells. Figure 3 represents cross-section A-A', which was prepared with east-west orientation to present the various lithologies and their vertical and horizontal extent.

Former Circle K Store #1279 Oklahoma City, Oklahoma		DATE: 4/95
DESIGNED: <i>[Signature]</i>	CHECKED: <i>[Signature]</i>	APPROVED: <i>[Signature]</i>
CROSS SECTION A-A'		DRAWN: JMB
TRUST Environmental Services, LLC		PROJ.: 204-722
		Figure 3

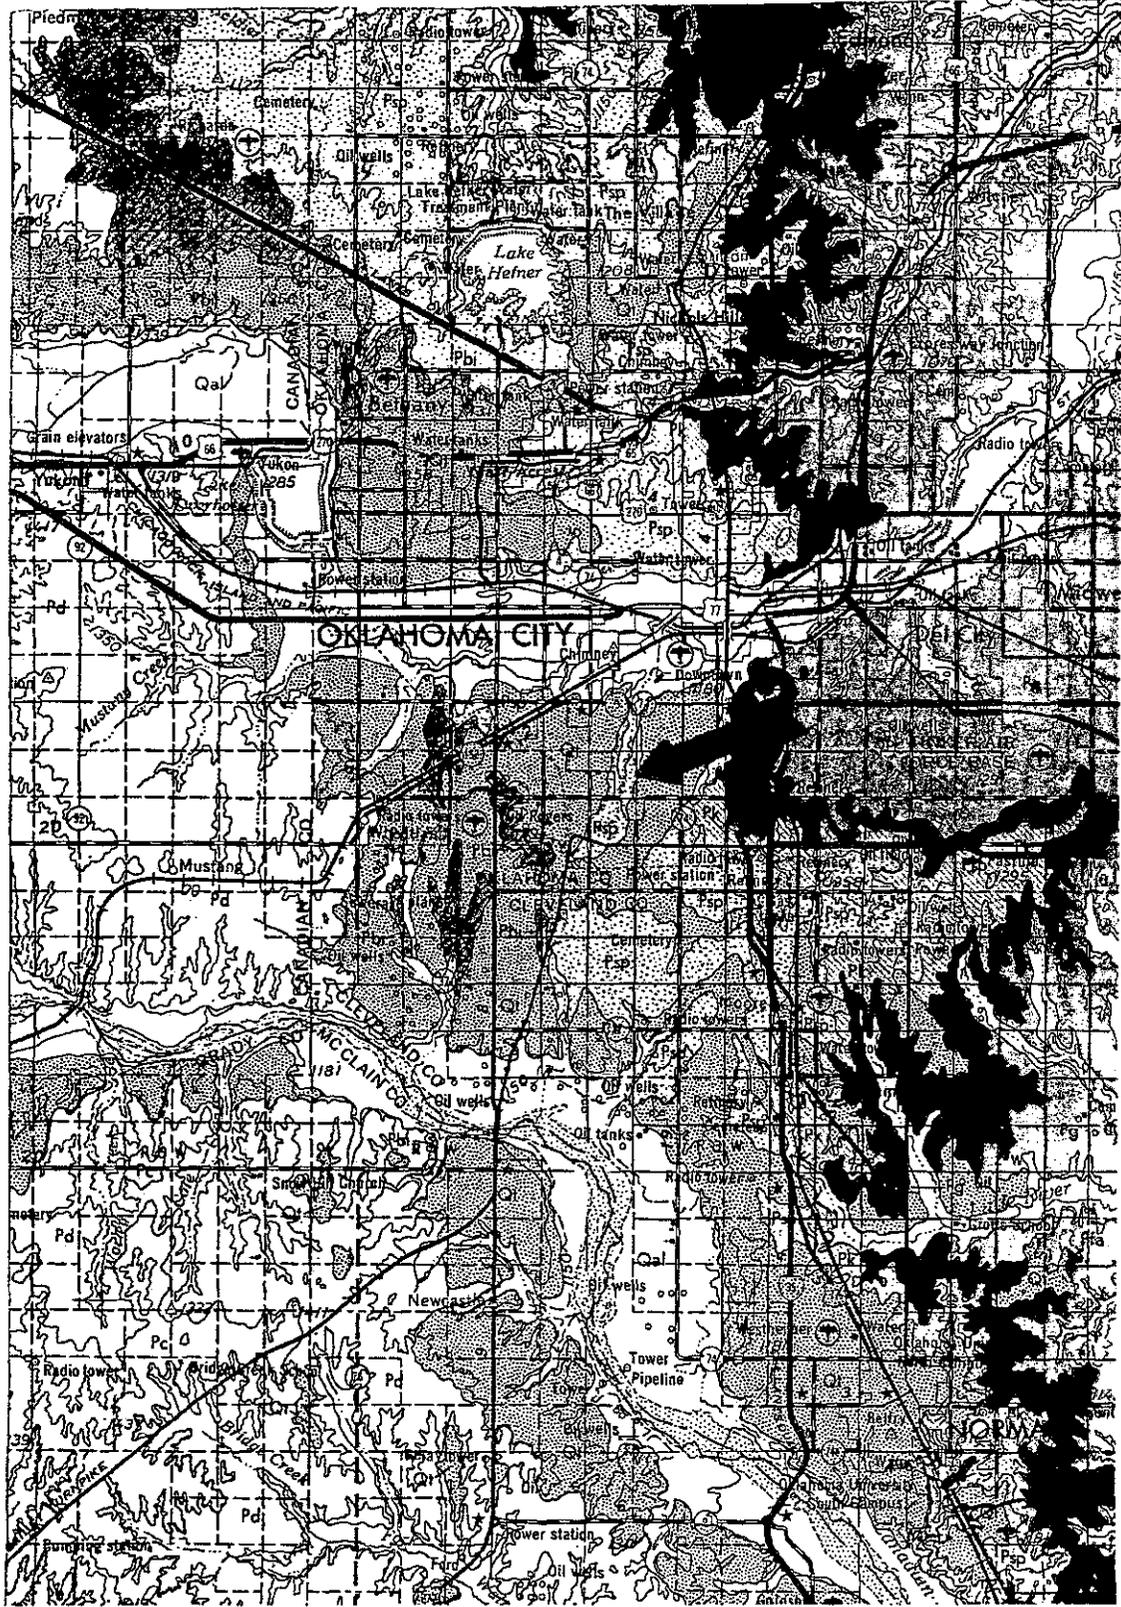
Figure 4. Geological Map

According to the Hydrologic Atlas No. 4 (Bingham and Moore, 1975), the area surrounding the site is underlain by the Salt Plains Formation which consists of red-brown blocky shale and orange-brown siltstone (refer to Figure 4).

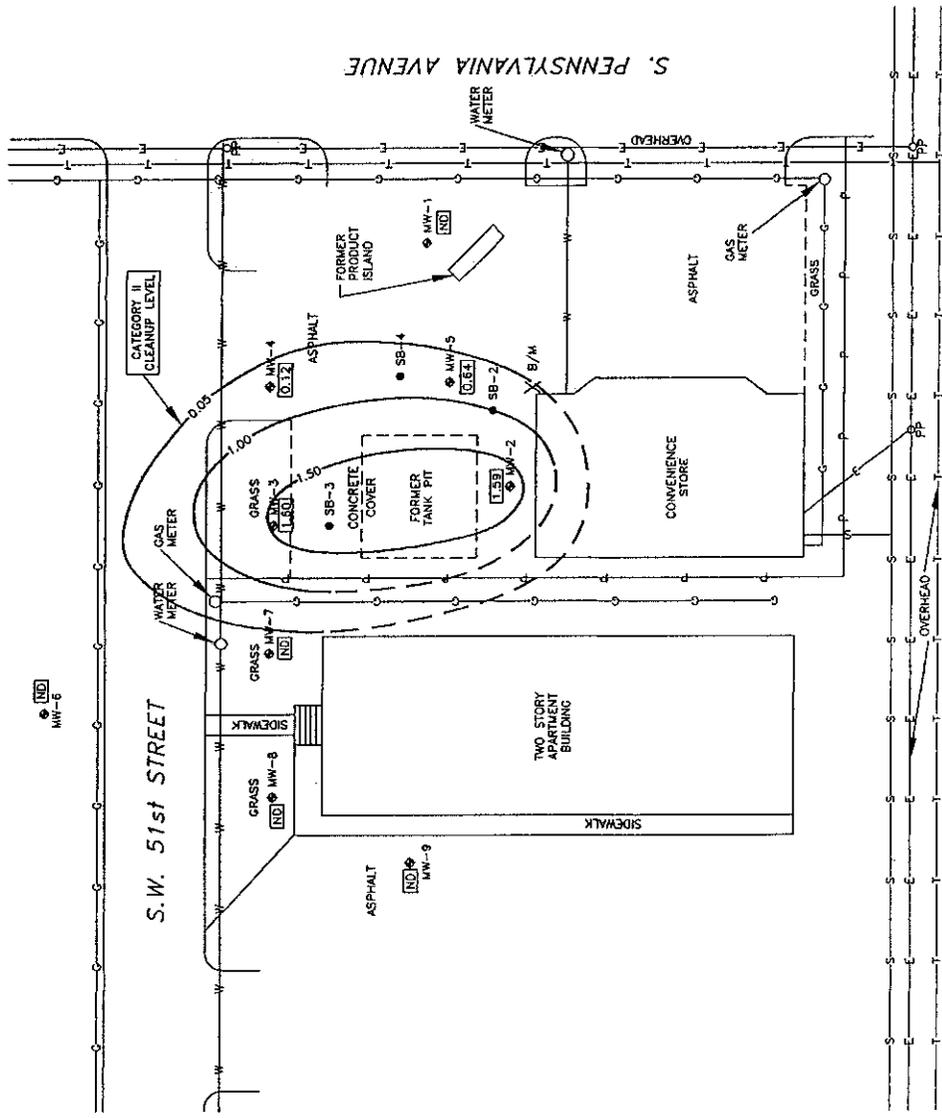
NOTE:
 MW-1 THROUGH MW-5 SAMPLED 8/2/95
 MW-6 THROUGH MW-9 SAMPLED 4/5/95 & 4/13/95

Former Circle K Store #1279 Oklahoma City, Oklahoma	DATE: 4/95
BENZENE CONCENTRATIONS IN GROUNDWATER, (ppm)	DESIGNED: <i>[Signature]</i>
	CHECKED: <i>[Signature]</i>
	APPROVED: <i>[Signature]</i>
	DRAWN: JMB
	PROJ.: 204-719
TRUST Environmental Services, LLC	Figure 8
