TARGETED BROWNFIELD ASSESSMENT

**Oklahoma Army National Guard
Former Pawhuska Armory
Pawhuska, Oklahoma**

ASTM E 1527-05
Phase I Environmental Site Assessment
All Appropriate Inquiry

August 24, 2011

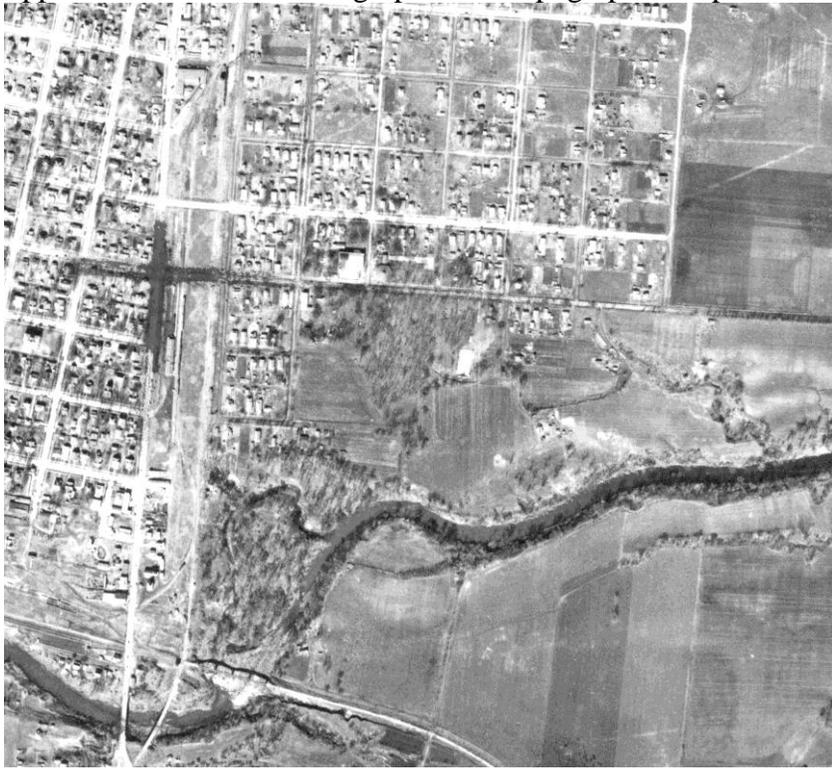
Figure 2 Pawhuska Armory 1937

The 1937 aerial photograph shows the subject property to be to the southeast of Pawhuska, Oklahoma near a residential area and near agricultural land. The photograph shows the building on the subject property to be under construction. Buildings on adjacent properties appear to be residences. No apparent environmental conditions were noted from the photograph.

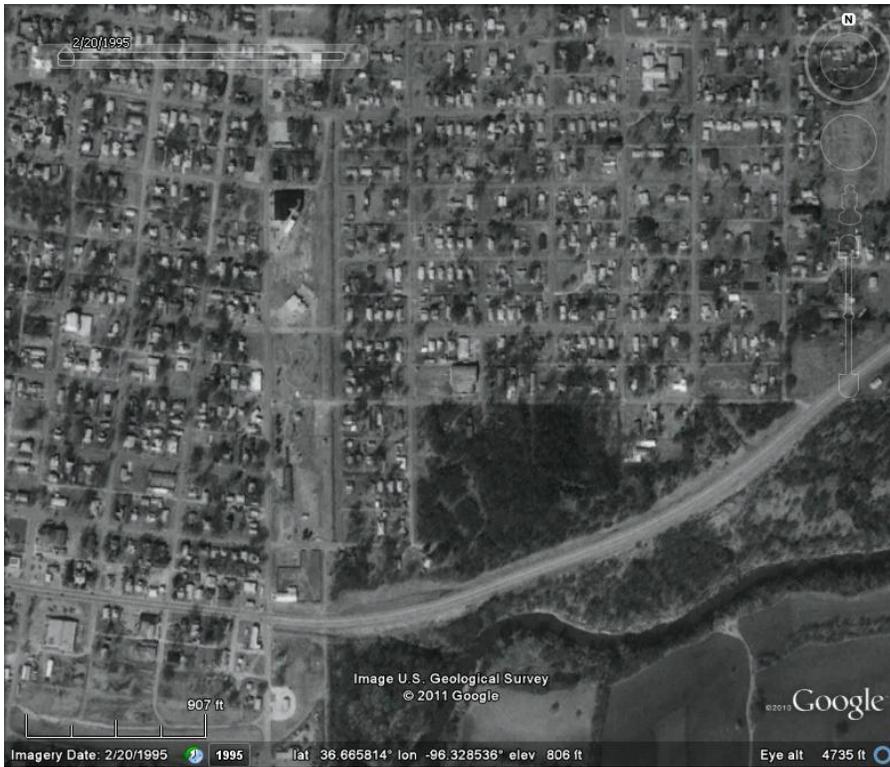
Figure 2 Pawhuska Armory 1995

The 1995 aerial photograph shows the subject property to be to the southeast of Pawhuska, Oklahoma near a residential area and north of a heavily wooded area. Buildings on adjacent properties appear to be residences. No apparent environmental conditions were noted from the photograph.

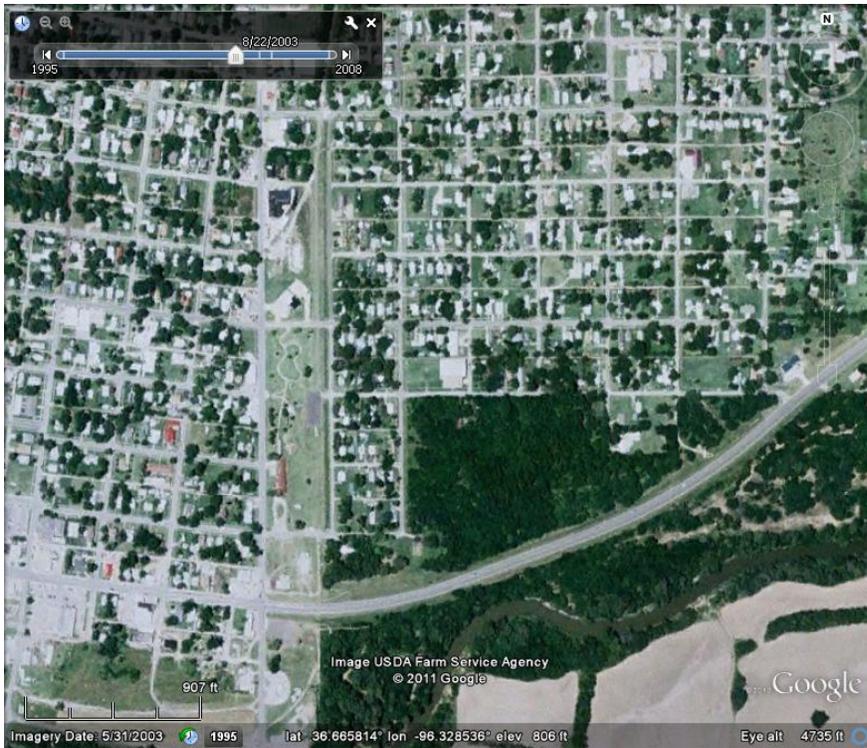
Figure 3 Pawhuska Armory 2003

The 2003 aerial photograph shows the subject property to be to the southeast of Pawhuska, Oklahoma near a residential area and north of a heavily wooded area. Buildings on adjacent properties appear to be residences. No apparent environmental conditions were noted from the photograph.

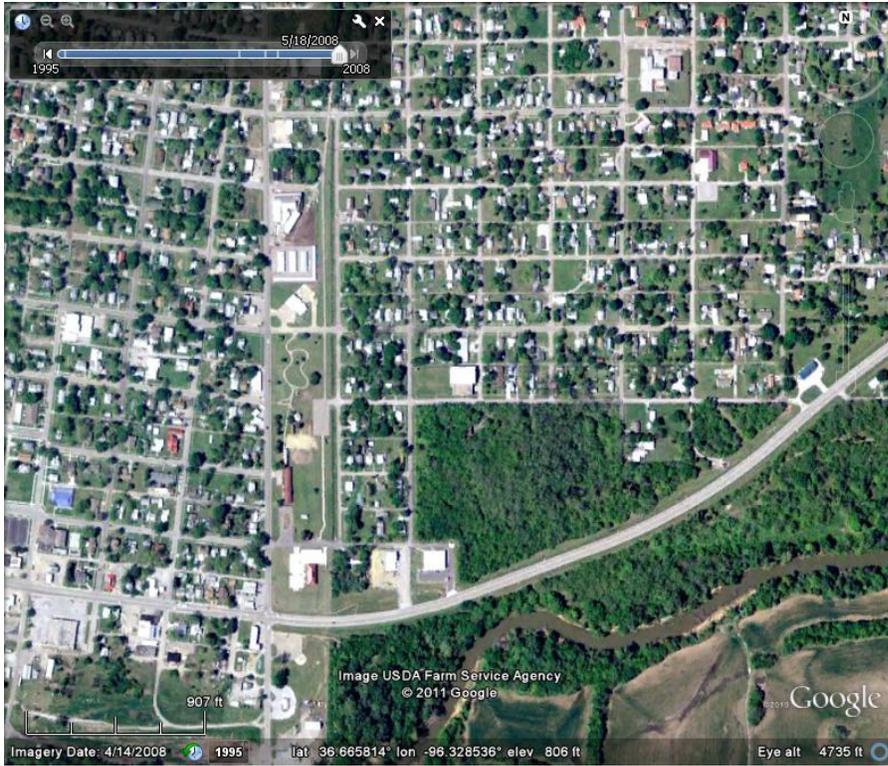
Figure 5 Pawhuska Armory 2008

The 2008 aerial photograph shows the subject property to be to the southeast of Pawhuska, Oklahoma near a residential area and north of a heavily wooded area. Buildings on adjacent properties appear to be residences. No apparent environmental conditions were noted from the photograph.

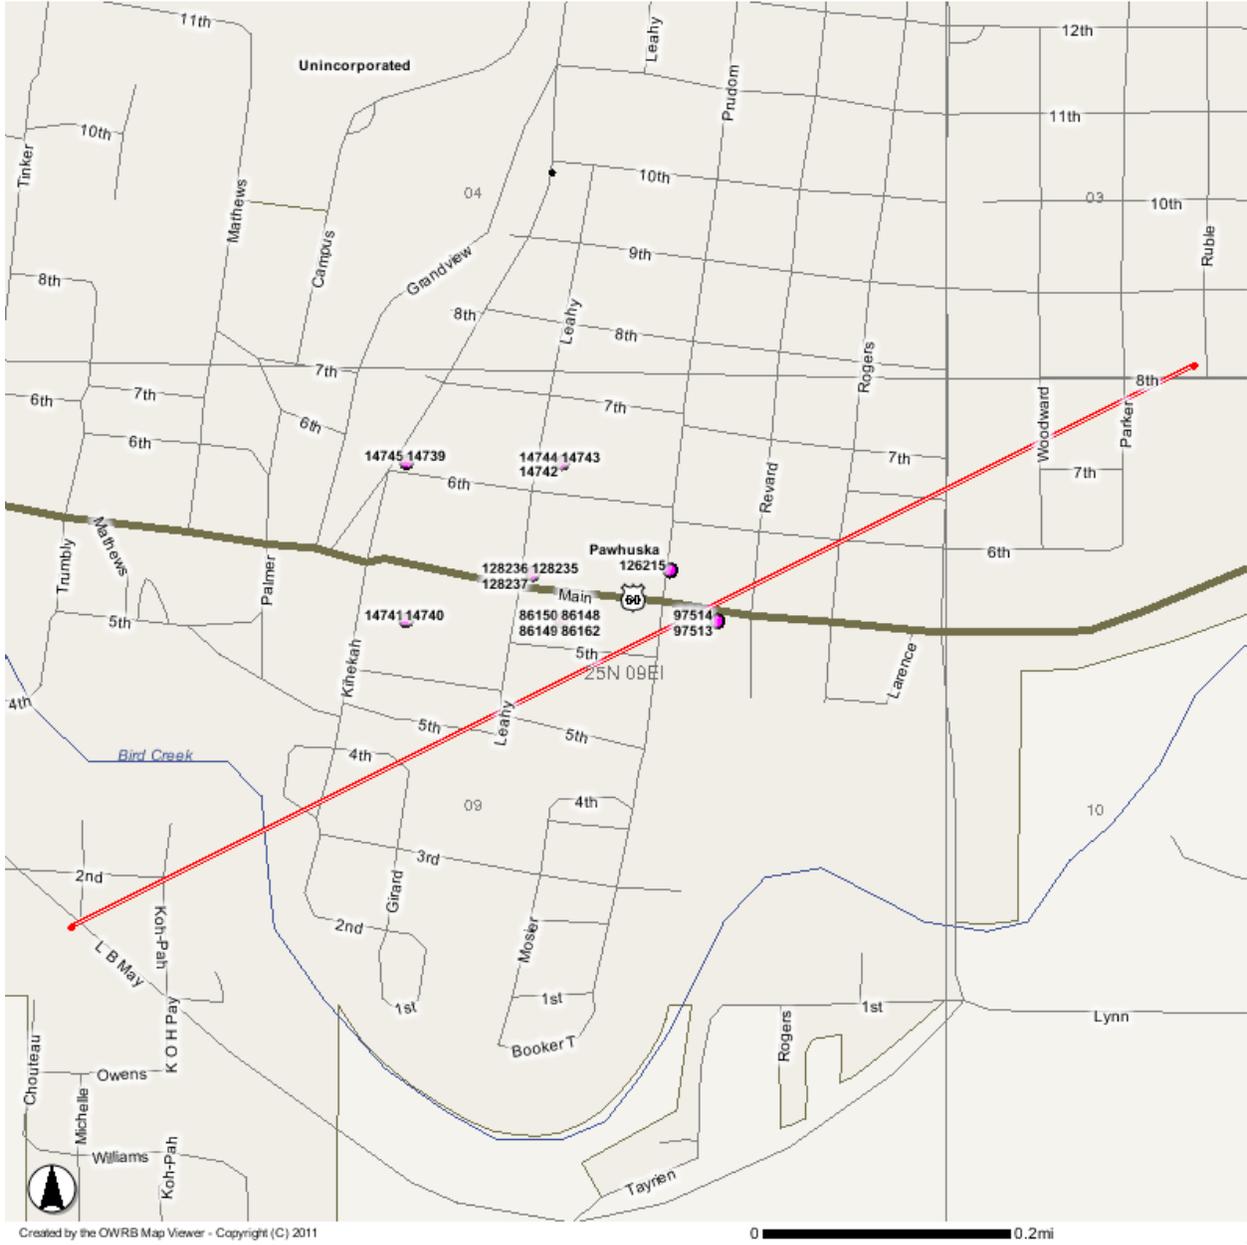
Monitoring wells from OWRB

No monitoring wells are present on the property. According to the Oklahoma Water Resources Board well search, performed on February 14, 2011, there are twenty-three monitoring wells within the designated search radius of 1 mile. These wells were installed in 1998, 2001, 2002, 2005, and 2009 for groundwater monitoring. These three wells are located downgradient of the subject property. See Appendix C for a map of OWRB wells found within 1 mile of the subject property.

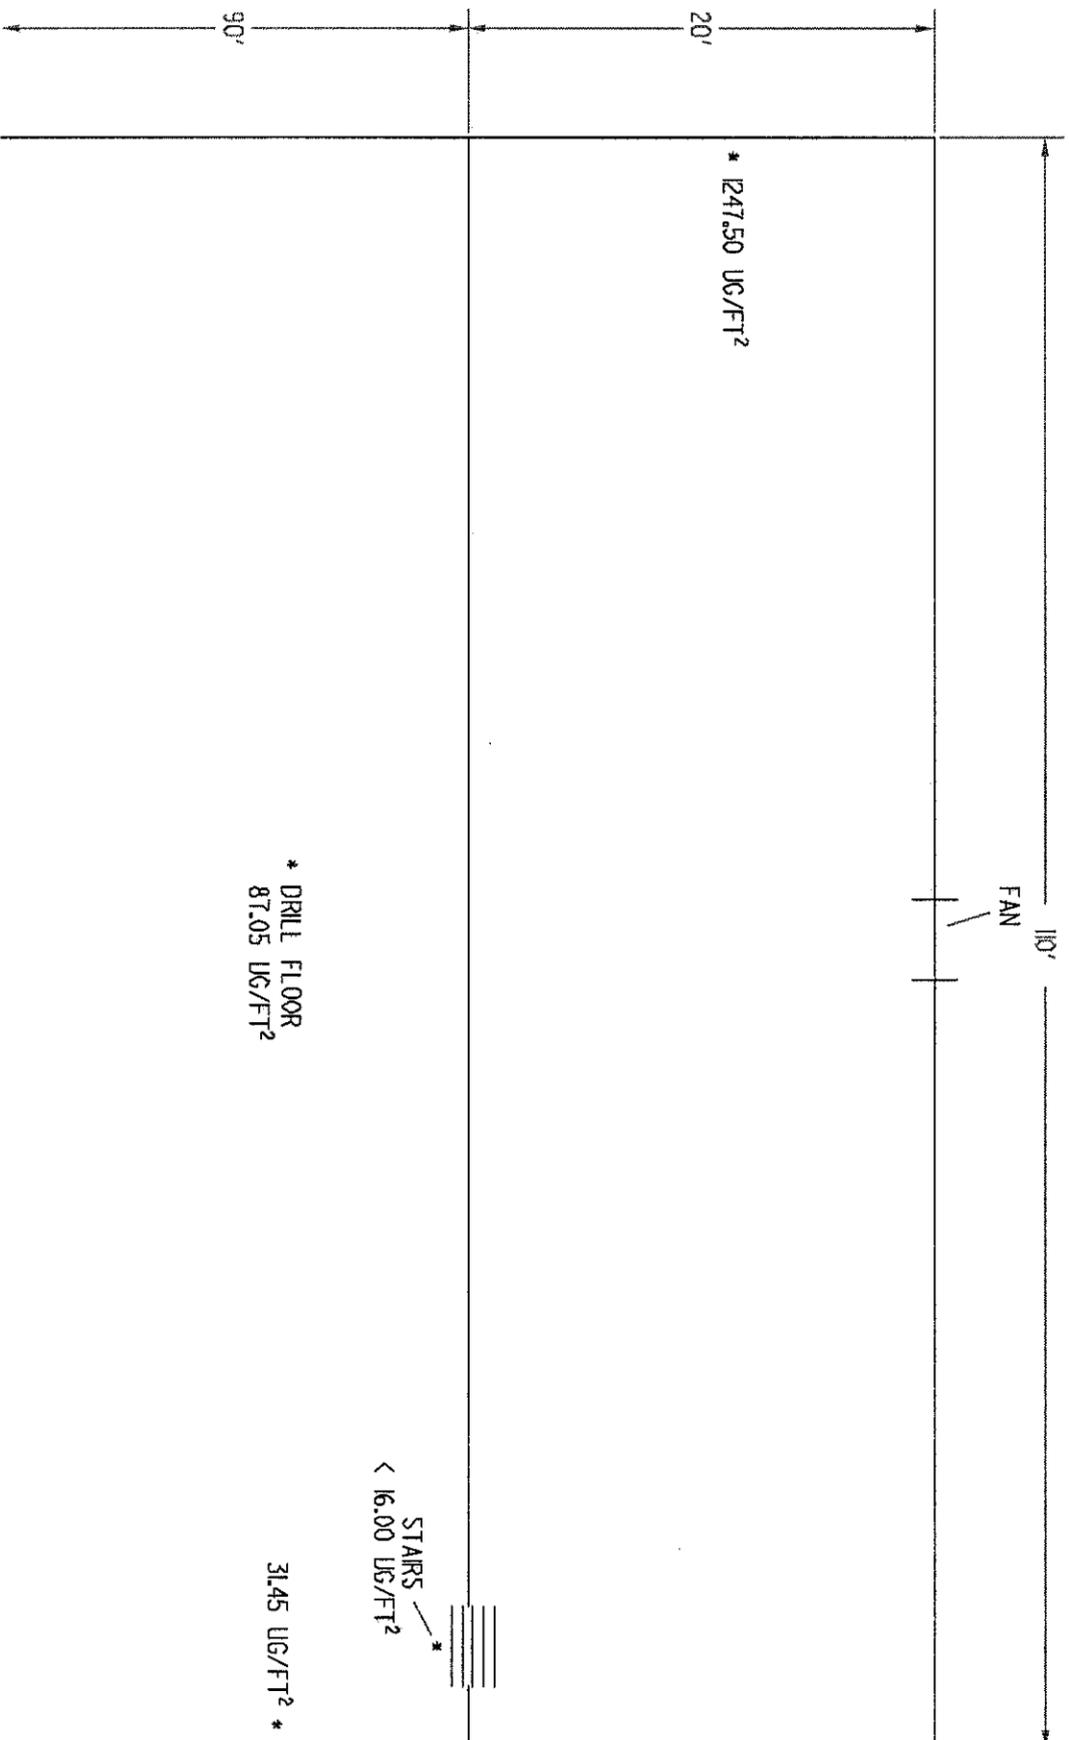
- PANHUSKA FIRING RANGE NOTES:**
1. ALL MEASUREMENTS ARE APPROX.
 2. SAMPLE LOCATIONS ARE APPROX. & IDENTIFIED BY **
 3. SAMPLE CONCENTRATIONS ARE IN MICROGRAMS PER SQUARE FOOT (UG/FT²)
 4. SAMPLES COLLECTED BY OMD PERSONNEL 28-APRIL-04
 5. SEE PHOTOGRAPHS FOR REFERENCE
 6. SEE INVENTORY LIST FOR DESCRIPTION OF EQUIPMENT TO BE CLEANED
