**Targeted Brownfield Assessment
Oklahoma Army National Guard
Pawnee Armory
Pawnee, Oklahoma**

**ASTM E 1527-05
Phase I Environmental Site Assessment
All Appropriate Inquiry**

December 11, 2006

**Oklahoma Department of Environmental Quality
Land Protection Division
707 N. Robinson
P.O. Box 1677
Oklahoma City, Oklahoma 73101-1677
(405) 702-5100**

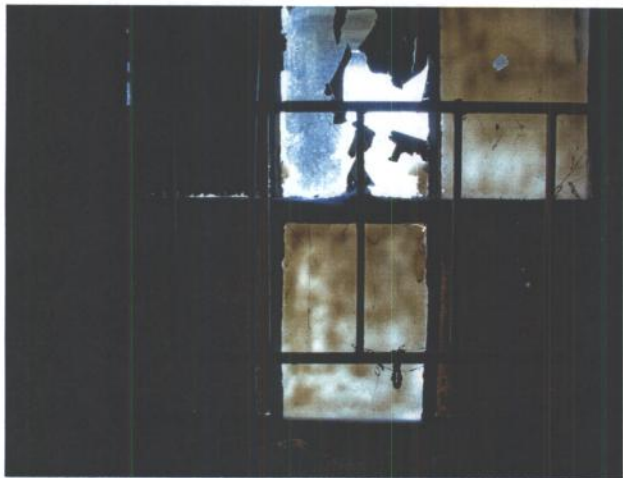
Photo #1: Peeling paint on one of the windows of the building.

Peeling paint on the walls, piping adjoining the light switch fixtures, and windowpanes was found, which may contain lead. No samples were collected from the paint, but it is recommended that the paint be analyzed for lead. Based on the age of the facility and the nature of the paint there is a possibility that it could contain lead.

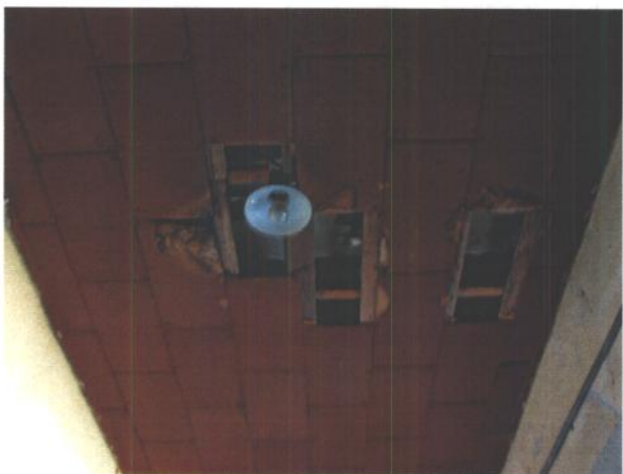
Photo #3: Missing ceiling panels in one of the rooms.

Suspect ACM potentially in the drop ceilings of several rooms located in the north, south, and west wings should be sampled for asbestos. The tiles and pipe wrapping located in the south wing and the heating unit insulation located in the lobby area of the west wing should be tested for ACM as well. If ACM is found, proper remediation should be conducted.

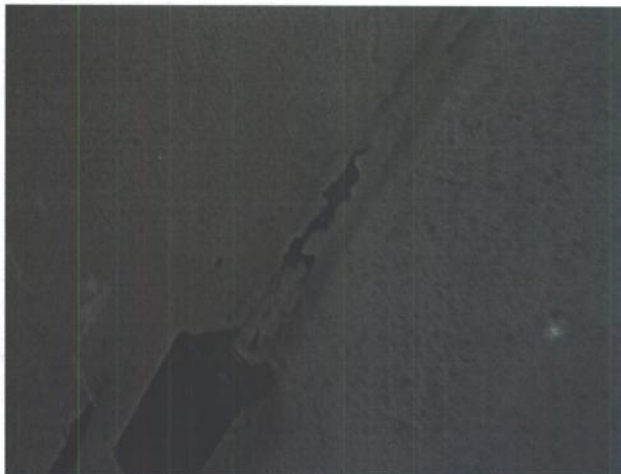
Photo #4: Peeling paint on one of the light switch fixture piping.

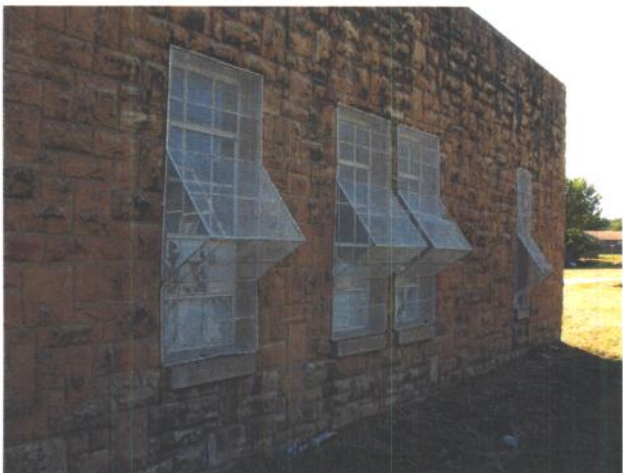
The sandstone structure of the armory appeared to have green algae stains and black stains due to water damage and weathering. The majority of windowpanes throughout the facility were either broken or missing entirely. Some of the windowpanes that were either broken or still intact were found to have peeling chips of paint that could possibly be lead-based paint. This weathered paint was also found peeling off the open roof drains and overhead doors of the facility.

Photo #5: Outside wall of the west wing.

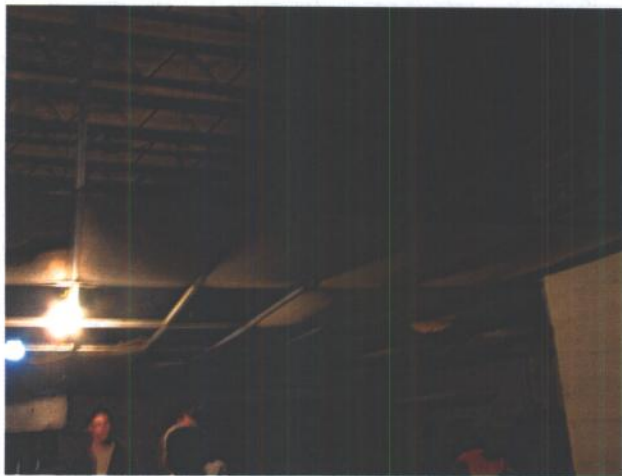
Photo #7: Missing ceiling panels in one of the rooms in the west wing of the armory.

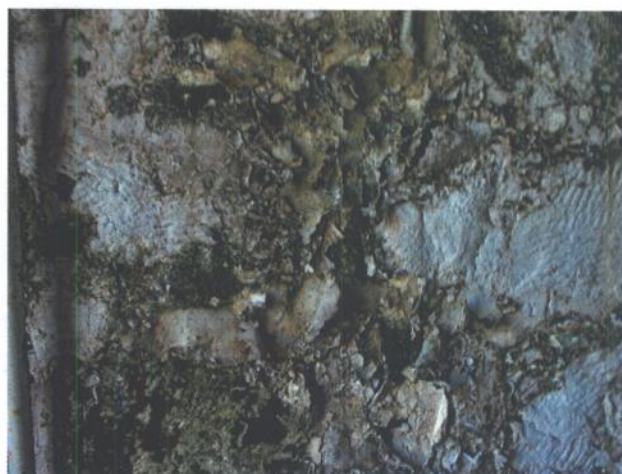
The odor of mold was apparent throughout the armory building, especially in the IFR. Noticeable growth of Mold was found on the wall in the west wing and on the floors in the Drill Hall. The water damage and lack of upkeep in the facility may have caused the presence of mold.

Photo #10: Mold growth on one of many walls in the armory.

The purple liquid stains should be cleaned and remediated in the south wing and the floor drain nearby should be evaluated for potential contamination from the fluid. Areas where there is water damage should be investigated for possible mold growth. The drums of used oil found in the Drill Hall and the car battery found outside the west wing should be disposed of properly. Soils where the battery is located should be analyzed for heavy metals. Proper

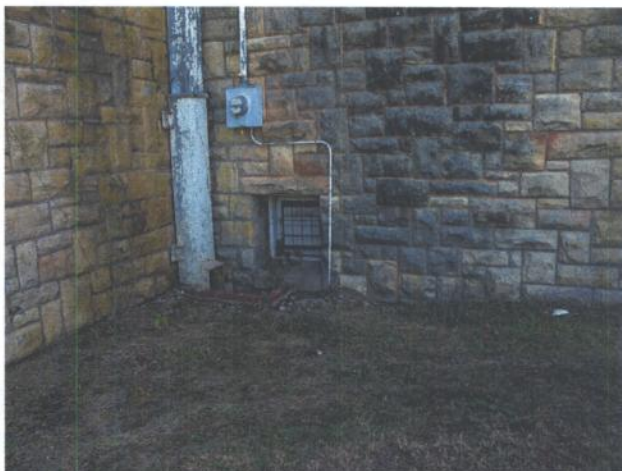
Two composite surface soil samples were collected outside of the IFR vent area for lead analysis. These samples were collected on September 26, 2006 as well. Five separate aliquot samples were collected in a bowl for each soil sample and mixed together with a spoon to collect a composite sample. One sample had a lead concentration of 479 mg/kg. The other sample had a lead concentration of 535 mg/kg. One of these samples exceeds the DEQ lead screening level for soil of 500 mg/kg. Analytical results for the sand and soil samples can be found in Appendix F.

Photo #12: Vent window from the indoor firing range located in the basement. Soil samples were collected here.

Additional evaluation and remediation of the IFR sand trap and dust residue is needed. The vent area of the IFR, which allows indoor air to escape to the outside air, should be investigated further for lead contaminated soils and possible remediation. Other suspected lead issues that should be further investigated include the testing of lead in the peeling paint found on the walls, piping adjoining the light switch fixtures, and windowpanes. If the paint is tested positive for lead, proper cleanup and remediation is recommended.

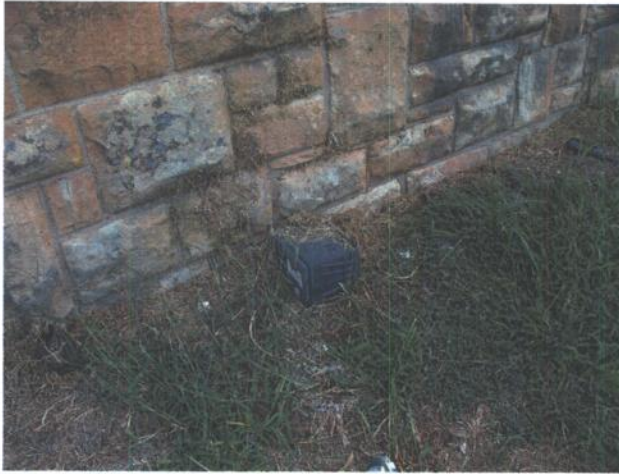
A car battery was lying on the ground next to the west outside wall of the armory. The battery was intact and did not look like there was any corrosion or leakage from it. In the same area to the north of the battery, there was a natural gas meter connected to the building. This meter was in good condition. However, the City of Pawnee does not use the gas for heating purposes. A remnant of the UST that was removed in September of 1995 was observed in front of the armory on the east side. Piping was found above the ground surface indicating that it was part of a UST at one time (see Photo #25 of Appendix B). Several areas around the armory building had stressed vegetation. A few spots east of the central overhead door on the east side had stressed vegetation. However, no stained soils were noticed on the east side. The areas with the most noticeable stressed vegetation were found on the south end of the armory's west wing. The soils in this area appeared to have stains from vehicle traffic and used oil.

Photo #13: Car battery located on the west end of the armory building.

cleanup and remediation of soils in the area is recommended if the soils tests positive for heavy metals.

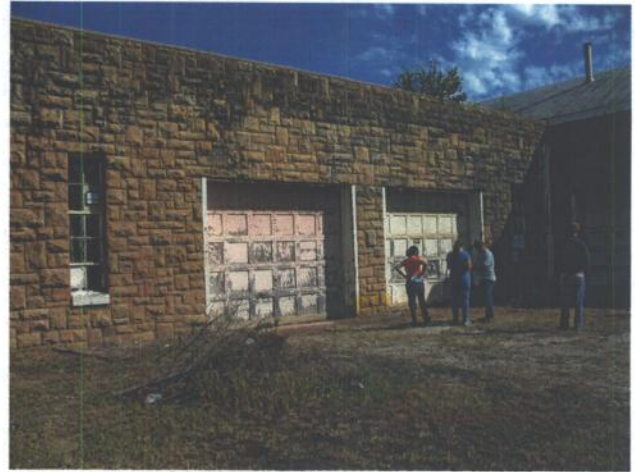
One area outside of the armory building had some disturbed soil. Located on the south end of the west wing of the building, there were several stained areas of soils near two overhead doors of the building. These soils appeared to have past oil and grease stains. During the site visit, this part of the building was used as the Street Department's painting area. Some spots in front of the Drill Hall had stressed vegetation, but the soil did not look disturbed. Physical stresses on the soil may be the cause of this stressed vegetation.

Stained soils were found south of the west wing of the building. Soils in several areas appeared to have oil and grease stains from vehicle usage in the area. The south part of the west wing is where painting operations occur for the City of Pawnee Street Department.

Photo #14: Motor Pool located in the west wing of the armory. Center of painting activity and area of disturbed soils.

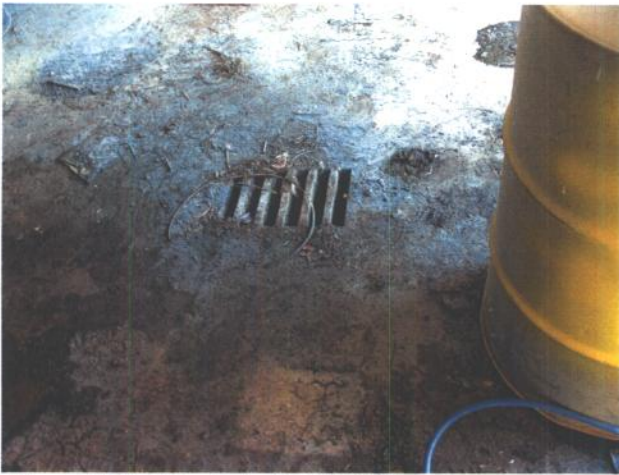
Several floor drains were noticed throughout the armory building. Three drains were found in the north wing north of the Stage area. Three drains were found in the south wing and one drain was found in the west wing. No drains were found in the Drill Floor or the Indoor Firing Range. However, throughout the armory there were equipment and storage items cluttered in the majority of the rooms that would make it easy to miss a drain in some areas. The drains found are marked on the floor plan provided in Appendix C. All of the drains are connected to the City of Pawnee wastewater system. According to the City of Pawnee Street Department staff, there are no septic tanks on the property. No cisterns were noticed during the site visit either (Ref. 8).

Photo #15: Drain in Drill Hall

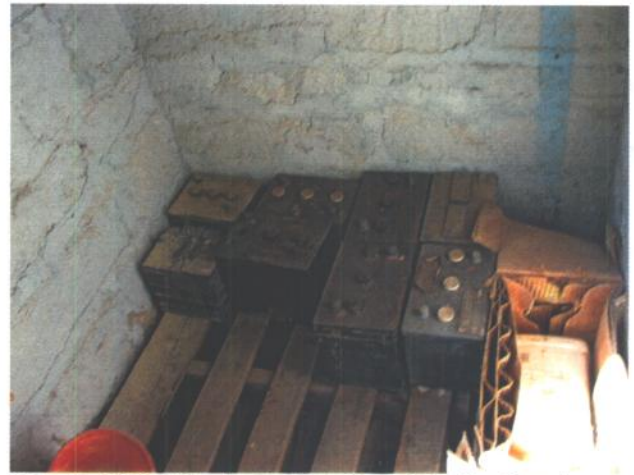
No pole-mounted transformers were found on the subject property. However, several car batteries were found at the property that may contain acid or heavy metals. One car battery was found outside of the armory building on the west side of the west wing (Appendix B, Photo #13). Another lone car battery was found on a wooden pallet in the Drill Hall in good condition. Eight more car batteries were found inside the southwest corner of the west wing of the building on top of a wooden pallet (Appendix B, Photo #16). No corrosion or leakage of acid, lead, or other heavy metals were evident.

Photo #16: Car batteries found in the South Administration section.

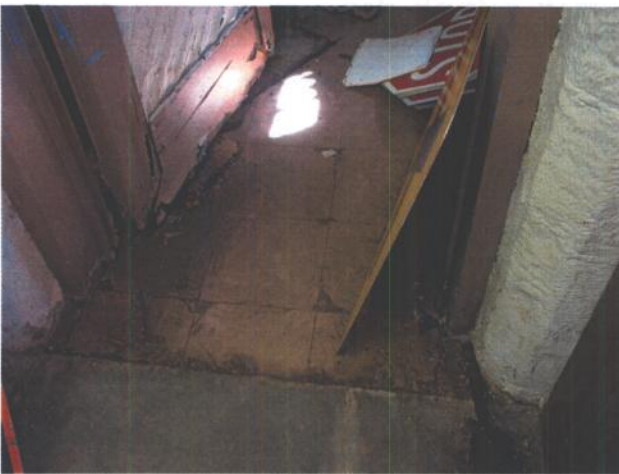
12" x 12" square tile was found in the south wing of the armory where Pawnee County stores its equipment and miscellaneous items. This tile has deteriorated and may contain friable asbestos. The suspect asbestos material will be sampled and analyzed by Marshall Environmental at a latter date. Asbestos containing materials (ACMs) were found to be suspect in the piping insulation found in a room on the south wing of the building and the drop ceiling panels found in the west wing, north wing, and south wing of the building. The heating units in the armory may also have insulation with suspect ACM.

Photo #17: 12" x 12" tile found in the South Administration section.

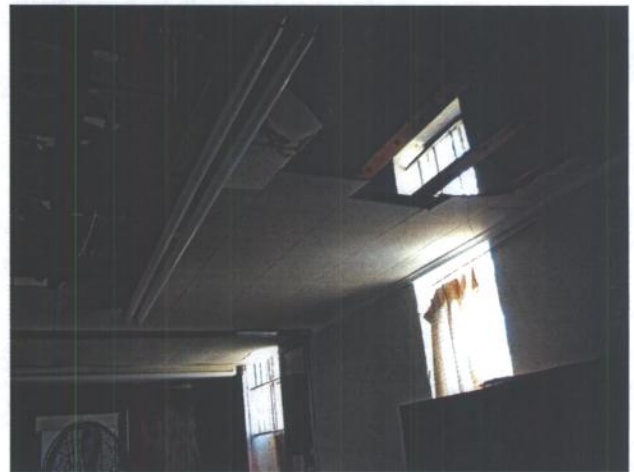
Photo #18: More missing ceiling panels located in the South Administration section.

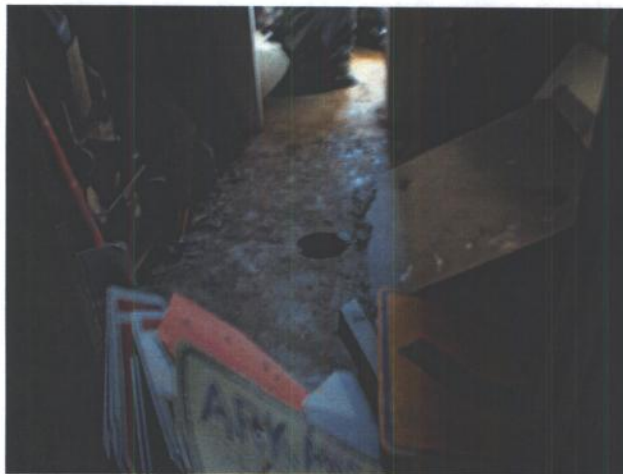
Photo #19: Floor drain inside one of the rooms in the South Administration section.

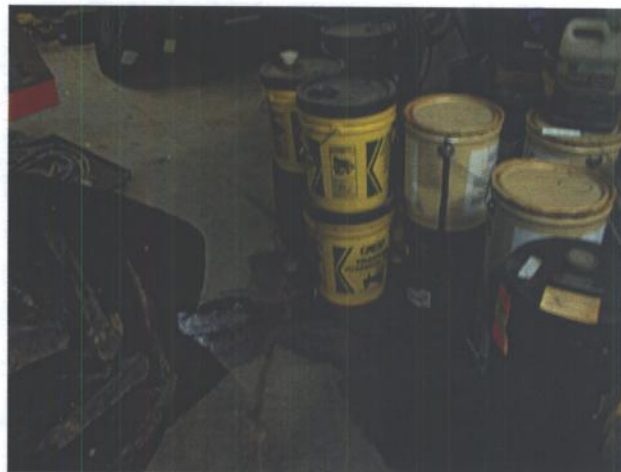
Two small puddles of a purple-like substance were found in a room located on the east half of the South Administration section (south wing) of the armory building. This fluid was found near several buckets containing tractor hydraulic fluid. No other chemical spill was found other than oil and grease stains found throughout the armory building. No spills were reported on the property from the Emergency Response Notification System (ERNS) database (Ref 10).

Photo #20: Purple fluid on ground next to buckets full of tractor hydraulic fluid in the South Administration section.

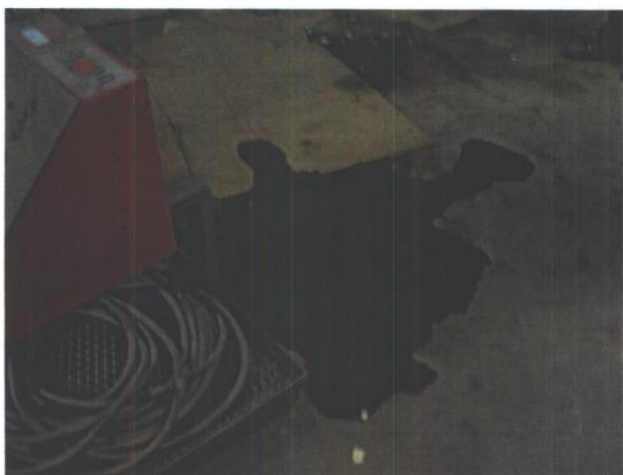
Photo #21: Another puddle of purple fluid on the ground several feet northeast of the puddle found in Photo #20.

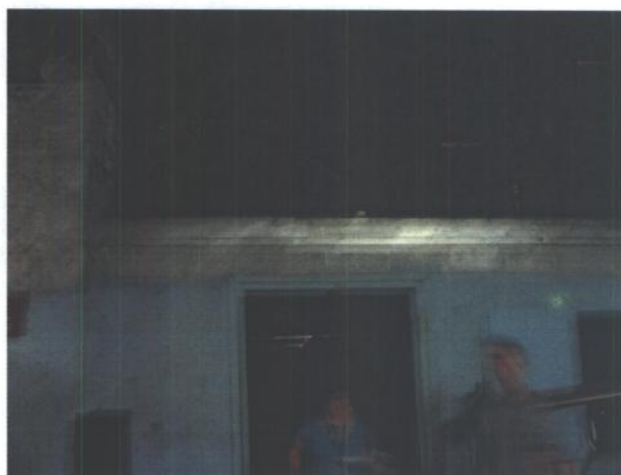
Photo #22: Possible ACM on some of the piping above a room in the in the northeast part of the South Administration section.

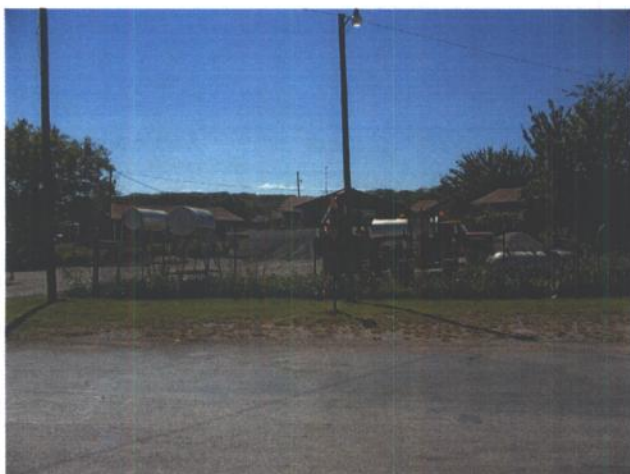
Four small ASTs are located south of the armory building in a fenced-in compound next to Cleveland Street. The ASTs contain gasoline and appear to be in good condition. These ASTs are owned by the City of Pawnee Street Department for fueling purposes. A propane tank is also located inside the compound. Photos #23 and #24 of Appendix B show the fenced-in compound with the ASTs and propane tank.

Photo #23: Fenced-in area owned by the Street Department showing two ASTs, a propane tank, and a fuel truck.

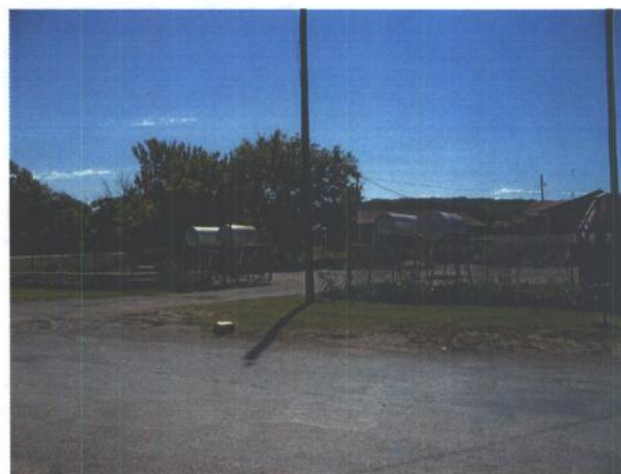
Photo #24: Fenced-in area showing all four of the ASTs.

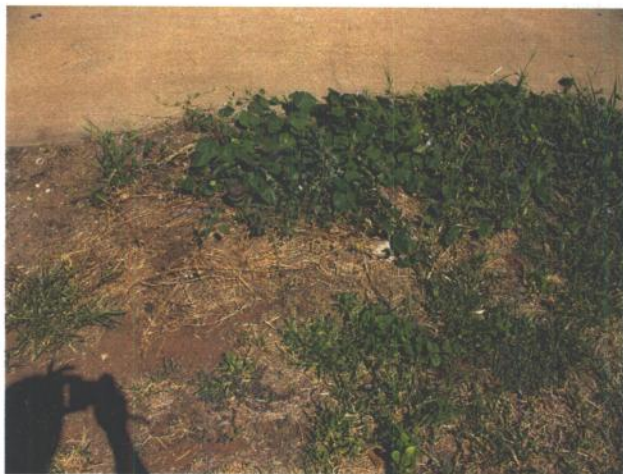
There is a historical finding on the subject property, but it is not considered a historical recognized environmental condition (HREC). The Oklahoma Army National Guard once had a 1000-gallon gasoline contained UST (ID Number: 5-905777). This UST was closed on May 30, 1988 and removed on September 27, 1995. Soil samples were collected after the removal at the center and side of the pit where the UST was buried.

Soils were tested for Benzene/toluene/ethylbenzene/xylenes (BTEX) and TPH Gasoline Range Organics (GRO)/Diesel Range Organics (DRO). Concentrations were all below the detection limits for BTEX and TPH GRO/DRO for the sample collected from the side of the pit. However, the sample collected from the center had concentrations of toluene at 0.0017 mg/kg, xylene at 0.00075 mg/kg, and a TPH DRO concentration of 3.7 mg/kg. The concentrations are well below the DEQ screening levels. The ground surface has since been restored. However, during the site visit there was a brown metal pipe found above the ground surface where the UST was once located.

Photo #25: Area where 1,000 gallon UST may have been. Rusted metal pipe sticking out of the ground.

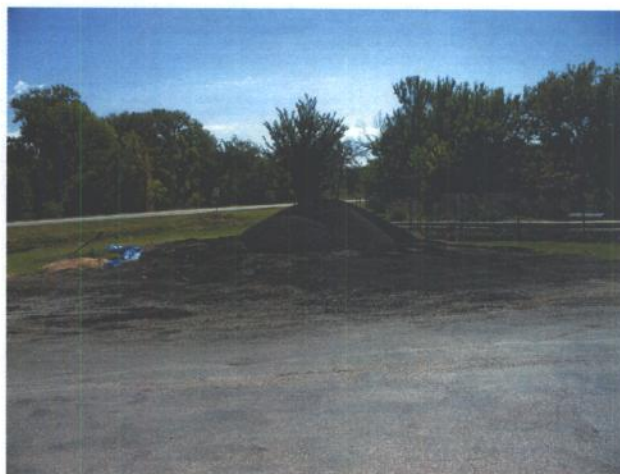
There are no landfills at the subject property or adjoining properties. Several piles of blacktop gravel were found approximately 30 feet southeast of the armory (See Appendix B, Photo #26). Several piles of grayish gravel were found as well inside the fenced-in compound where the ASTs are stored. No other kinds of dumping were found on the subject property.

Photo #26: Piles of black tarrish gravel located on the southeast corner of the property.

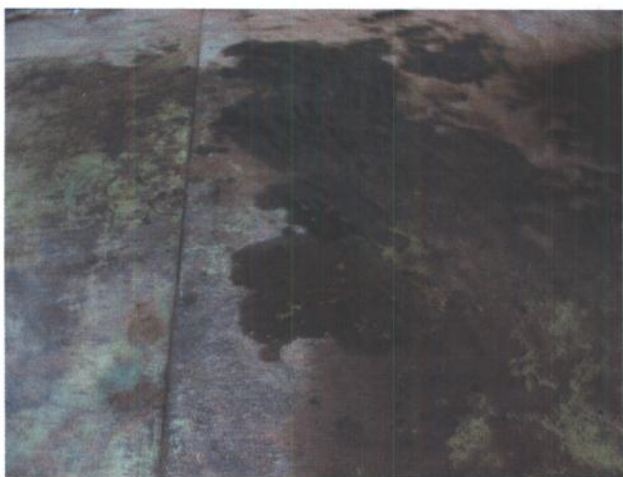
A walk-through was conducted in each room of the armory. No renovations to the armory appeared to have been made. The Drill Hall floor has some mold growth and is heavily stained with oil and grease from the servicing of street maintenance vehicles. The south rooms of the west wing and south wing were found to have oil and grease stains as well. All floors throughout the armory appeared to be very dusty. Lack of upkeep in the facility is apparent. Drums of used oil are located in the Drill Hall along with the Street Department's vehicles. A car battery was noticed on a pallet near the stage area in the Drill Hall. In a room in the west wing there is mold growth (Photo #10, Appendix B). This is apparent in other areas of the armory as well. Sandstone walls

Photo #27: Oil and grease stains found in the Drill Hall.
