TARGETED BROWNFIELD ASSESSMENT

**Oklahoma Army National Guard
Former Wagoner Armory
Wagoner, Oklahoma**

ASTM E 1527-05
Phase I Environmental Site Assessment
All Appropriate Inquiry

February 3, 2009

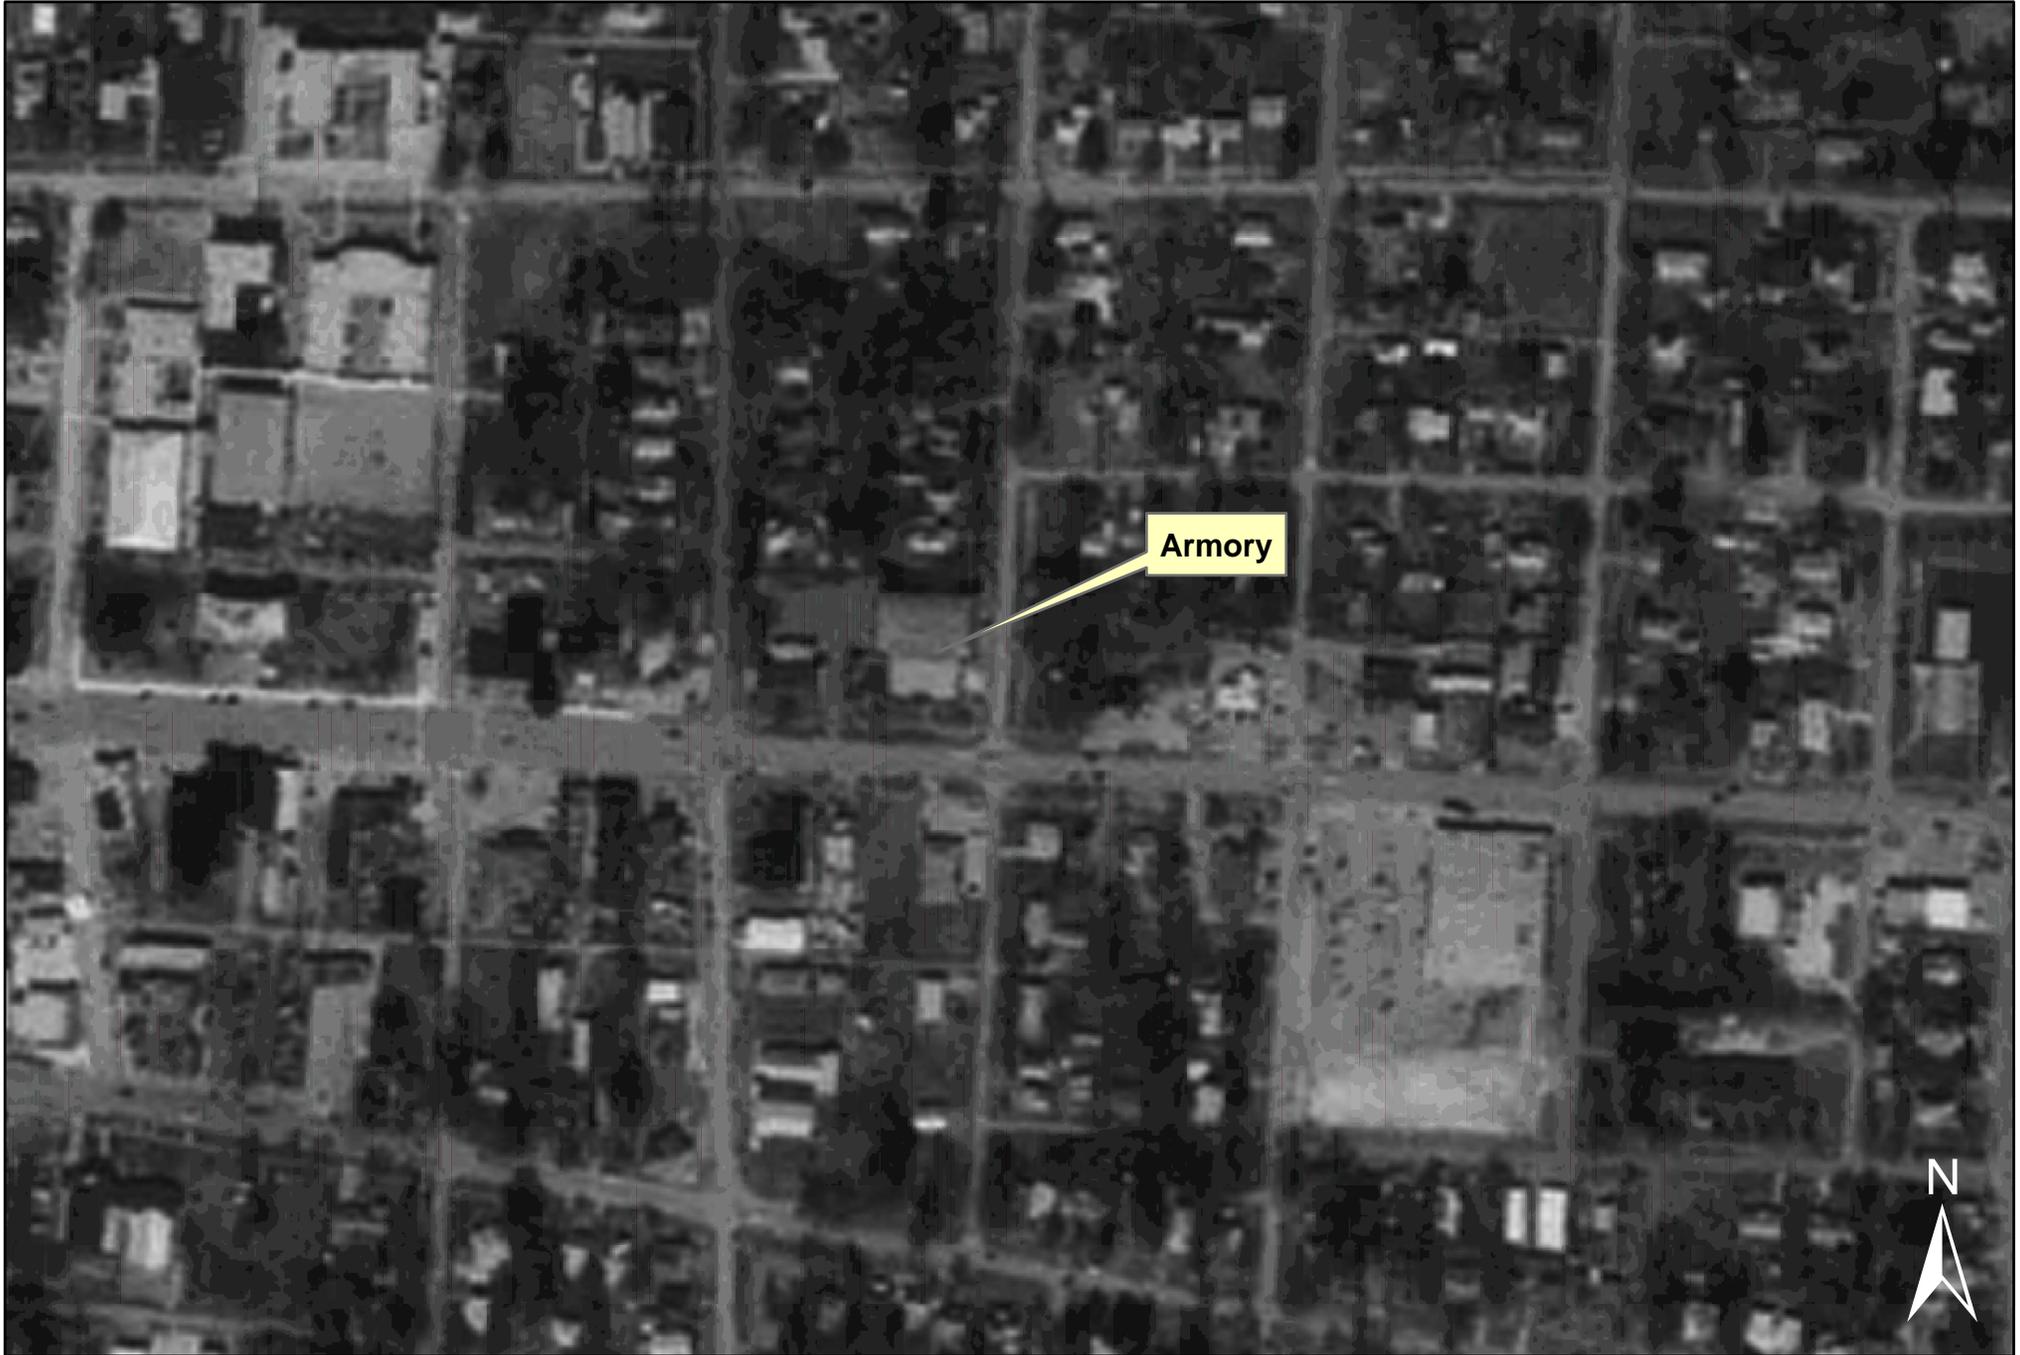
1995 Aerial Photo

It is difficult to determine the change between the 1952 and 1995 aerial photographs, due to the heavy tree growth in the area and poor resolution of the 1952 aerial photo. The 1995 aerial photograph shows residential and commercial structures on all adjacent properties. There is no change on the subject property. Construction and development appears to be occurring to the east and southeast of the armory building. No apparent environmental conditions were noted from the photograph.

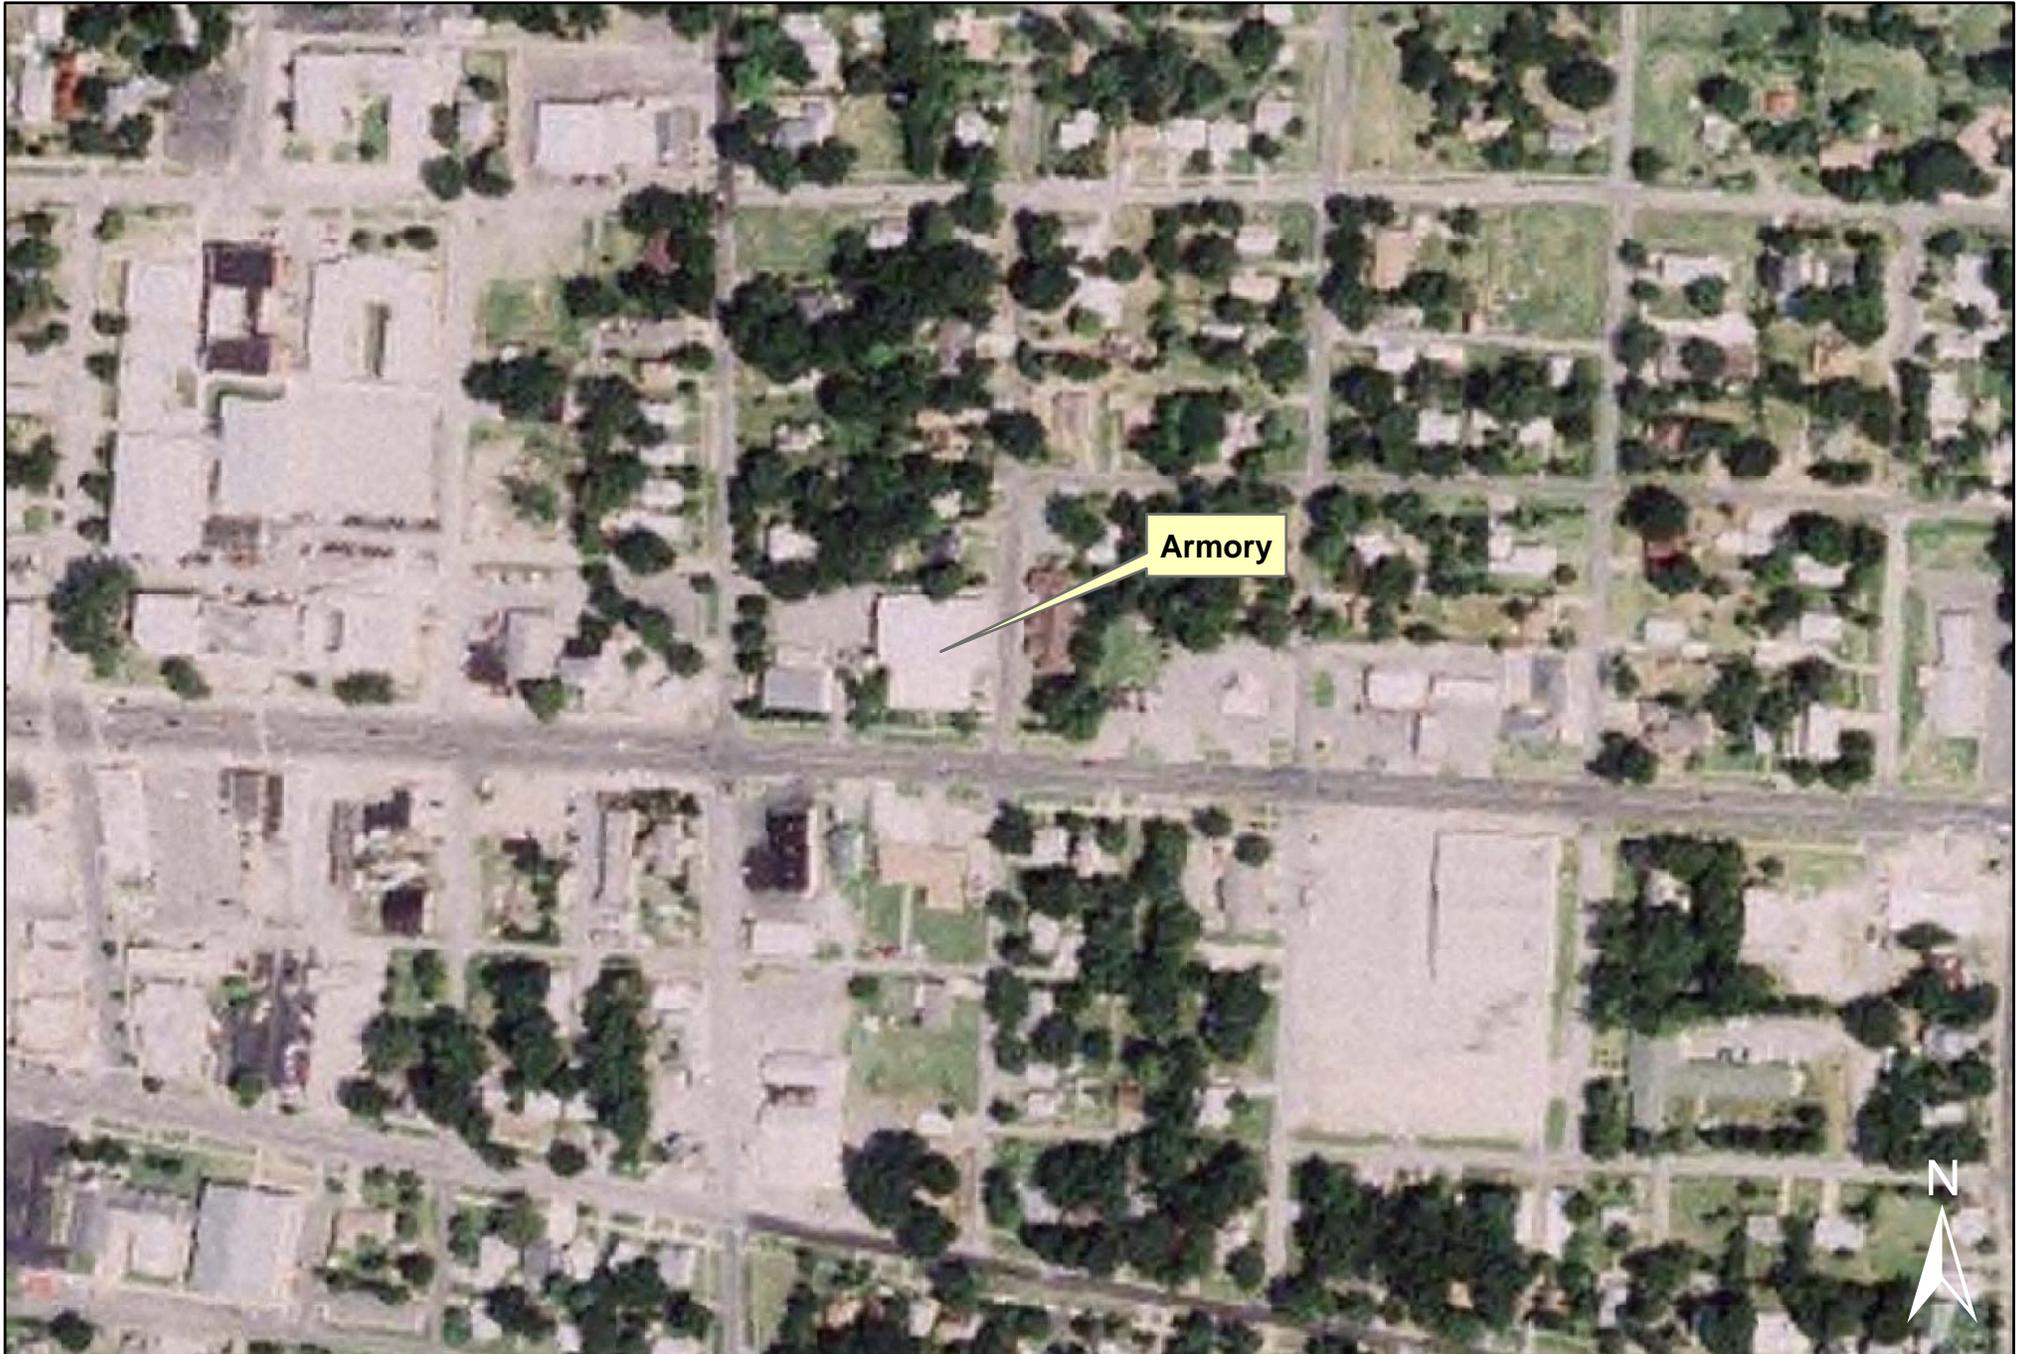
2003 Aerial Photo

The 2003 aerial photograph shows little change on the subject property. A new building has been built to the east of the armory building. New buildings and parking lots have been built in the areas that showed construction and development to the east and southeast of the armory building. All other adjoining properties appear to be the same as in 1995. No apparent environmental conditions were noted from the photograph.

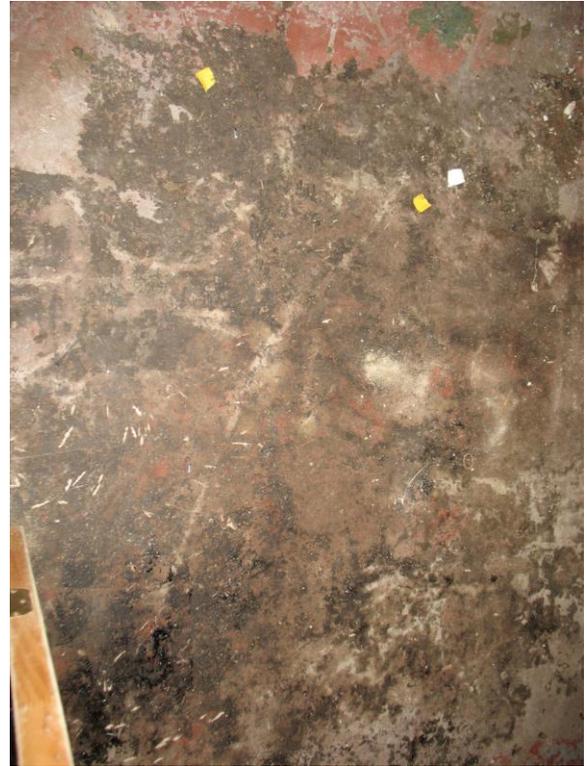
Standing water on IFR stairway

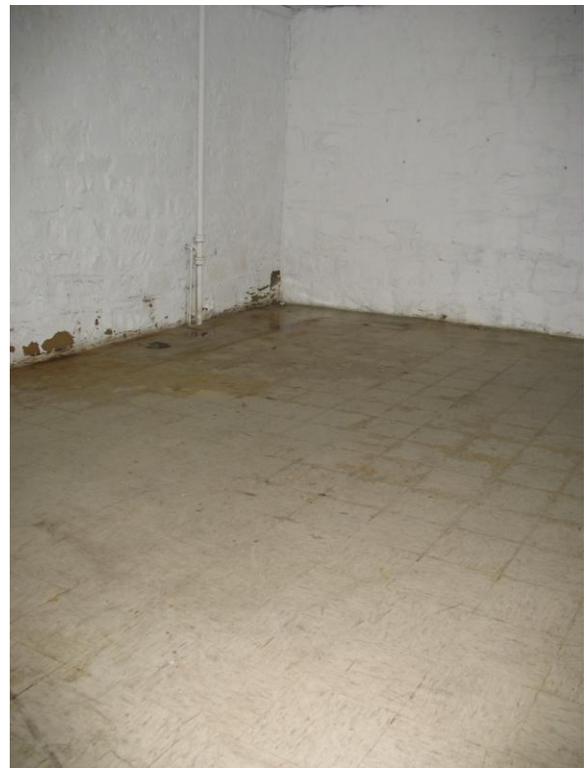
Mastic in room 28

The building has limited asbestos containing materials. All asbestos containing floor tile and mastic has been removed from the building. No information was available on the removal of the floor tile. Marshall Environmental Management conducted an asbestos survey on July 19, 2008 and found asbestos only in the caulking around the windows of the building.

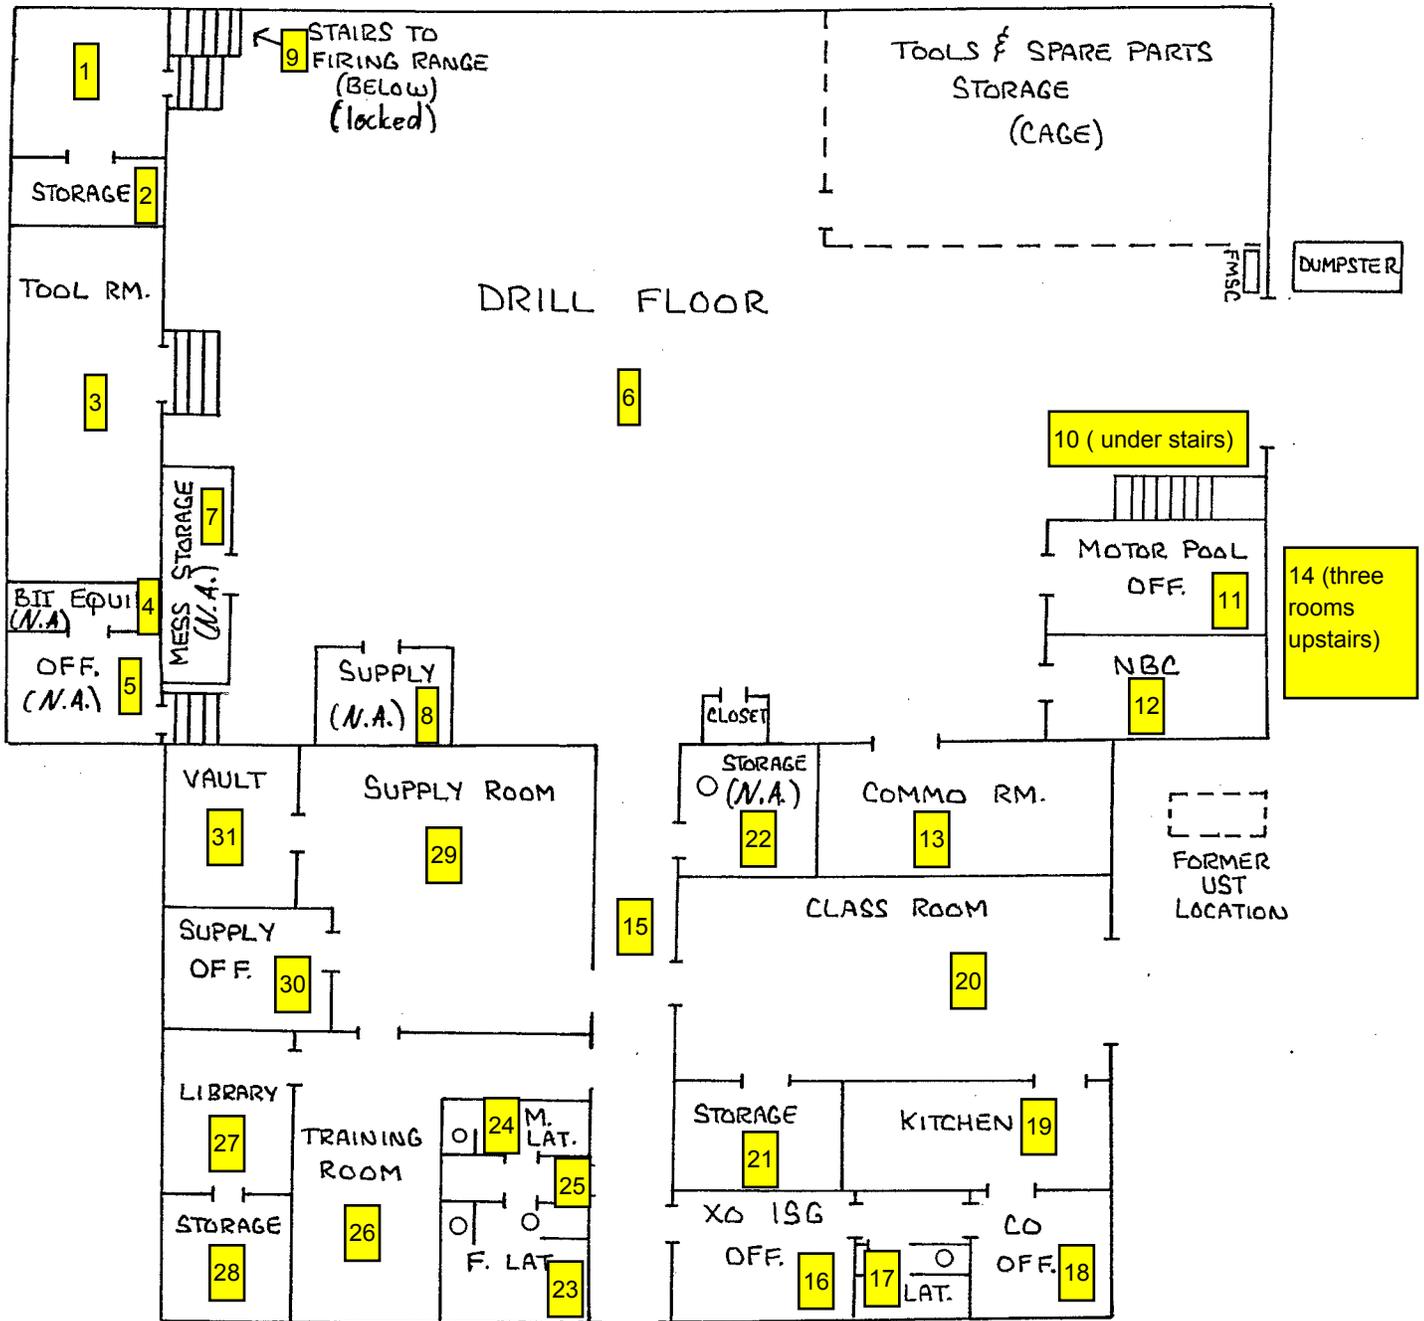
Note: These room numbers were used by DEQ for photo labels and site notes. Marshall Environmental Management used different room numbers.

- Room 24 – Male latrine: had pine oil and pine x
- Room 25 - Hallway between latrines
- Room 26 – Training room
- Room 27 - Library
- Room 28 - Storage
- Room 29 – Supply room, rust stains on floor, standing water

- Room 30 – Supply office
- Room 31 – Vault – stored weapons and ammunition

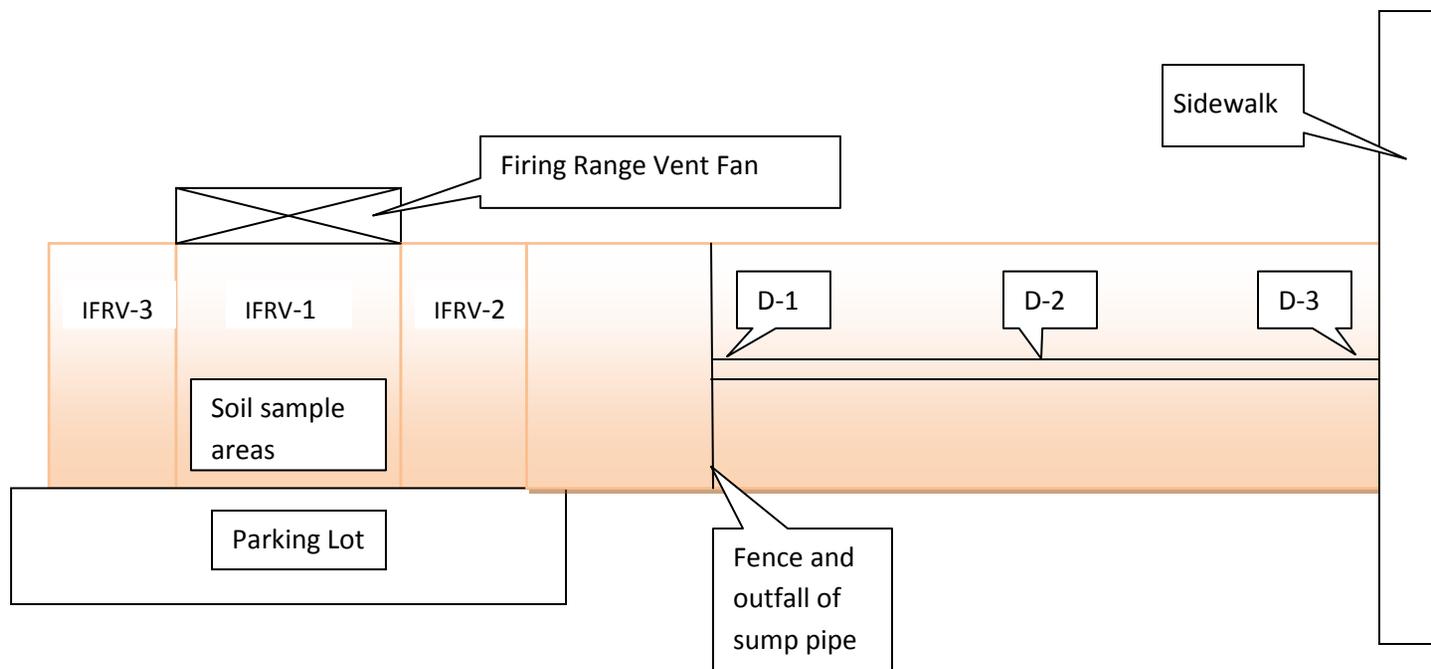
Soil Samples Taken Outside of Firing Range Vent Fan and in the Ditch Below the Sump Pipe Outfall

of the property, distressed vegetation is present. This was only observed in the very bottom of the small ditch where water would flow periodically from the IFR and from rain events. Soil samples taken from the ditch revealed lead concentrations of 472 mg/kg at the top of the ditch, 71 mg/kg in the middle of the ditch, and 100 mg/kg at the end of the ditch. The sample point at the top of the ditch was located just below the outfall of the IFR sump pipe. The end of the ditch was deemed to be located where the ditch met the sidewalk. For a detailed sketch of the sample point locations see Appendix F.

Note: Samples IFRV-1, IFRV-2, & IFRV-3 are five part composites; sample D-1 is a three part composite; samples D-2 and D-3 are grab samples
