**Targeted Brownfield Assessment
Oklahoma Army National Guard
Wewoka Armory
Wewoka, Oklahoma**

**ASTM E 1527-05
Phase I Environmental Site Assessment
All Appropriate Inquiry**

August 18, 2006

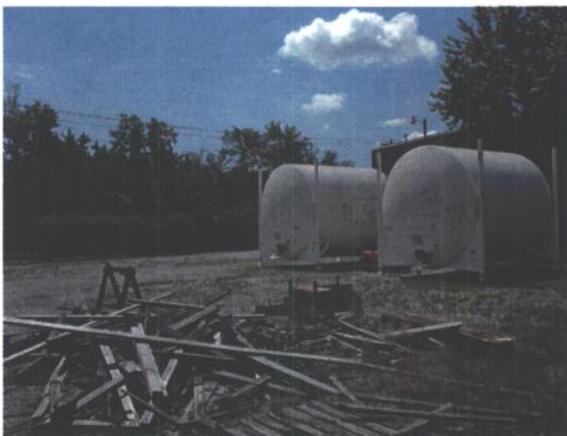
Two empty 850-gallon ASTs are located behind the armory building. The ASTs are in good condition and appear to have never been placed in service. One tank is labeled "Feed Tank – 5" and the other tank is labeled "Feed Tank – 6." These ASTs are believed to be owned by Cochran Chemical Company (Cochran) and were placed there during their short time of operational control of the property in 2004. Another storage tank was found as well lying on its side in the drill hall, which is also believed to belong to Cochran. This tank did not appear to have anything in it. Sam Cluck, retired Command Sergeant Major of the armory, mentioned that these tanks belonged to Cochran.

Photo #4: Feed Tanks #5 and #6 behind the armory.

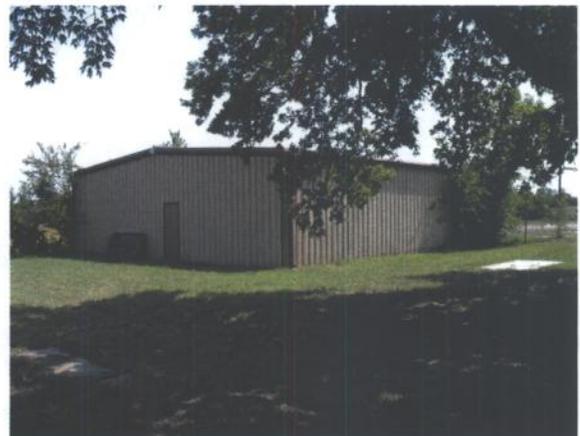
metal storage building. A cemented area south of the metal storage building is where a septic tank is located below the ground surface. Two concrete slabs are located west of the septic tank where the lateral lines are located. On the southeast corner of the property, there is a pile of debris, old wood, and loose concrete. One other noticeable external observation was several creosote log sections observed on the north central part of the property.

Photo #5: Metal storage building behind the armory. Septic tank to the south and lateral line in corner of photo.

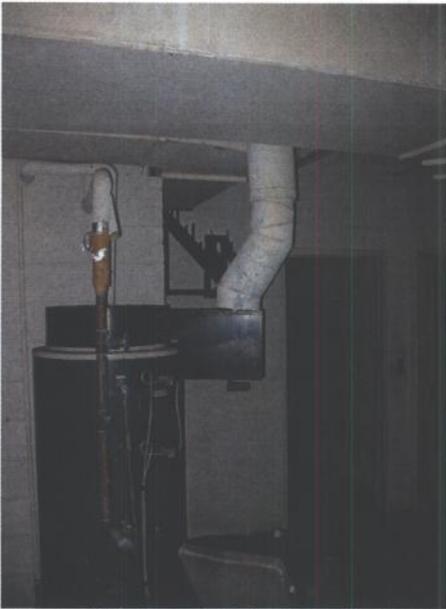
Photo #6: Potential ACM in the wrapping of the heating pipe.

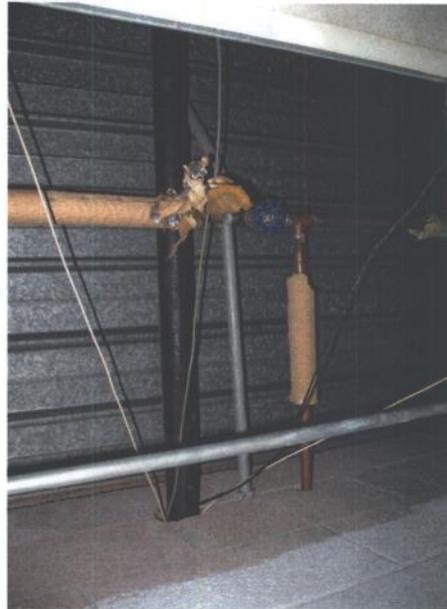
Photo #7: Potential ACM in the wrapping of the heating pipe.

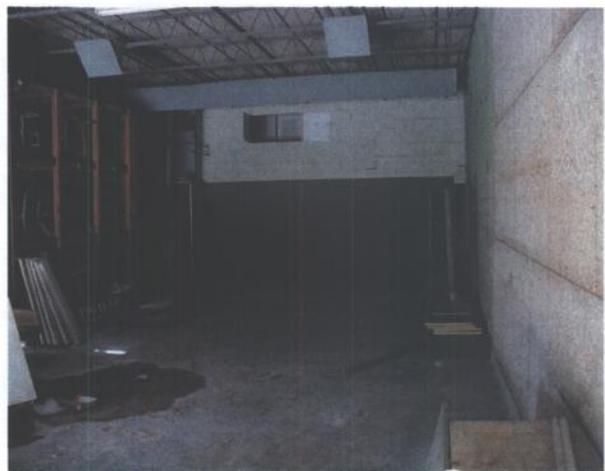
The indoor firing range sand trap and dust residue is contaminated by lead. Past sampling has been conducted to characterize the lead concentration of this room. A statewide sampling event for lead was conducted by C.H. Guernsey & Company for the Oklahoma Army National Guard on all armories containing indoor firing ranges. This report is called the "Indoor Firing Range Lead Issues Report" (Ref. 19). Five samples were collected inside the firing range room. The following are the locations and concentrations of lead found in the room.

- 165.00 ug/ft² of lead was found at the doorway leading into the indoor firing range (IFR) from the drill floor.
- 557.20 ug/ft² of lead was found next to the south central wall of the IFR.
- 4472.00 ug/ft² of lead was found at the floor near the bullet trap.
- 3496.00 ug/ft² of lead was found at the pit below.
- 80.85 ug/ft² of lead was found next to the west wall of the storage room above the sand trap.

Photo #11: Indoor firing range with sand trap at the end of the room.

Based on the findings of this assessment, The DEQ recommends that additional investigation be conducted to evaluate areas of the property that may need future clean-up and remediation.

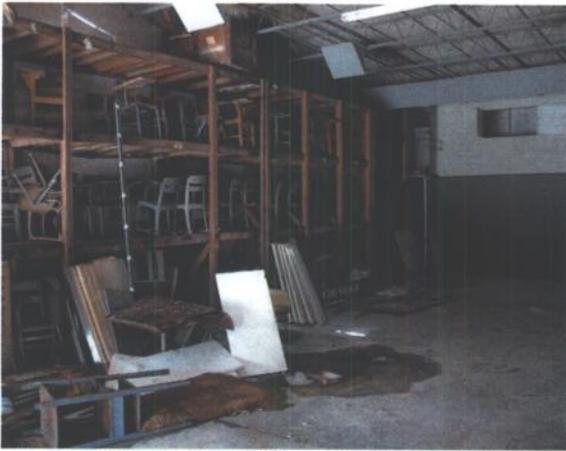
Photo #12: Indoor firing range. Wet spot where drain is located.

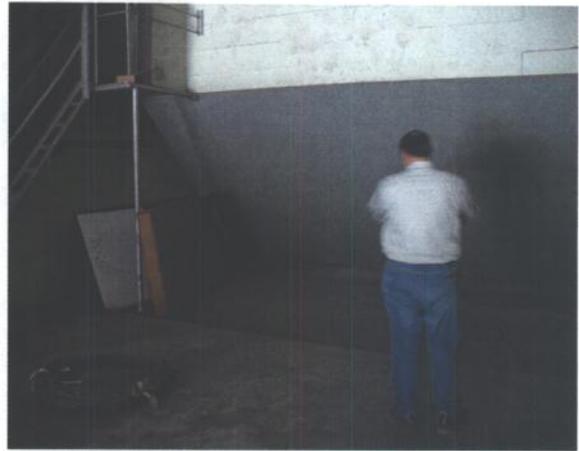
- An indoor firing range sand trap and dust residue was found to have lead contamination. Past sampling of lead in the sand trap and the rest of the indoor firing range show results of lead concentrations in need of remediation. The indoor firing range constitutes a recognized environmental condition (REC) based on the lead concentrations and its leachability.

Photo #13: Indoor firing range sand trap.

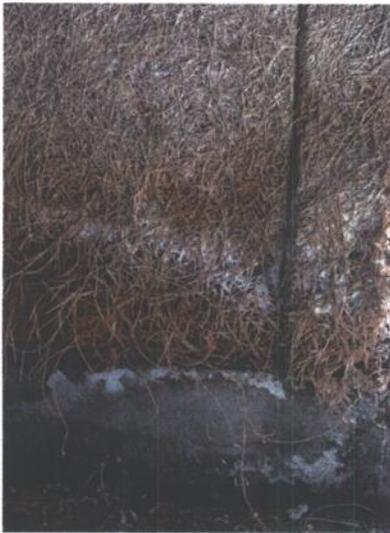
On June 19, 2006, the DEQ pulled two samples of the fibrous material on the walls of the IFR, which appears to be the same material as the roof. The samples were analyzed for asbestos. No asbestos was found. Test results can be found in Appendix F.

Photo #14: Potential ACM on wall of the indoor firing range.

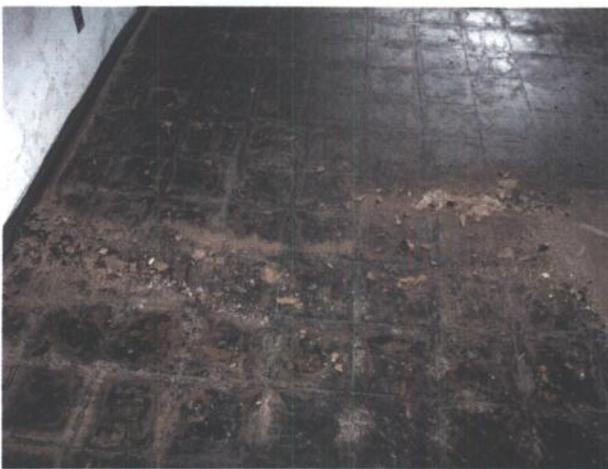
- Nine-inch square tile has been stripped out of the entrance, hallway, classrooms, and office areas. Some broken pieces of tile remain in several areas from past stripping. The DEQ sampled the tile and it tested positive for asbestos. Appropriately trained city personnel are in the process of removing all tile material in the Wewoka Armory.

Photo #17: Friable tile in one of the rooms.

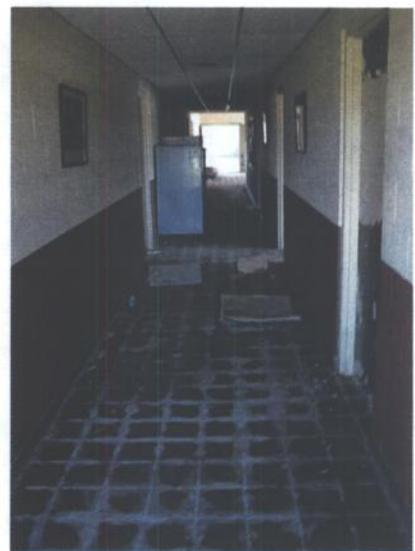
Photo #18: Stripped out tile in the hallway.

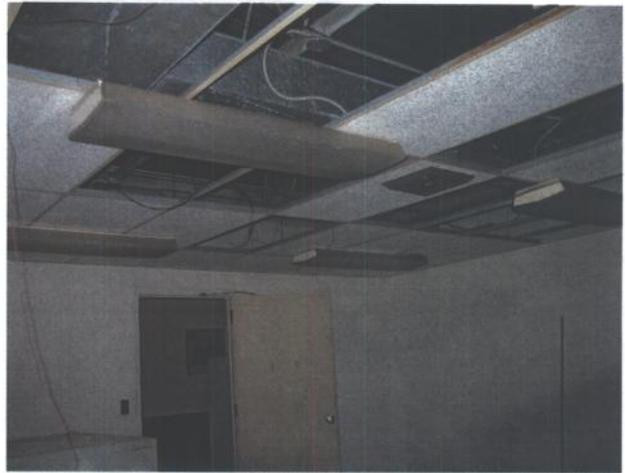
damage and deterioration. Some of these puddles contain mold. Various rooms are missing ceiling panels as well.

Photo #20: Missing ceiling panels in one of the classrooms.

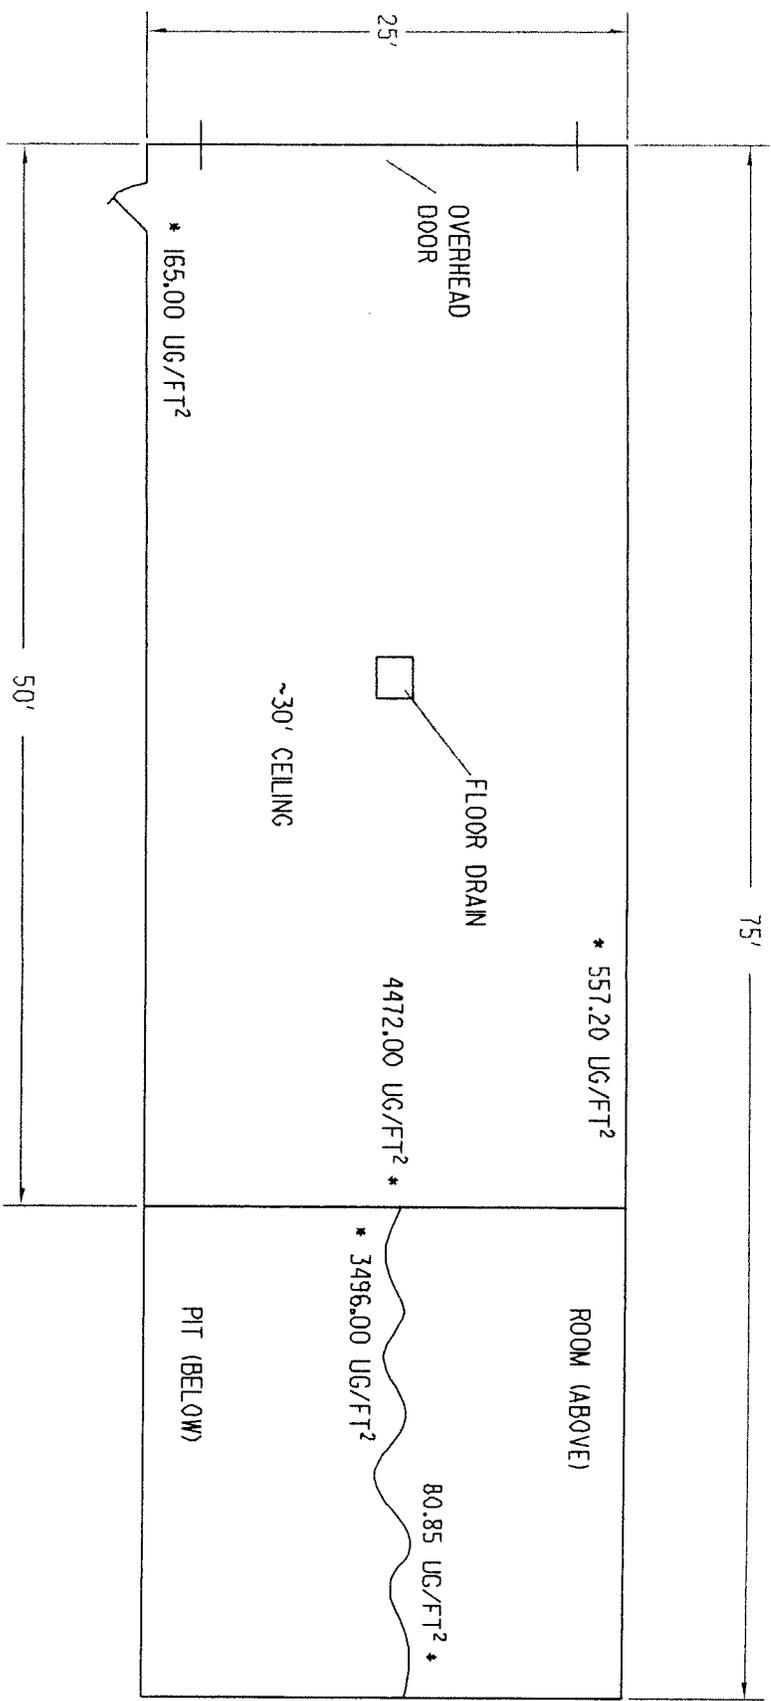
1. ALL MEASUREMENTS ARE APPROX.
2. SAMPLE LOCATIONS ARE APPROX. & IDENTIFIED BY "*".
3. SAMPLE CONCENTRATIONS ARE IN MICROGRAMS PER SQUARE FOOT
4. SAMPLES COLLECTED BY OMD PERSONNEL 10-MAY-04
5. SEE PHOTOGRAPHS FOR REFERENCE
6. SEE INVENTORY LIST FOR DESCRIPTION OF EQUIPMENT TO BE CLE.
