**Targeted Brownfields Assessment
Oklahoma Army National Guard
Atoka Armory (Readiness Center)
Atoka, Oklahoma**

**ASTM E 1527-05
Phase I Environmental Site Assessment
All Appropriate Inquiry**

February 5, 2007

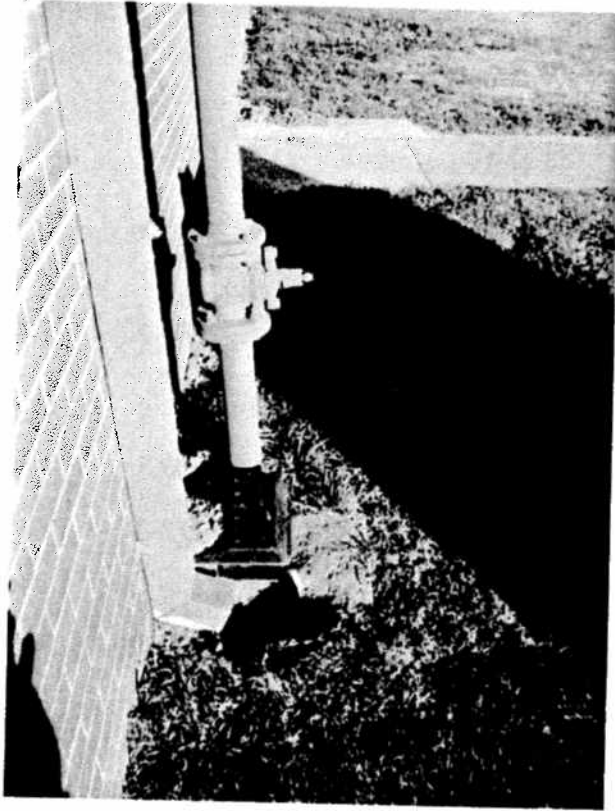
Figure 14. Rodenticide bait-station on east side of building – facing north.

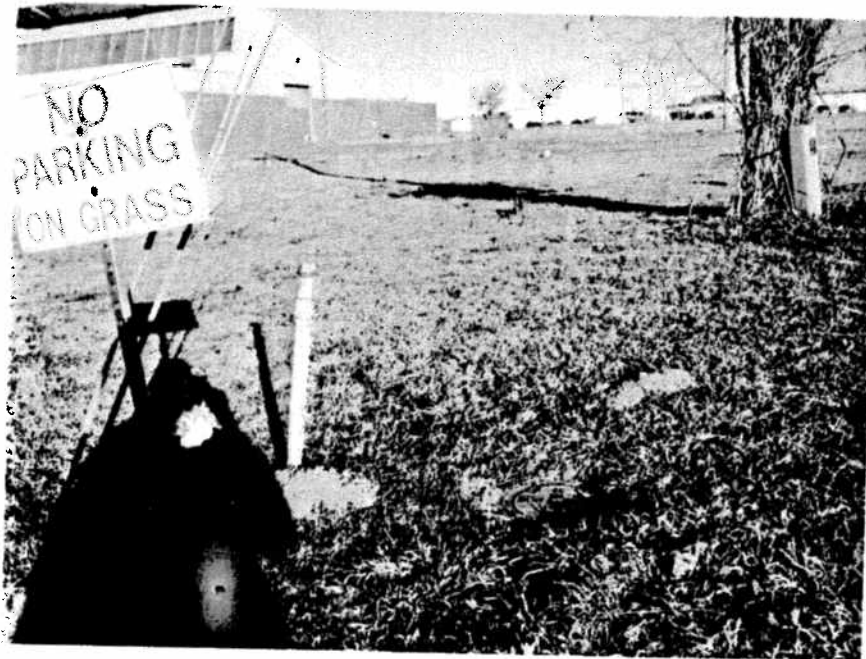
Figure 15. Utility lines on east perimeter of property – facing northwest.

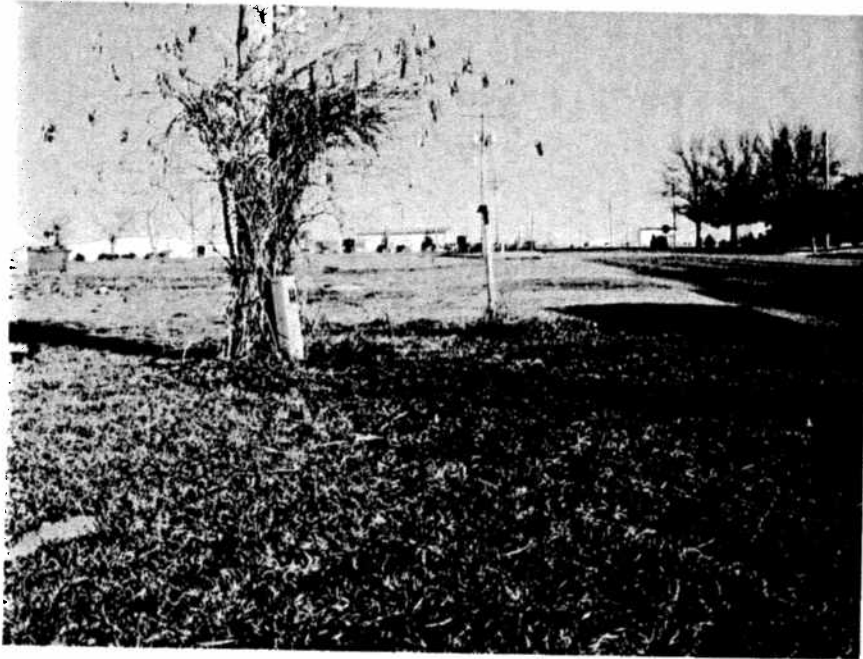
Figure 15. Utility lines on east perimeter of property – facing north.

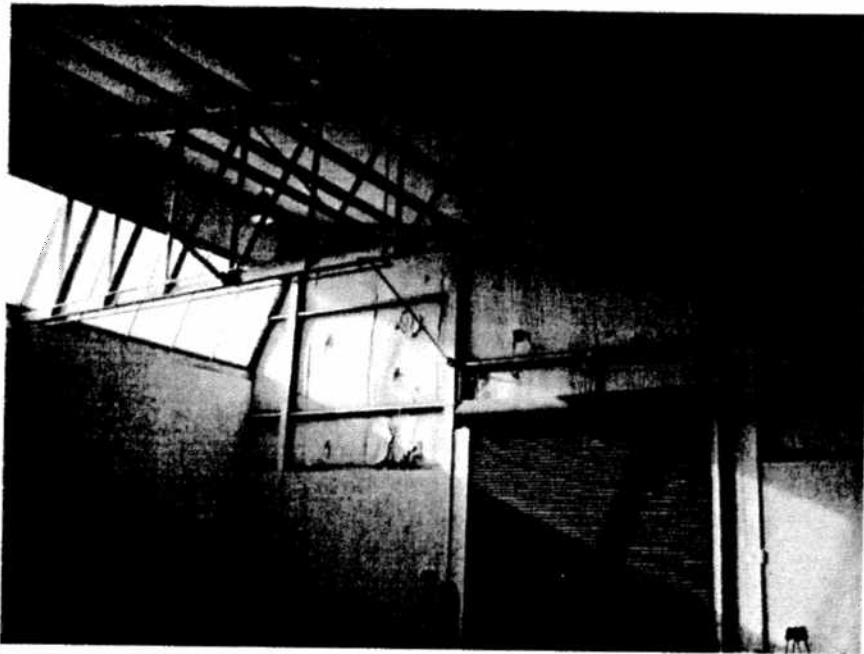
Figure 47. Drill floor looking southwest. Note IFR entrance door left of bay door.
