**OPERABLE UNIT 1  
OPERATION & MAINTENANCE  
ANNUAL REPORT 2022-2023**

TAR CREEK SUPERFUND SITE  
OTTAWA COUNTY, OKLAHOMA

APRIL 2023

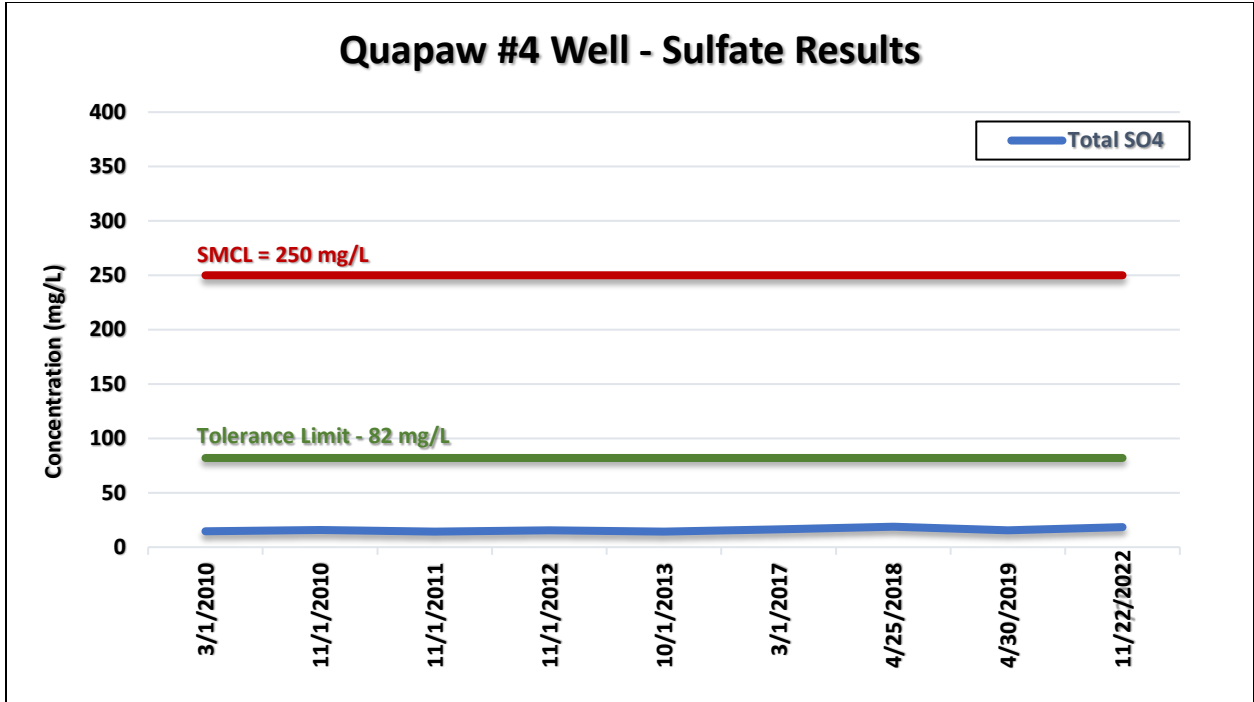
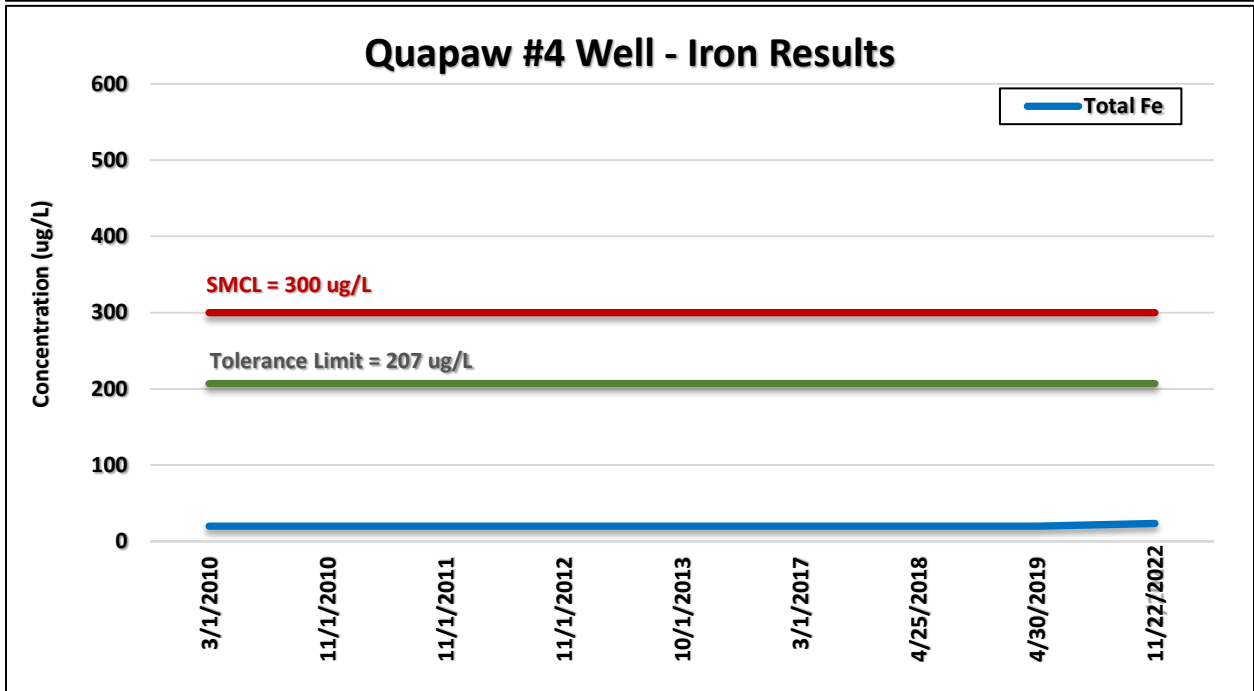
Figures 7A and 7B: Sulfate and Iron concentrations at Quapaw #4 well compared to tolerance limits and SMCLs

SO<sub>4</sub> concentrations at P7 have historically exceeded the Tolerance Limit, as shown in **Figure 7A**. The P7 well also exceeded the Tolerance Limit **and** SMCL for Fe (**Figure 7B**). This has suggested a concerning trend at P7.

DEQ recommends continued *annual* monitoring of all chemicals of concern, Pb, Cd, Fe, Zn, and SO<sub>4</sub> at well Q4. The CA1, C5, P6, and P7 wells are recommended for semi-annual testing for all chemicals of concern.
