**Former National Guard Armory
Hobart, Oklahoma**

Remediation Final Report

Prepared by:
Department of Environmental Quality
707 North Robinson
Oklahoma City, Oklahoma 73101

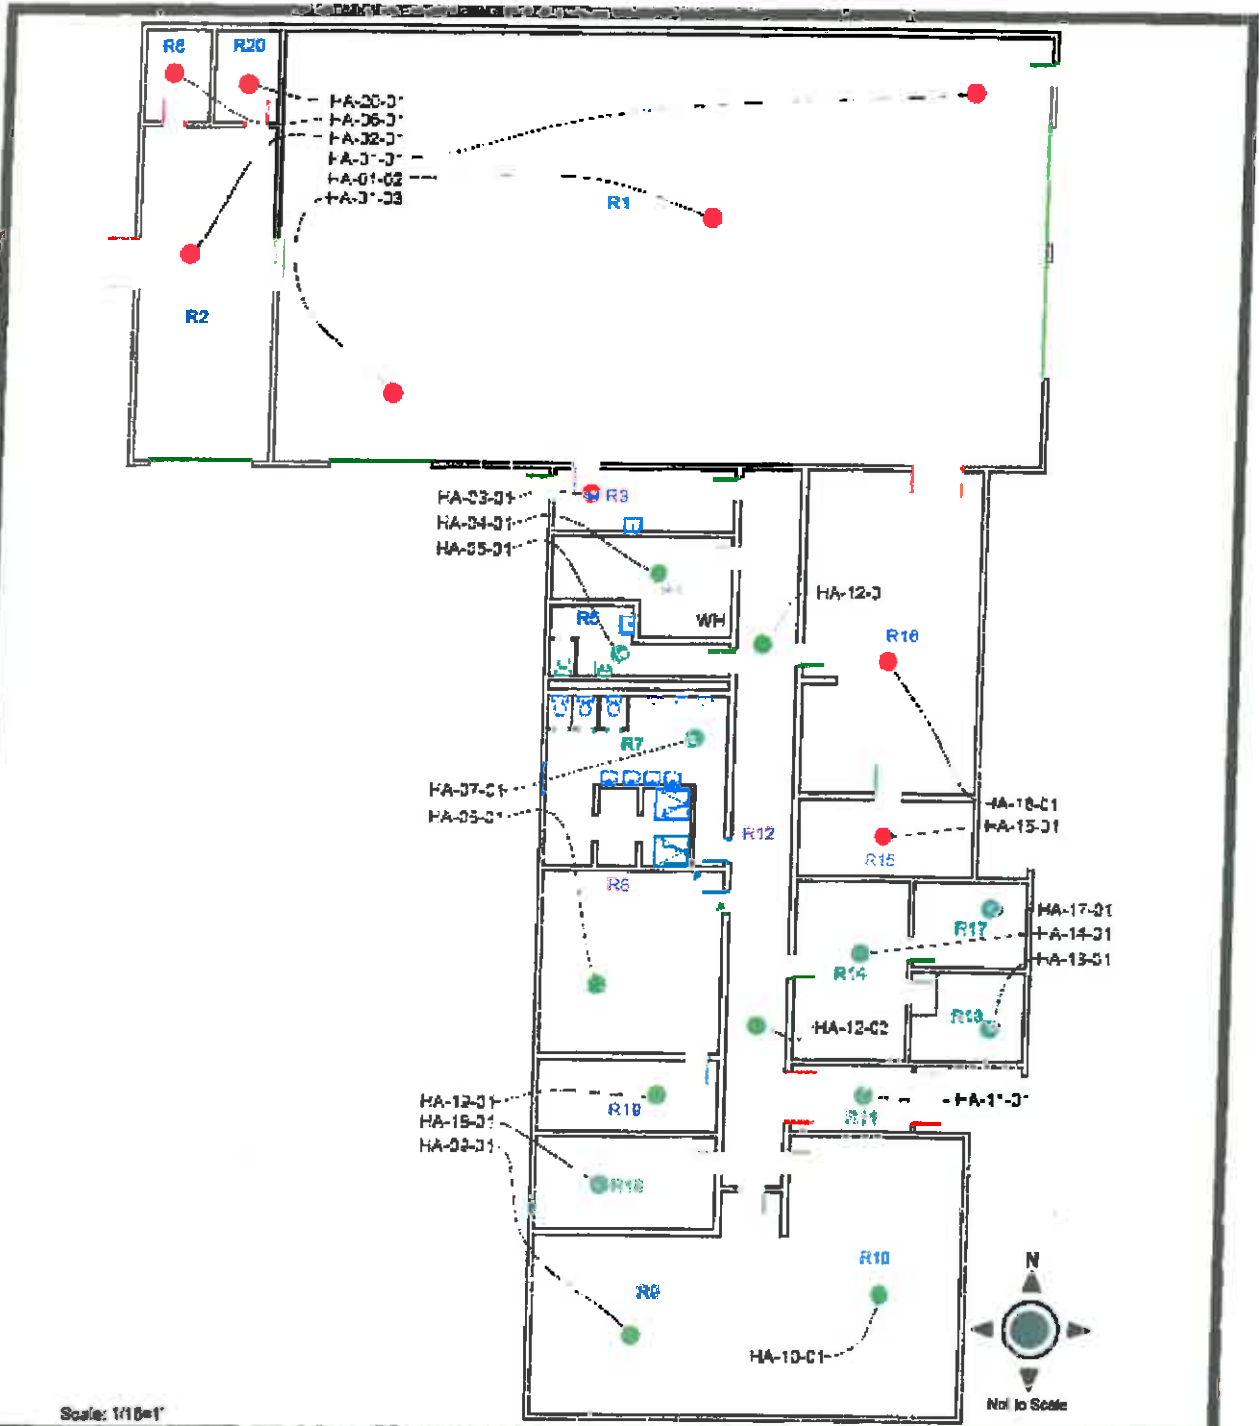
FIGURE 1
Lead-Based Paint Locations

NOTE: Many components were not tested and were assumed positive by reference to other similar components painted the same color that tested positive. These components were not listed in this table; however, their locations are noted on Figure 1 in Appendix A.

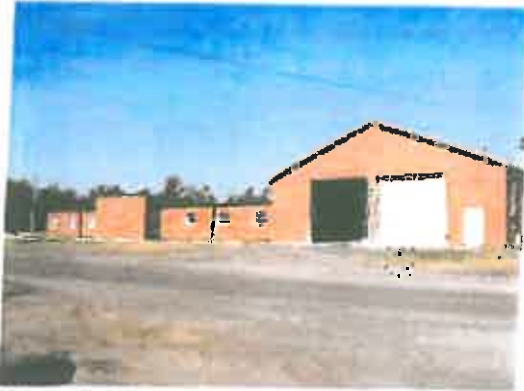
Photo #1: Hobart National Guard Armory.
