**Former National Guard Armory
Madill, Oklahoma**

Remediation Final Report

The Oklahoma Department of Environmental Quality (DEQ) is pleased to present the Marshall County Chamber of Commerce with the Final Remediation Report for the former Madill Armory.

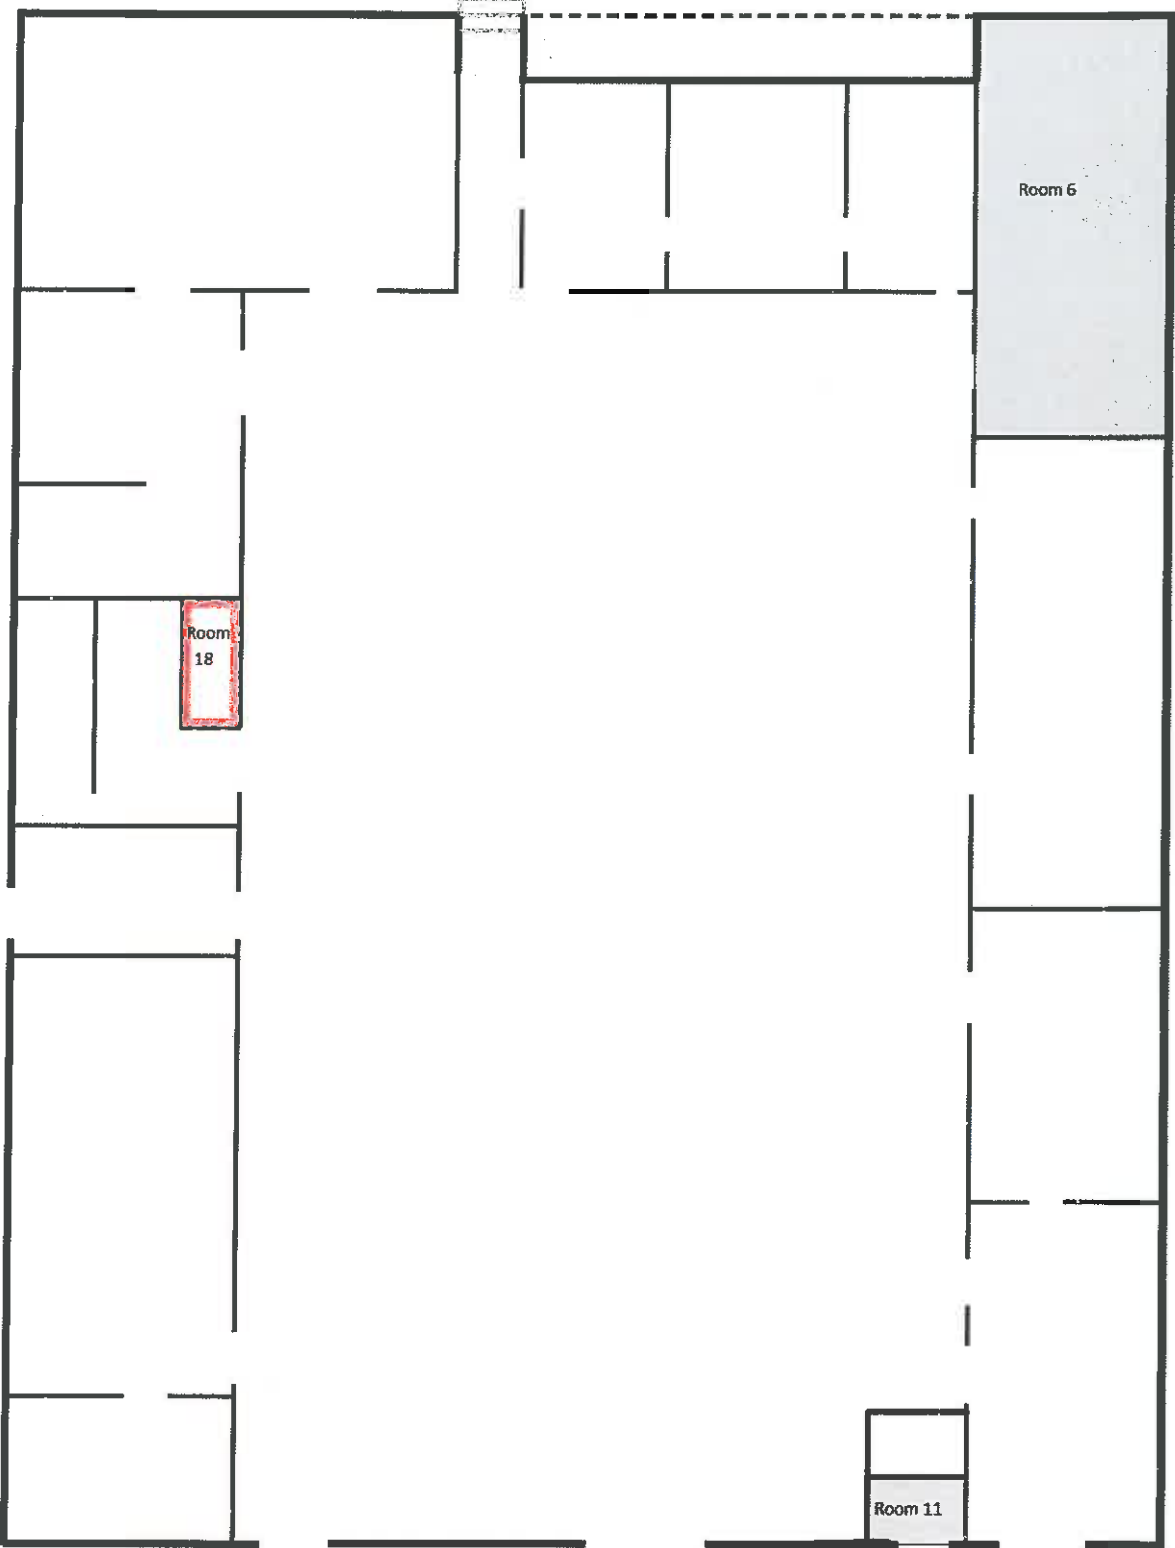
Madill Armory Floor Plan Map

1. All painted walls in Room 18 were scrapped and encapsulated with lead-based paint encapsulant. These surfaces need to be re-encapsulated if lead-based paint encapsulant shows signs of deterioration, damage, or flaking. See Attachment 2 for Madill Armory Floor Plan Map.
2. The floors of Room 6 and Room 11 had lead-based paint visibly removed, were cleaned and sealed to remediate surfaces below 40 μ g/SF for lead. These surfaces need to be resealed if sealant shows signs of deterioration, damage, or flaking. See Attachment 2 for Madill Armory Floor Plan Map.

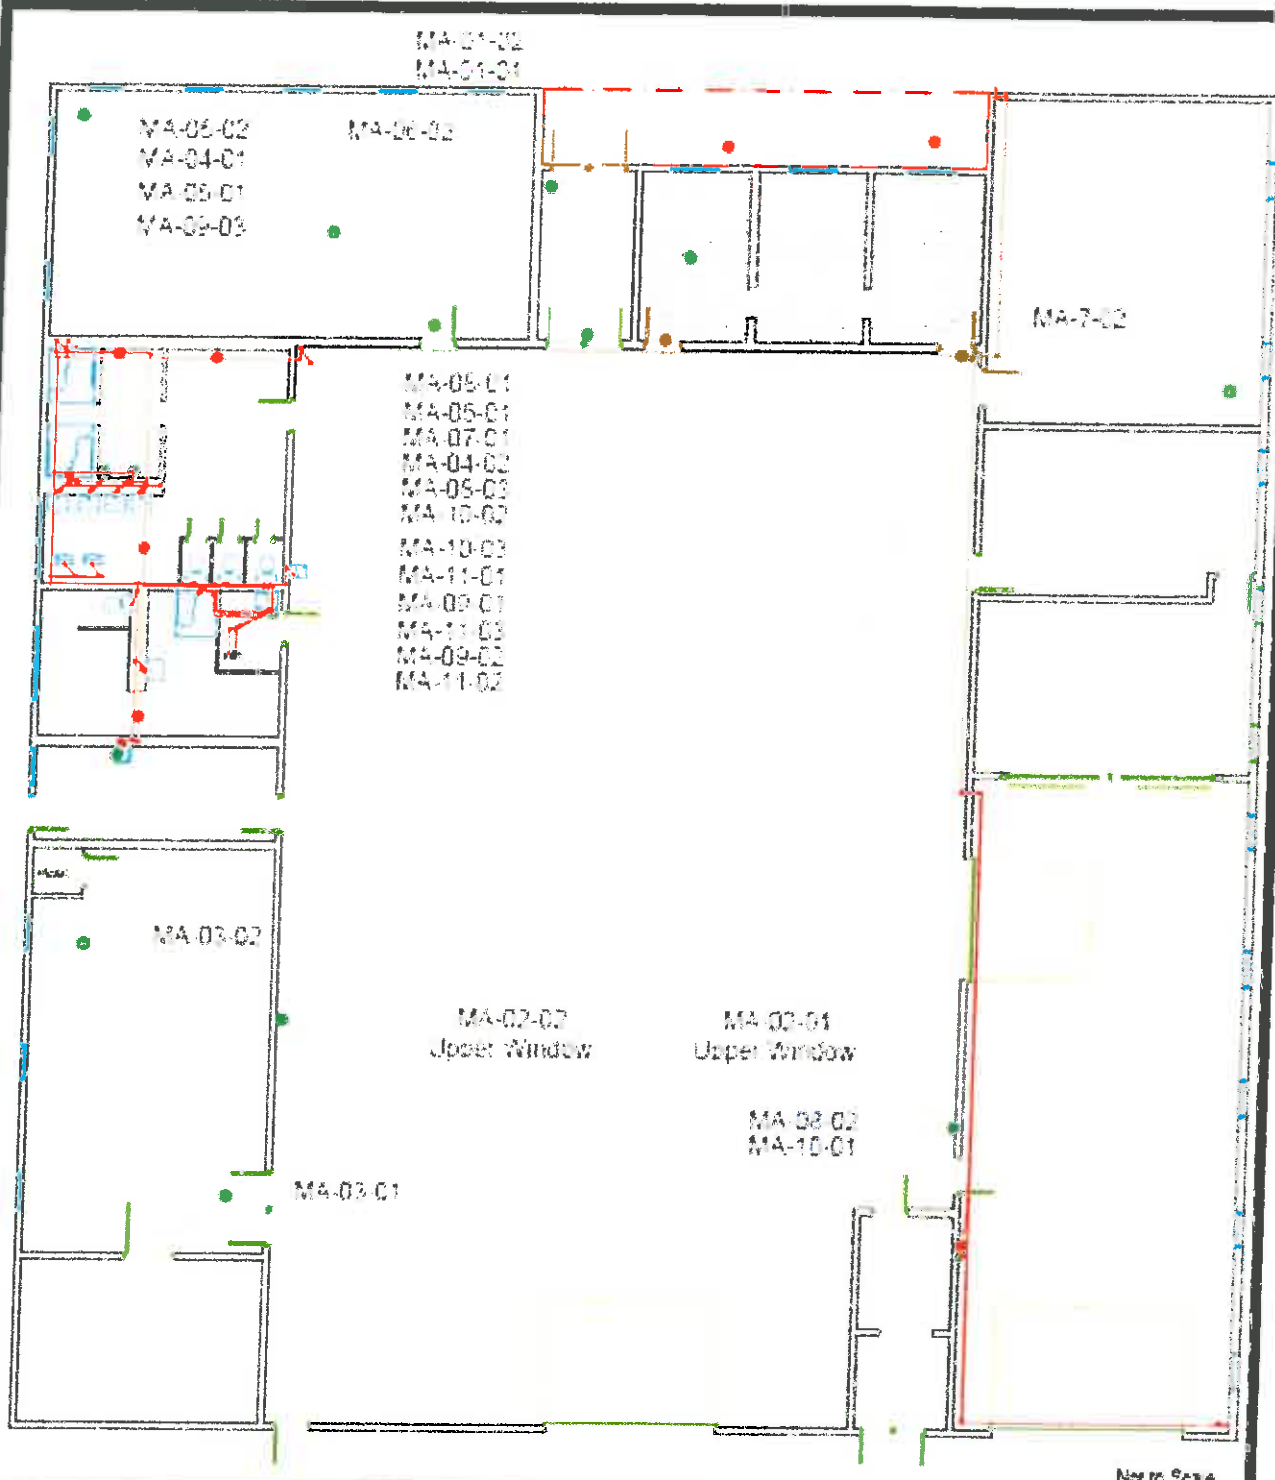
FIGURE 1
Asbestos Sample Locations

Recommendations for Non-friable Asbestos-containing Materials: Non-friable asbestos present were the black/yellow carpet mastic located in Rooms 3-5 and the Transite® panels located on the exterior of the north side of the armory building. These materials containing asbestos are not regulated unless they are disturbed in a manner that renders them friable; however, if they are to be removed, removal must be done by workers who are properly trained to remove them. The following actions are recommended for addressing non-friable materials:

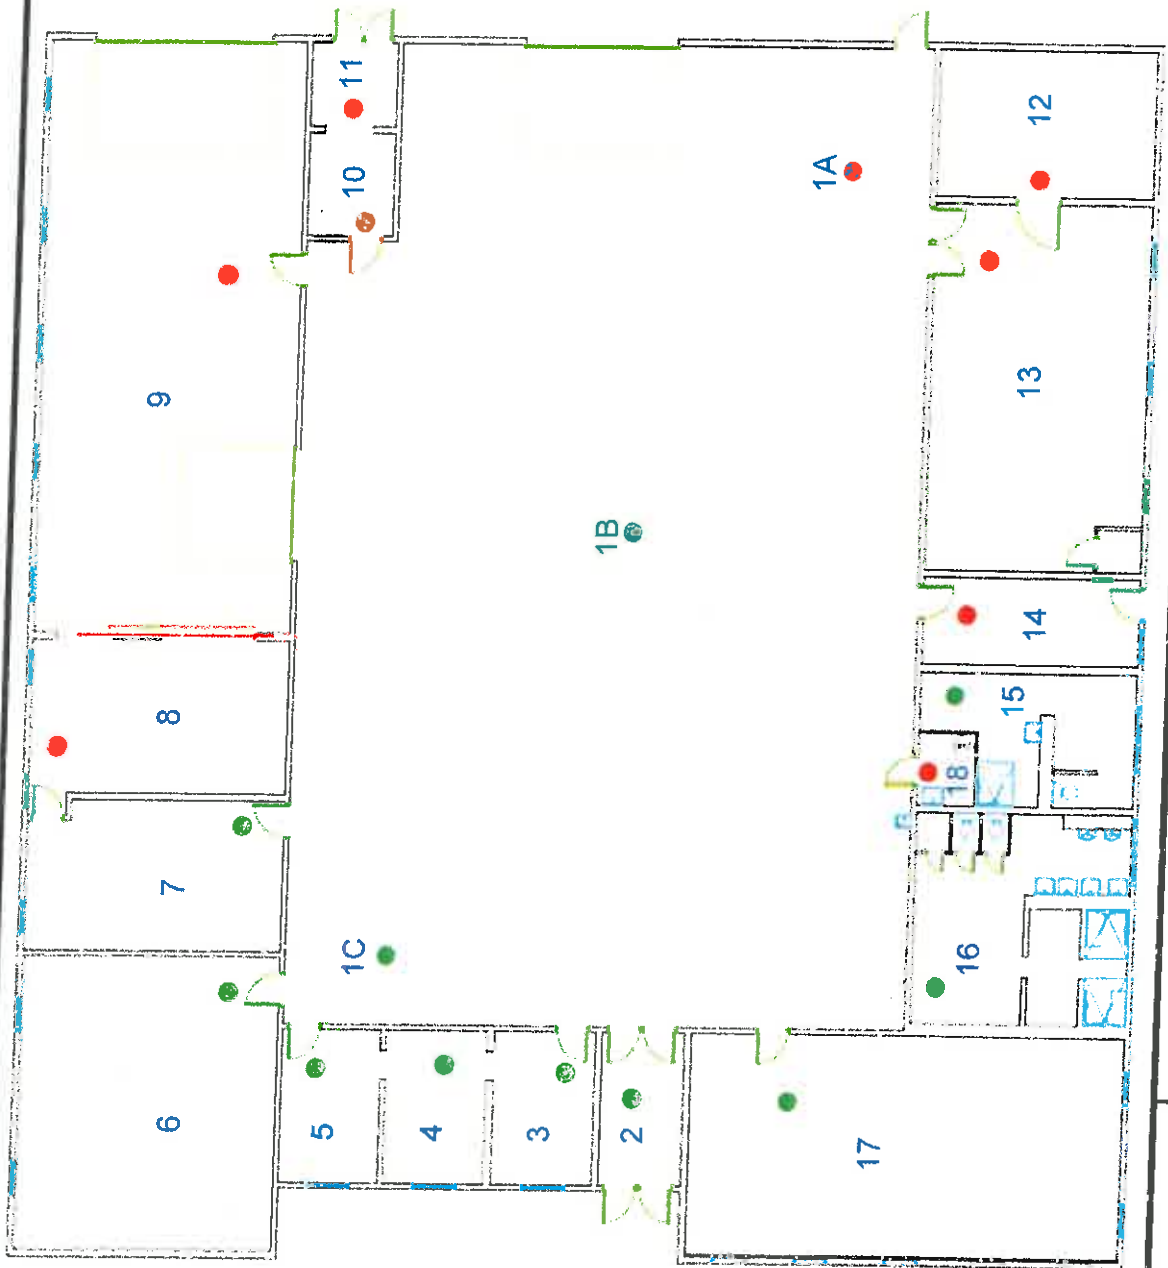
**Figure 1
LEAD-BASED PAINT LOCATIONS**

- Interior: The basketball hoop in Room 1, a small area of the concrete floor in Room 6, the concrete floor in Room 11, the pass through windowsill in Room 14 and the painted lower portion of the brick walls in Room 18 were coated with LBP.
- Exterior: No LBP was found on the exterior of the building.
