**Targeted Brownfields Assessment
Oklahoma Army National Guard
Mangum
Mangum, Oklahoma**

**ASTM E 1527-05
Phase I Environmental Site Assessment
All Appropriate Inquiry**

December 18, 2007

**Oklahoma Department of Environmental Quality
Land Protection Division
707 N. Robinson
P.O. Box 1677
Oklahoma City, Oklahoma 73101-1677
(405) 702-5100**

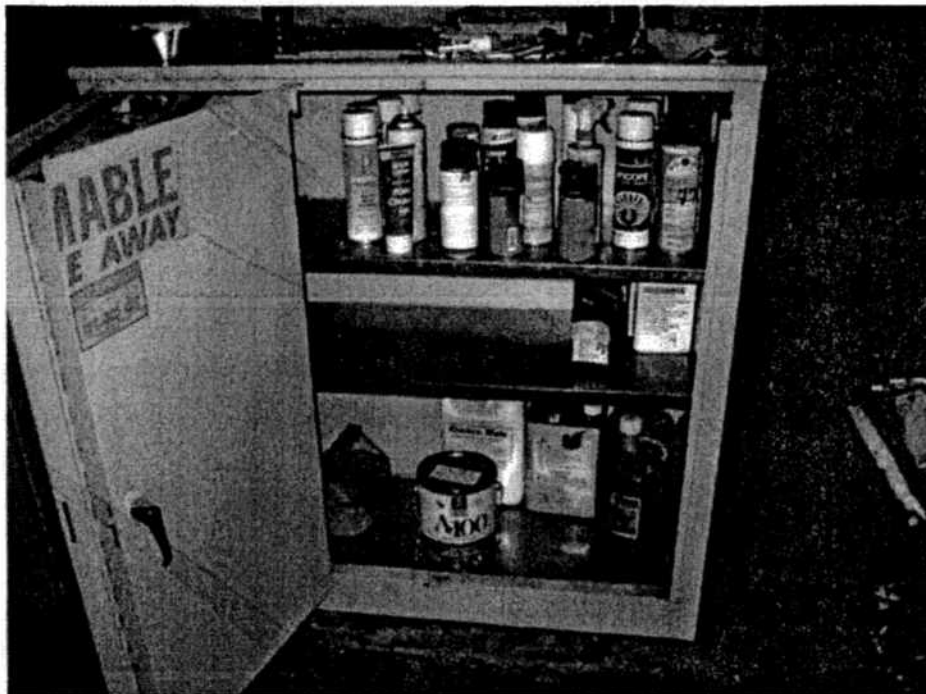
Photo 41. Chemical storage locker located on the south wall of the drill floor near the main hallway entrance. Note silicon spray lubricants, soaps, and oil.

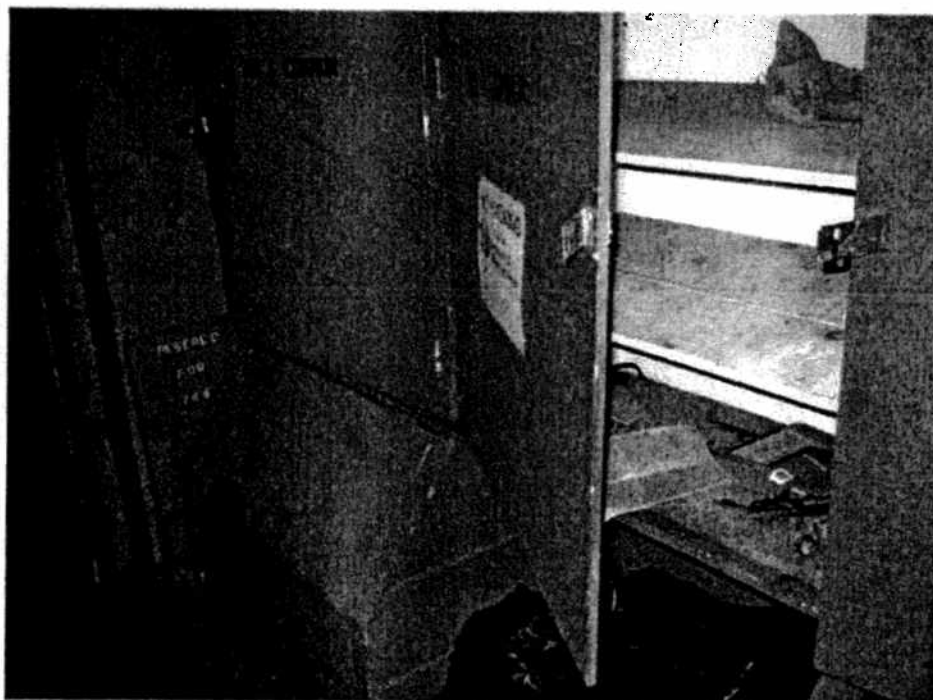
Photo 43. Storage lockers on the east wall of storage room seen in photo 42.

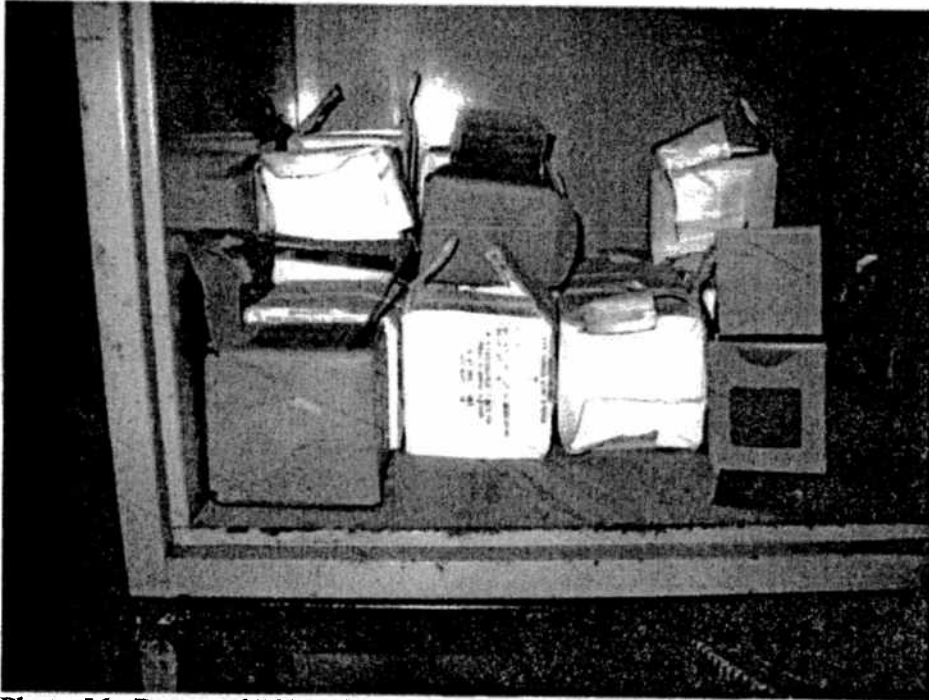
Photo 56. Boxes of "Chemical agent detector stored in shelving on the west-central area of the IFR wall

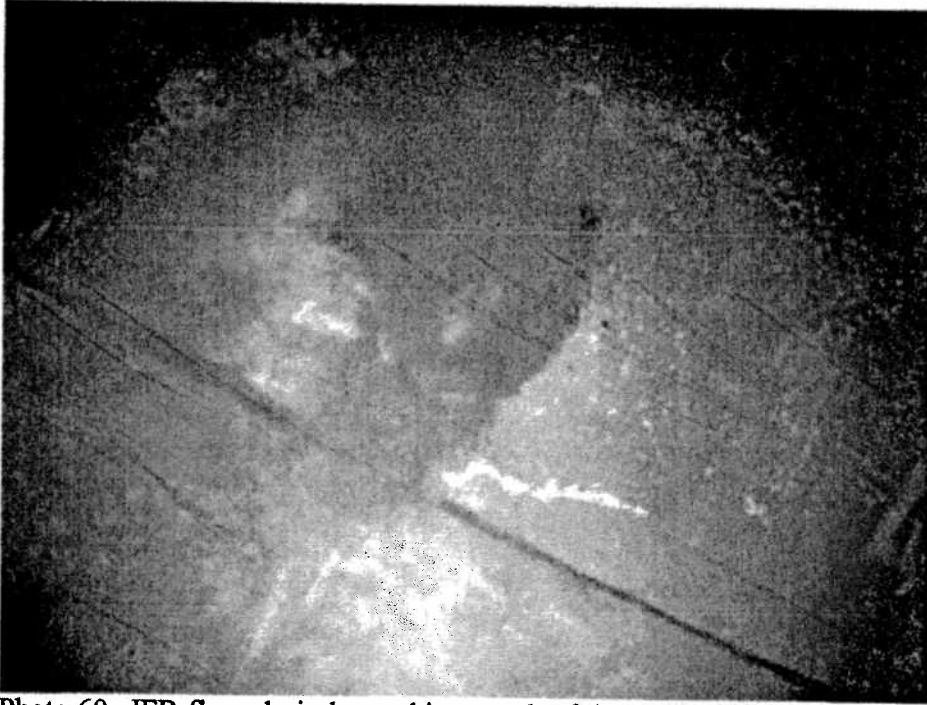
Photo 60. IFR floor drain located just south of the center of the IFR.

- The IFR and other areas found to be lead contaminated should be remediated.
- The drain in the middle of the IFR should also be investigated as a possible pathway for lead into the sewer system.
