**Former National Guard Armory  
Oklahoma City SW 44th Street, Oklahoma**

**Remediation Final Report**

**Prepared by:  
Department of Environmental Quality  
707 North Robinson  
Oklahoma City, Oklahoma 73101**

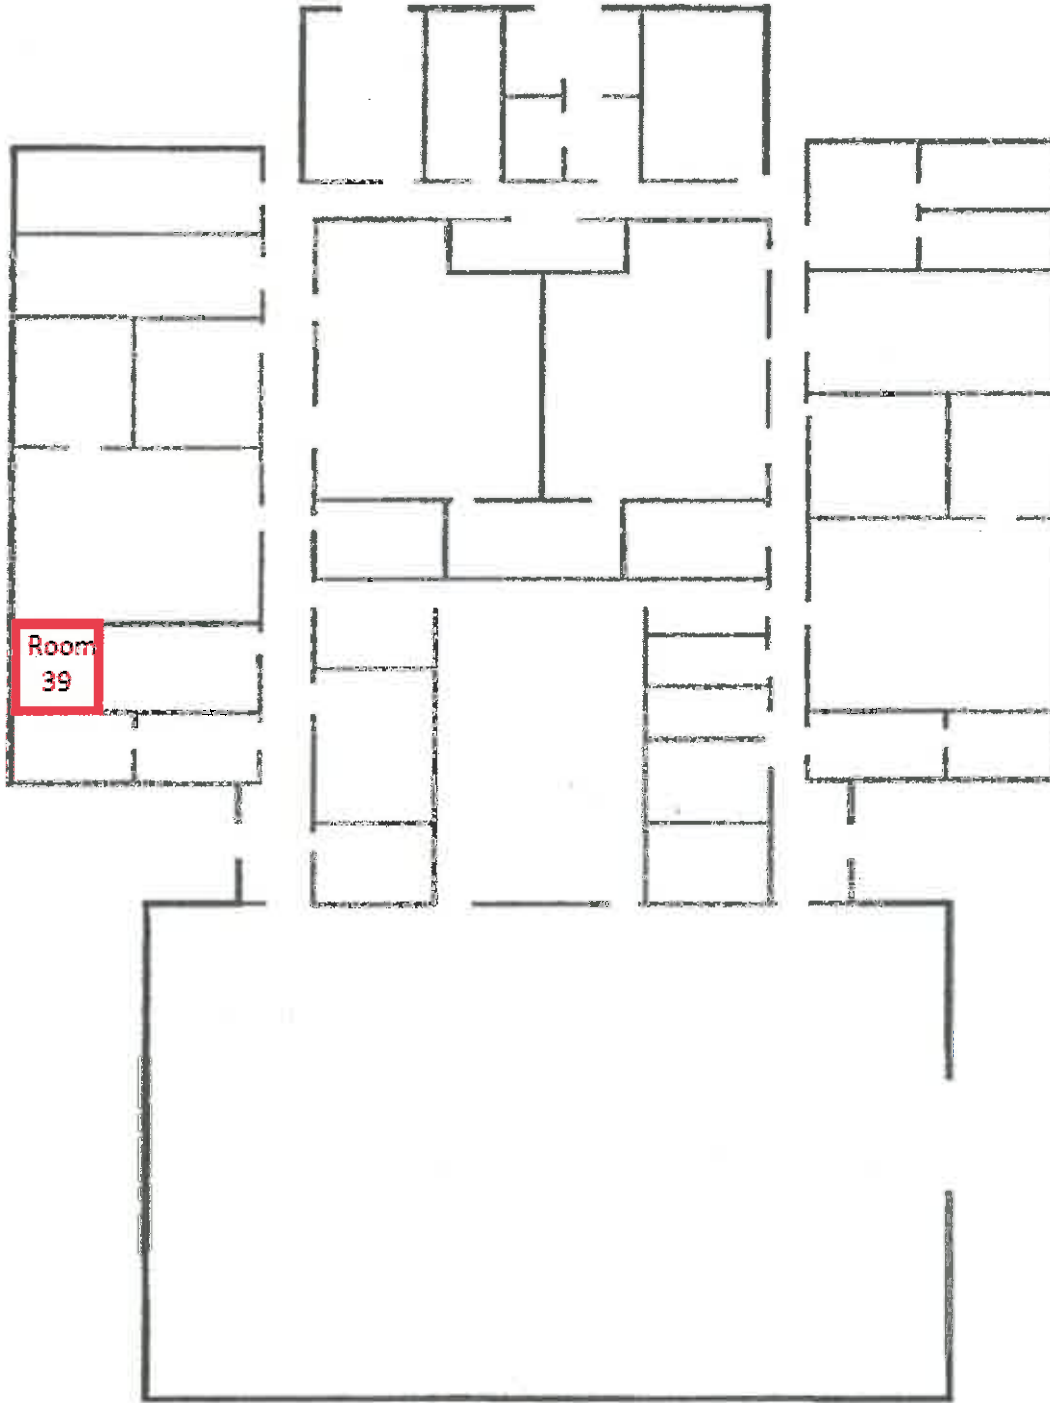
1. All painted walls in Room 39 were scrapped and encapsulated with lead-based paint encapsulant. These surfaces need to be re-encapsulated if lead-based paint encapsulant shows signs of deterioration, damage, or flaking. See Attachment 2 for Oklahoma City SW 44<sup>th</sup> Street Armory Floor Plan Map.

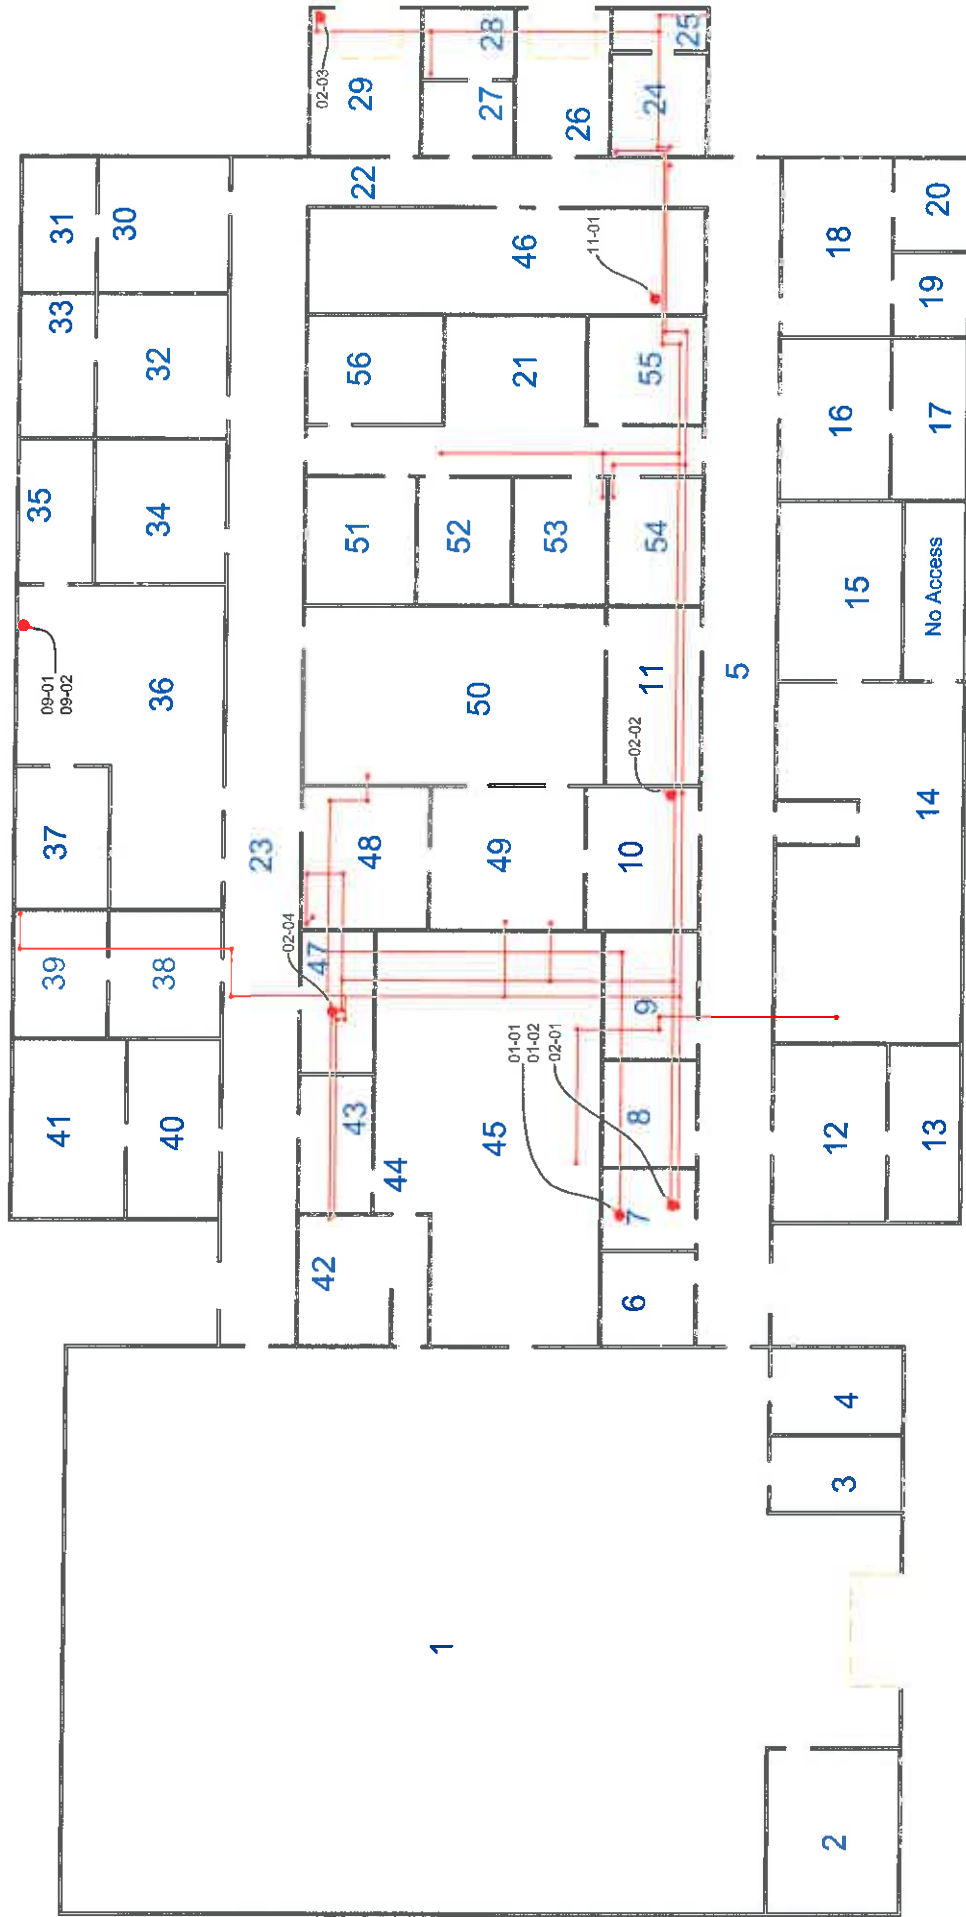
**Figure 1**  
**Thermal System Insulation**

- Domestic Water Fitting Insulation: Approximately 65 fittings in good to poor condition were present above ceilings and inside walls/chases.
- Roof Drain Pan and Fitting Insulation: One pan and one fitting in good condition was present above the ceiling Room 36
- Water Storage Tank Insulation: Approximately 100 SF of insulation in good condition was present on the water tank in Room 7.
- Vibration Isolation Gaskets: Approximately 100 LF of woven asbestos gasket material in good condition was present in Room 46.

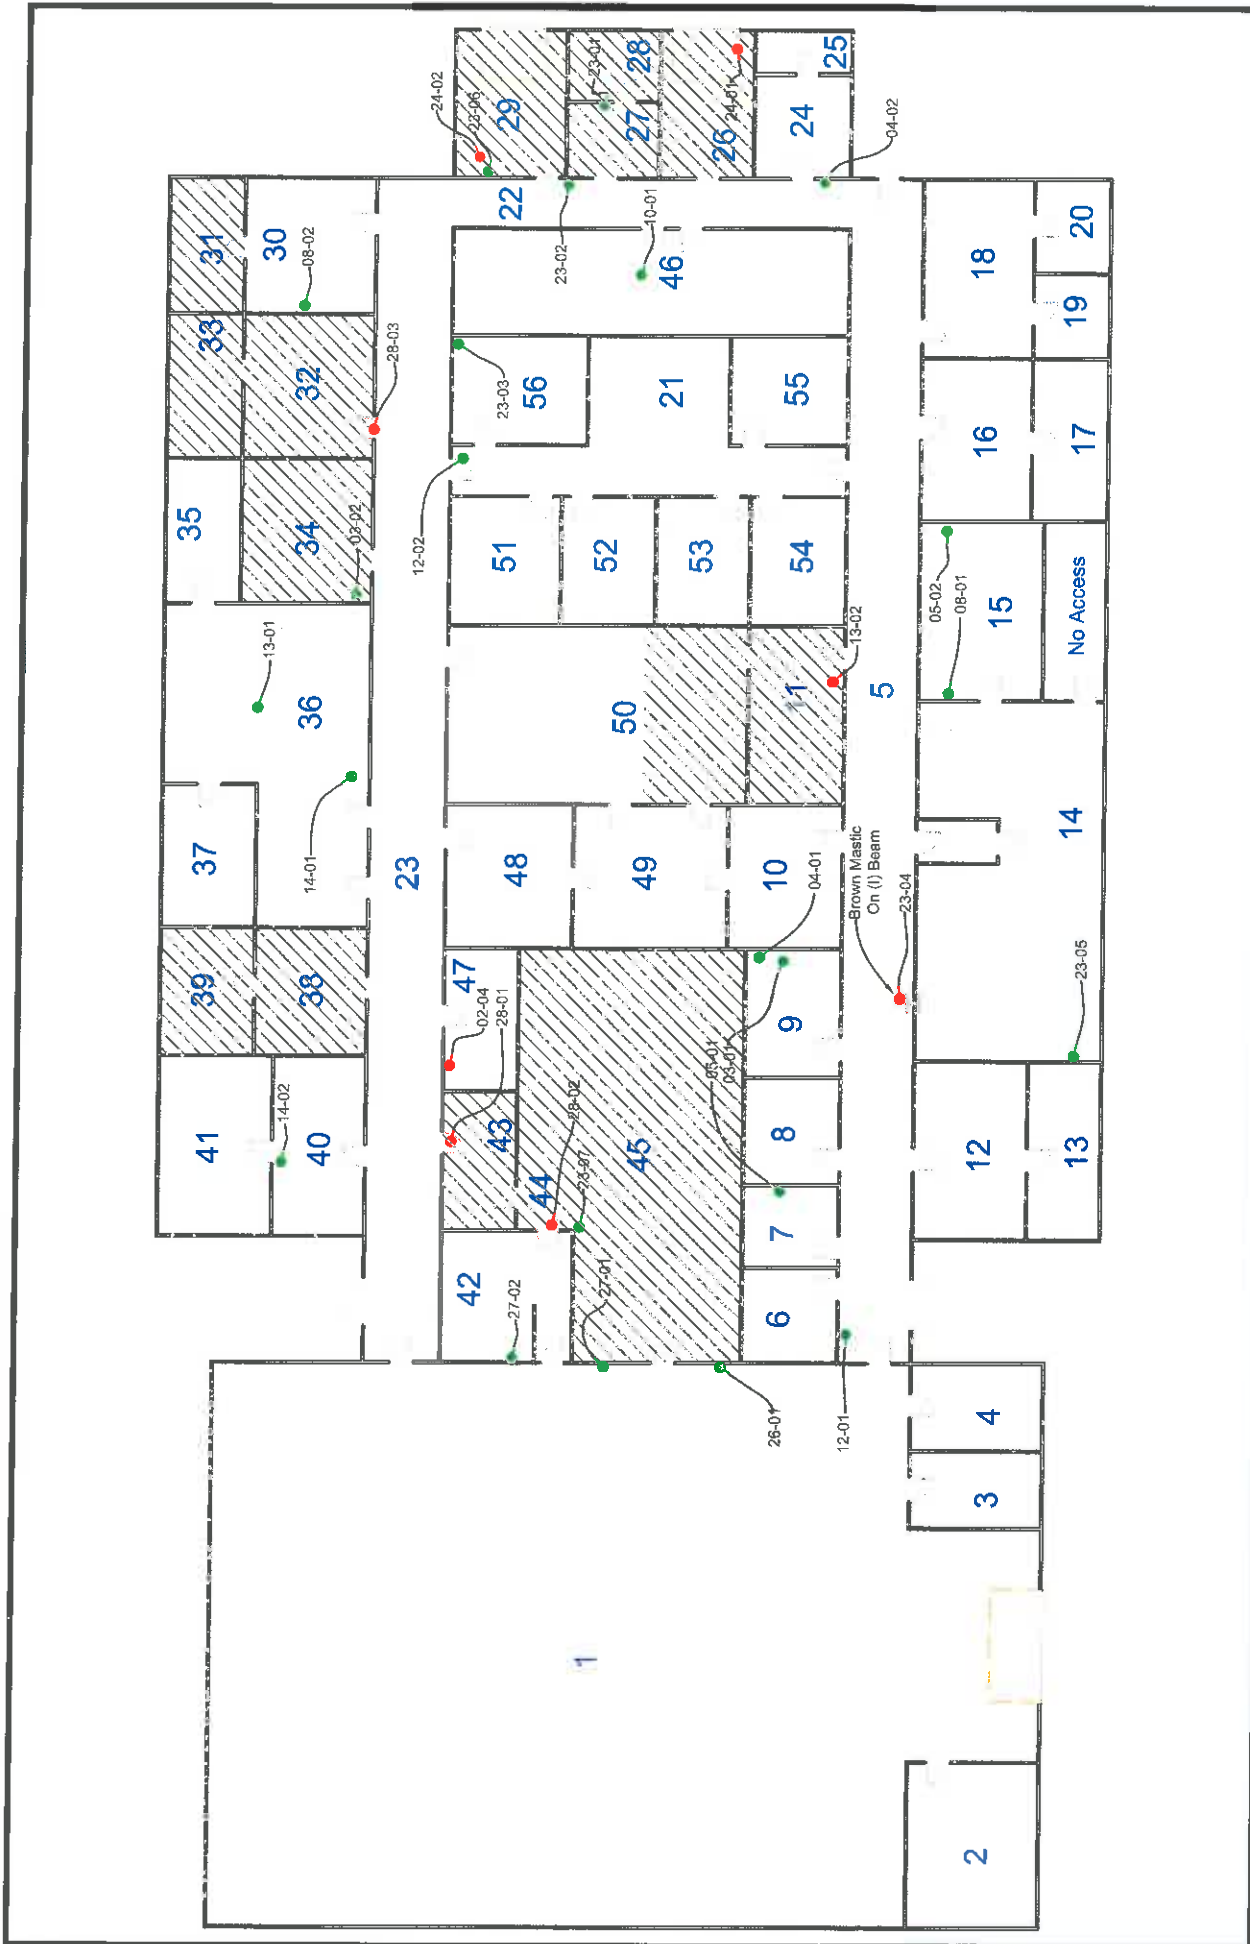
**Legend:**  
 ● Positive ACM Sample Location  
 ● Negative Sample Location  
 Brown Mastic on Beam = 1 @ 25 LF  
 ACM Mastic Beneath Floor Tile = 4,435 SF

- Black Floor Tile Mastic: Approximately 4,865 SF of asbestos-containing black mastic was present beneath various colors of non-asbestos floor tiles in Rooms 11, 26-29, 31-34, 38, 39, 43-45, and a portion of Room 50. The location of these materials is shown on the Layout in Appendix B.
- Brown Mastic on I-Beam: Approximately 25 LF of brown mastic in good condition was present on one I-beam in Room 5.

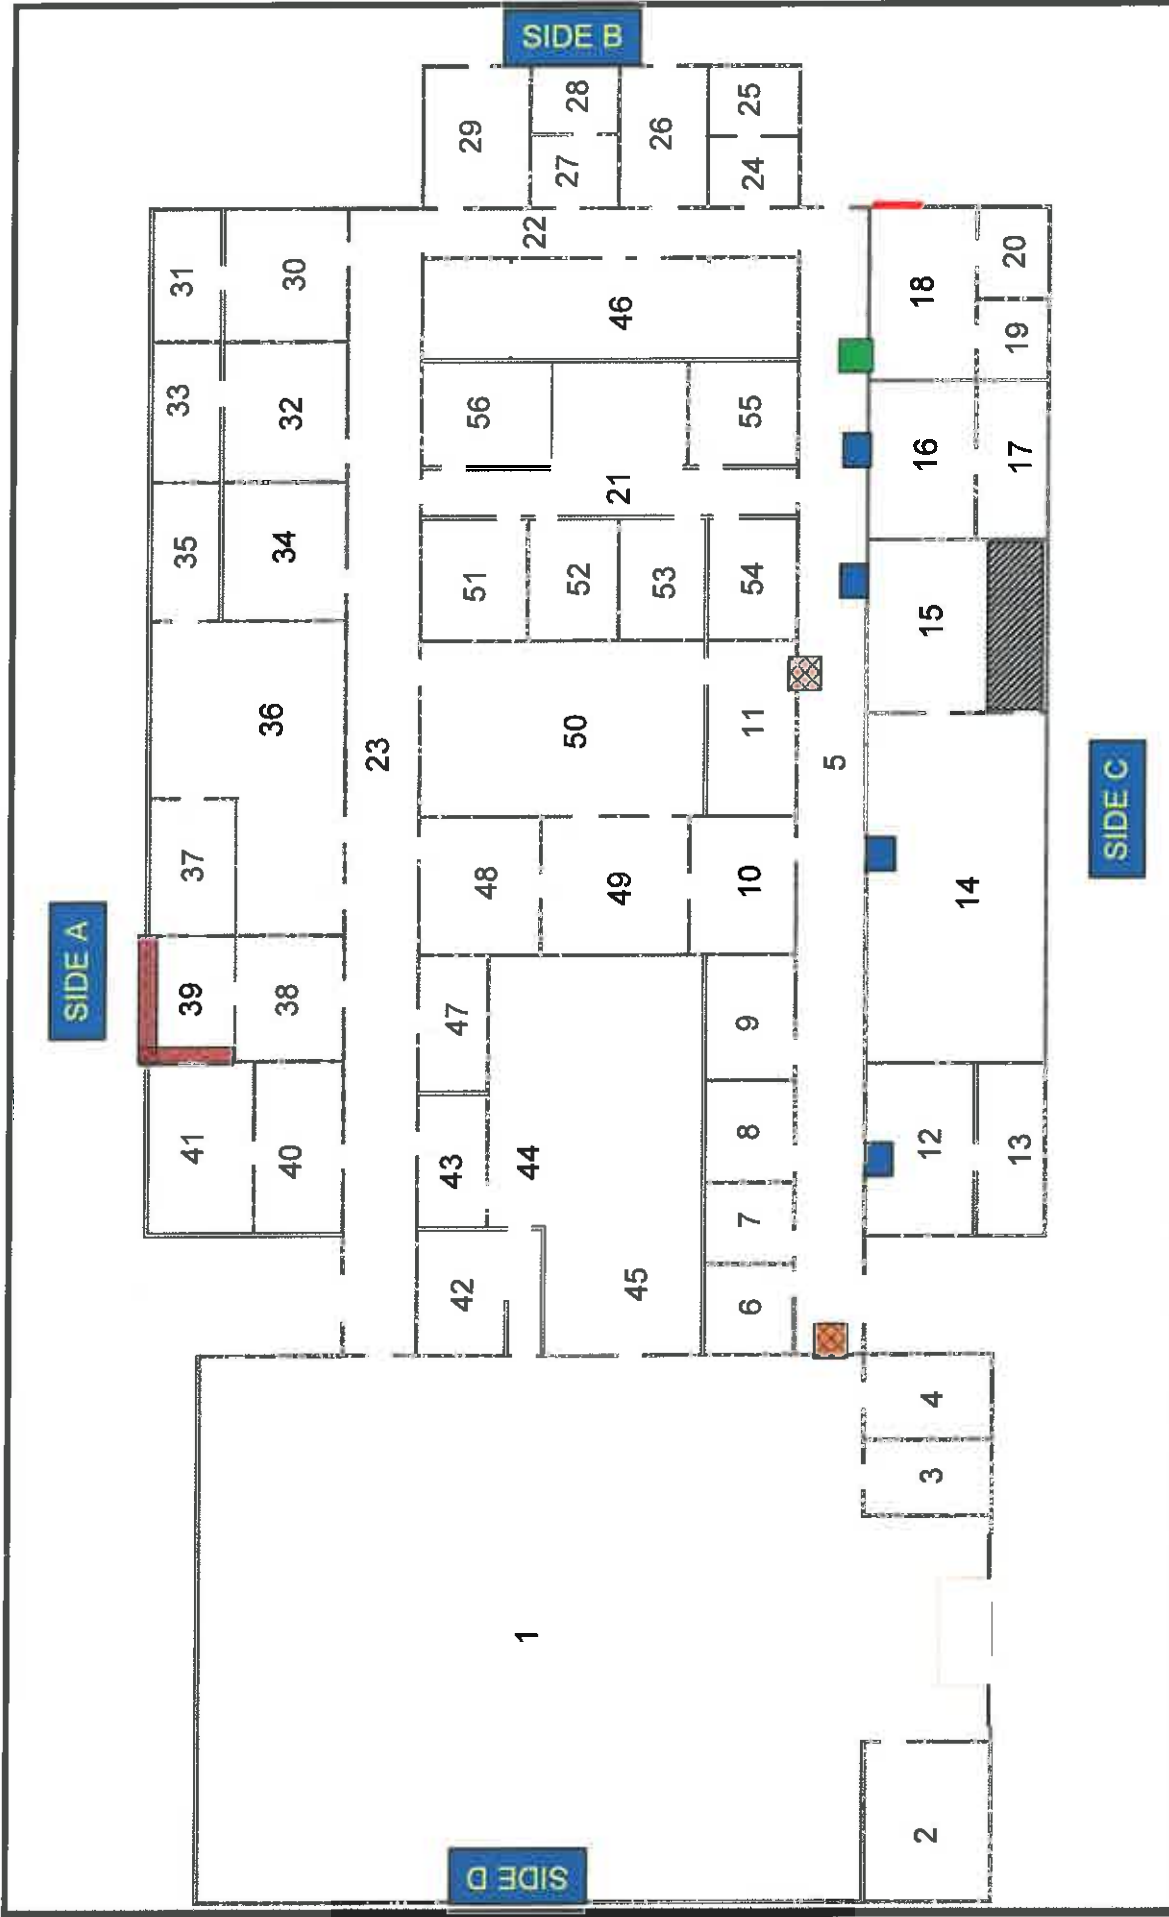
Figure 1  
**LEAD-BASED PAINT LOCATIONS**

A total of 415 XRF samples were collected, including calibration and null readings. Figure 1 in Appendix A shows the location of painted components with LBP. Tables 1, 2, and 3 provide a summary of building components with LBP as identified by XRF sampling along with their locations and sizes. The painted surfaces sampled during the survey ranged from intact to poor condition. Painted surfaces sampled during the survey ranged from fair to intact condition. Representative photographs were taken of components where positive readings ( $1.0 \text{ mg/cm}^2$  or greater) were obtained and are provided in Appendix B.

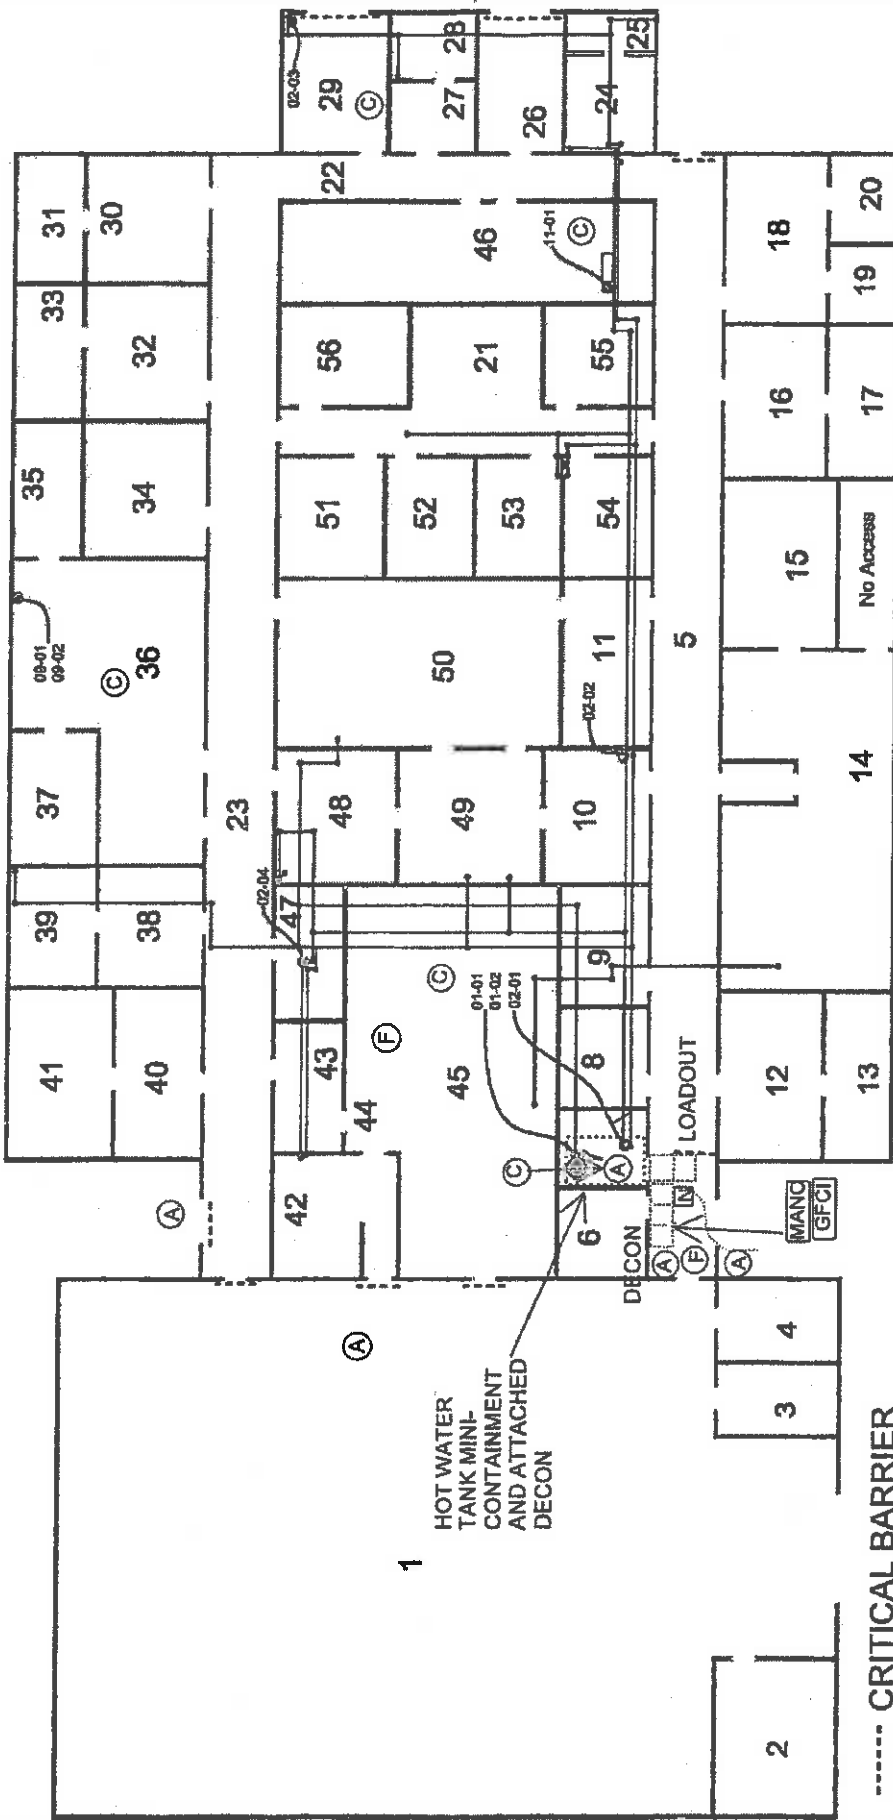
1. GLOVE-BAG ALL FITTINGS; DECON ATTACHED TO GLOVE-BAG WORK AREA
2. CRITICAL BARRIERS AT EXTERIOR OPENINGS & DROP CLOTHS
3. MINI-CONTAINMENT WITH ATTACHED DECON FOR WATER TANK ABATEMENT
4. FIVE PCM CLEARANCE SAMPLES FOR GLOVE-BAG AND VIG ABATEMENT
5. FIVE PCM CLEARANCE SAMPLES FOR MINI-CONTAINMENT
