**Former National Guard Armory
Sapulpa, Oklahoma**

Remediation Final Report

**Prepared by:
Department of Environmental Quality
707 North Robinson
Oklahoma City, Oklahoma 73101**

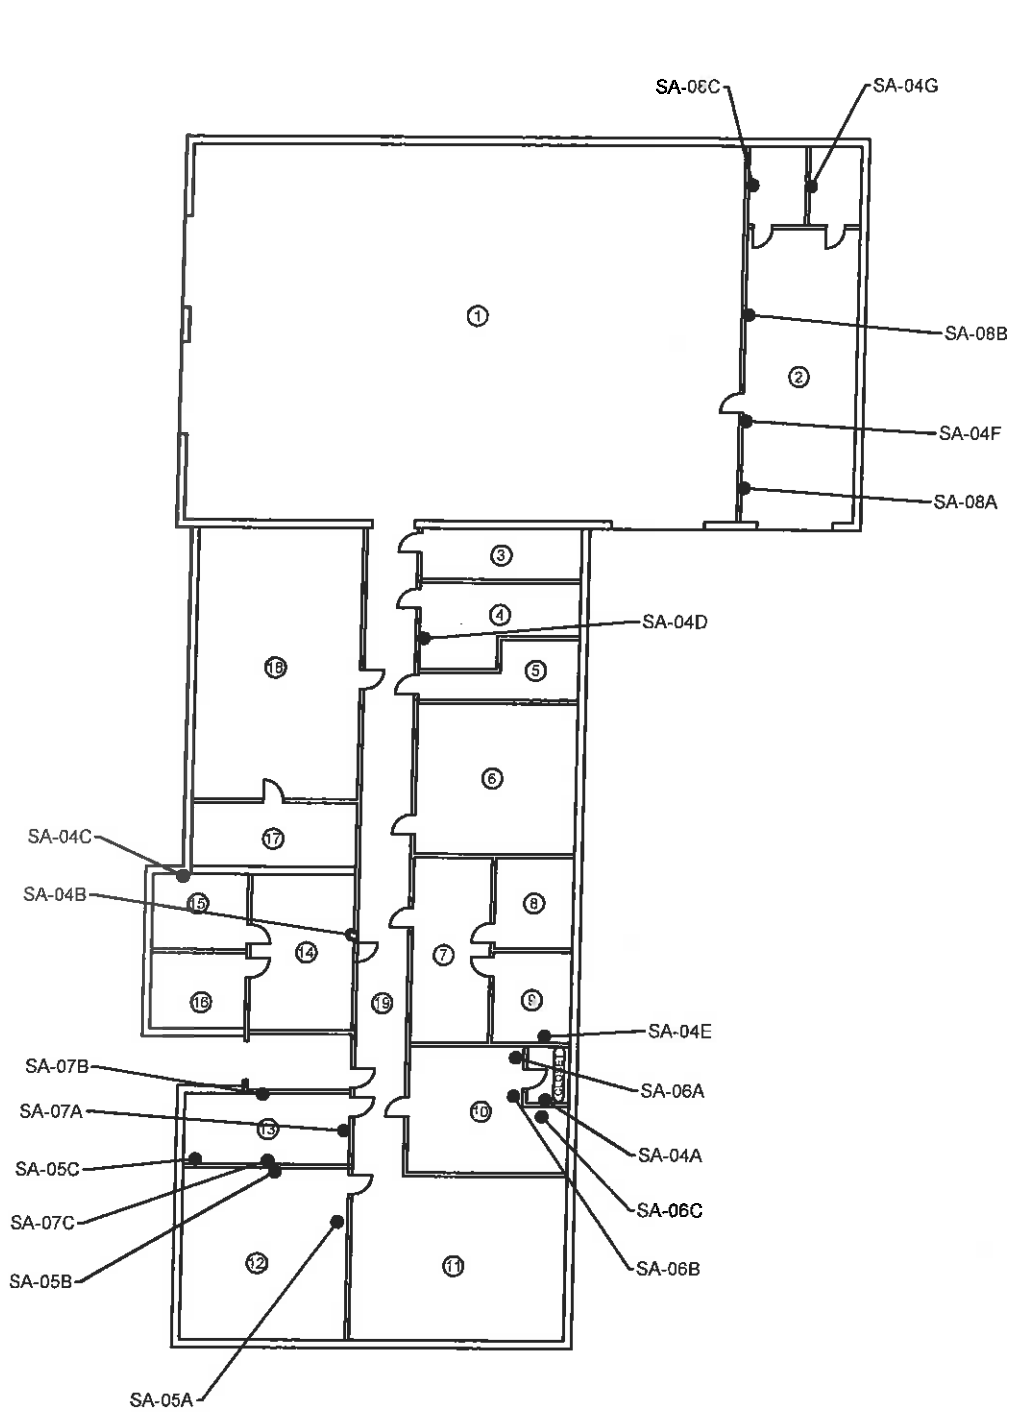
Figure 1
Asbestos Surface Sampling Locations
Sapulpa Armory
13 Sahoma Lake Road
Sapulpa, Oklahoma 74066

Material Category	Description	Quantities	General Location
Friable	Thermal Pipe Insulation – Water Pipe (SA-22A thru SA-22C)	225 Lineal Feet	Exposed in Rooms 3, 4, 5, 6, 8, 9, 10 and 11
Friable	Thermal Pipe Fittings – Water Pipe (SA-23A thru SA-23C)	25 Fittings (Observed)	Exposed in Rooms 3, 4, 5, 6, 8, 9, 10 and 11.
Category 1 Non-Friable	Gray Floor Tile (SA – 11A)	250 Square Feet	Room 14
Category I Non-Friable	Black Mastic	380 Square Feet	Rooms 14 & 16

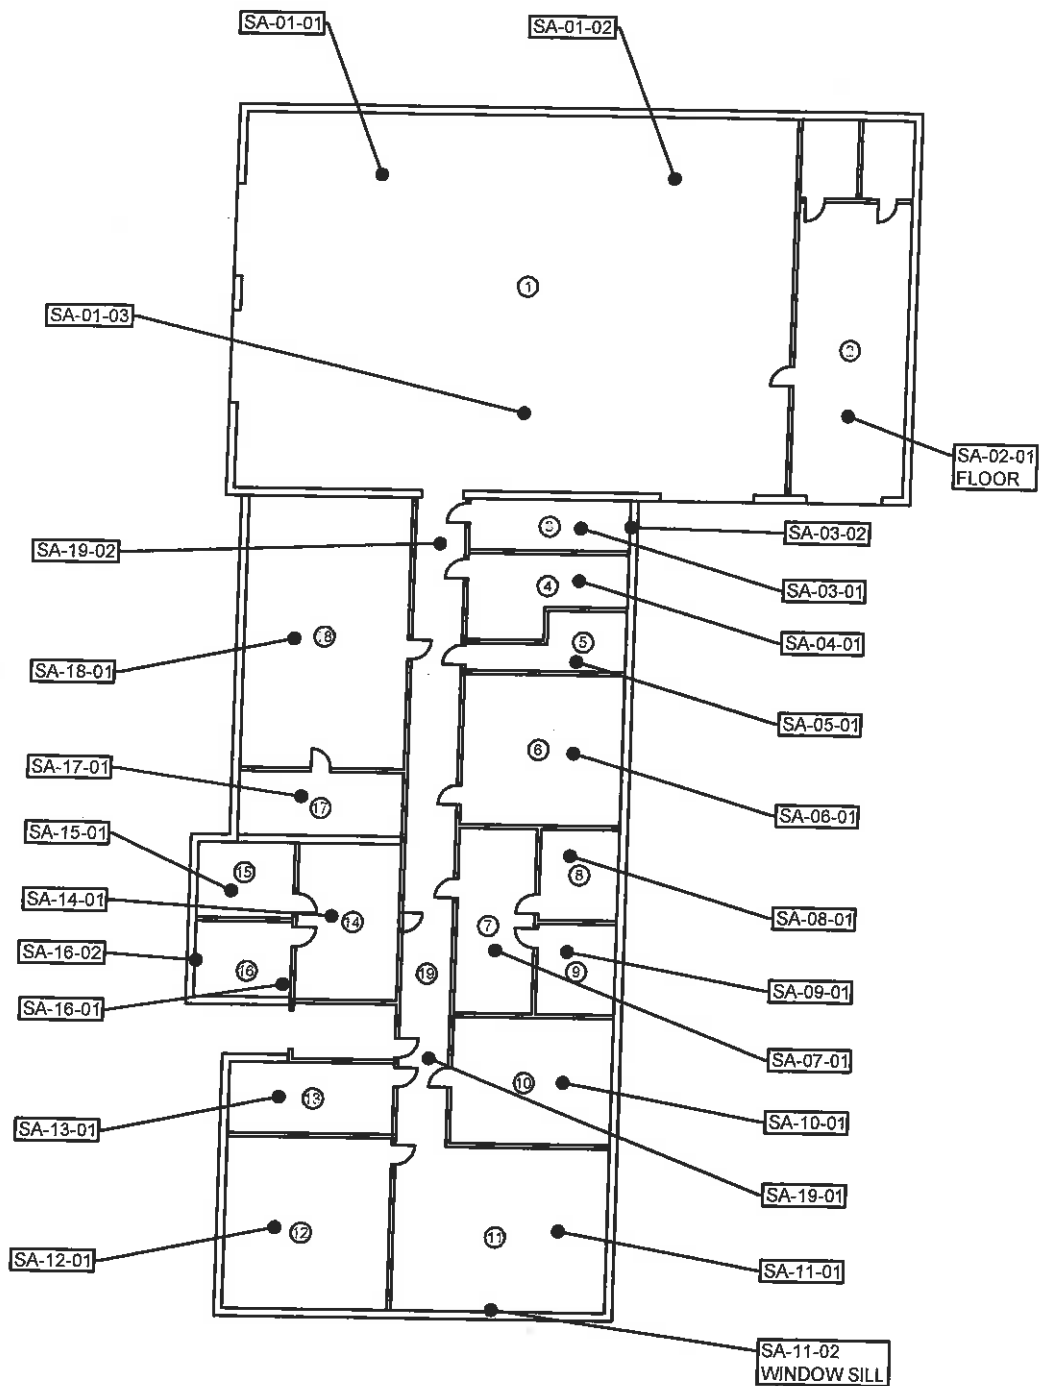
Figure 1
Dust Sampling Locations
Sapulpa Armory
13 Sahoma Lake Road
Sapulpa, Oklahoma 74066

Laboratory results from the dust wipe samples are presented in Appendix C. Floor and sill samples having lead levels greater than EPA/HUD recommended maximum concentrations are shown in Table 1 below. A layout of the building is presented in Appendix B.

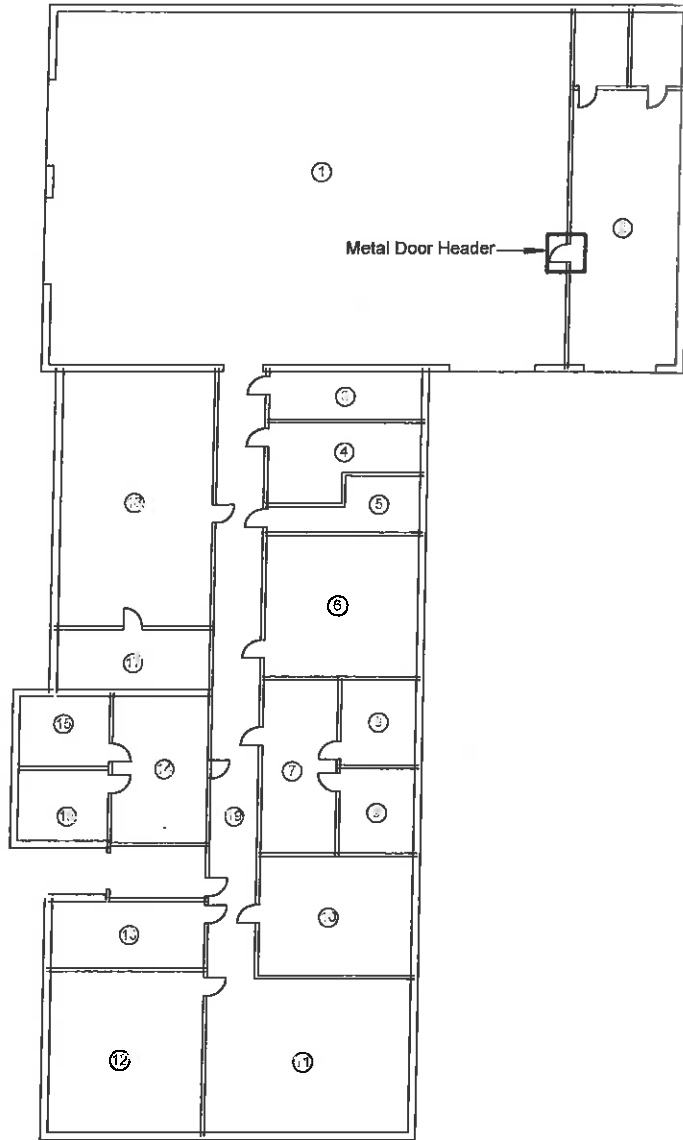
FIGURE 1: Door Components with Lead-Based Paint

Reading Number	Room	Side	Component	Feature	Color	Condition	Substrate	Lead (mg/cm ²)
552	1		Ceiling	Beam	Red	Fair	Metal	5.6
553	1		Ceiling	Cross Member	Red	Fair	Metal	3.7
570	2	A	Door	Header	Beige	Poor	Metal	8.7
582	2		Ceiling	Beam	Gray	Fair	Metal	2.4
778	19	C	Wall		Yellow	Intact	Concrete	2.3
785	Exterior	A	Porch	Ceiling	White	Intact	Wood	2.9
786	Exterior	A	Porch	Beam	White	Intact	Wood	2.1
794	Exterior	A	Garage Door	Fascia	White	Intact	Metal	1.6
795	Exterior	A	Garage Door	Fascia Plinth	White	Intact	Metal	4.3

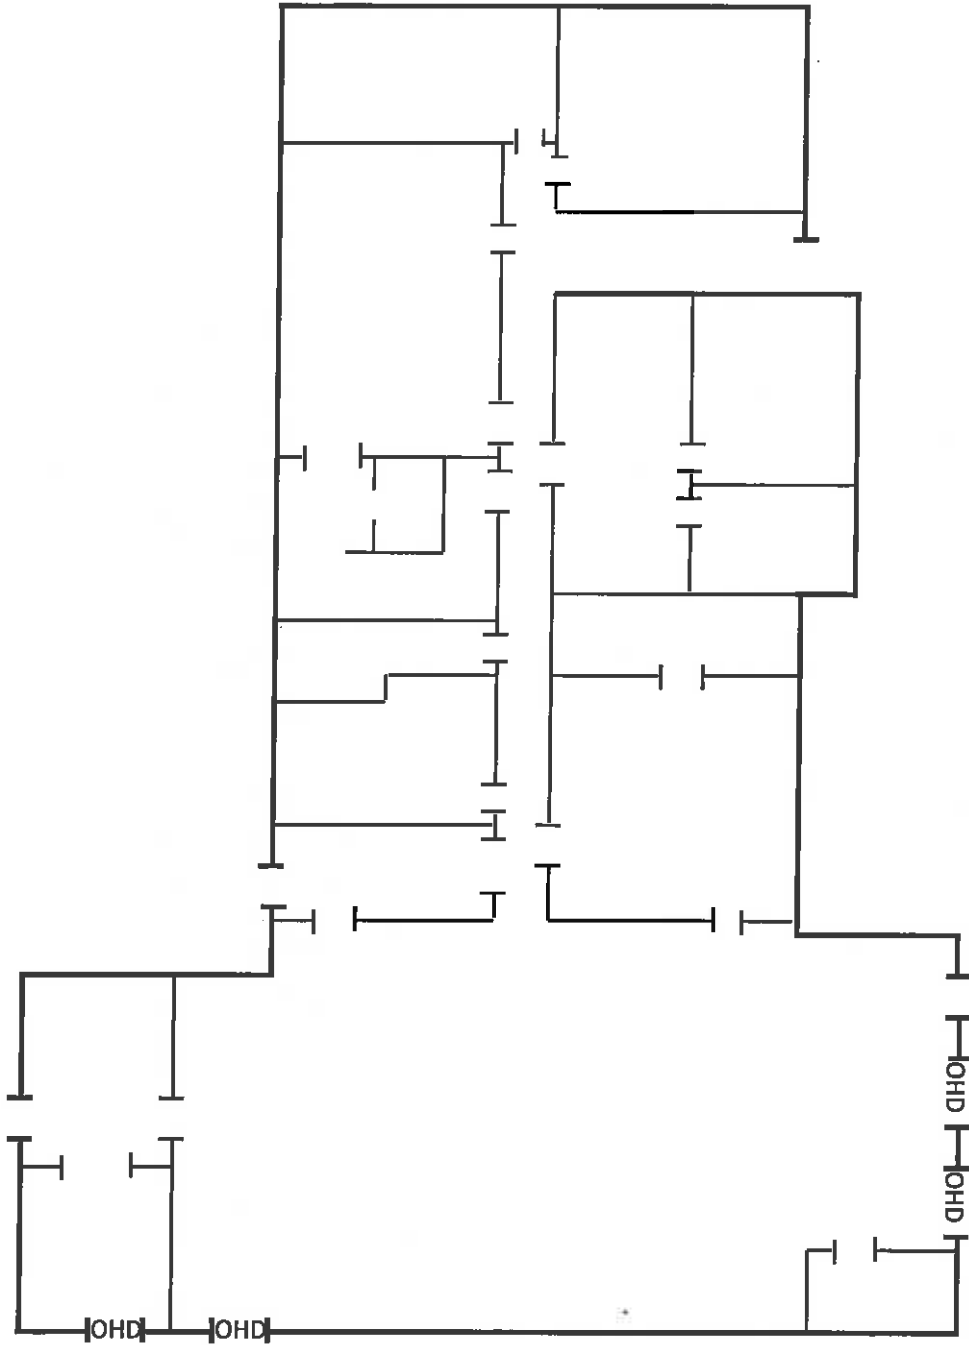
Sapulpa Armory Floor Plan Map

Labeled areas represent walls and floors with encapsulant and/or sealant.

1. All interior and exterior portions of all four garage door frames and guards, the exterior porch ceiling and beams, the wall logo in Room 19, and the door frame and lintel between Room 1 and Room 2 were wet scraped, painted, and encapsulated with lead-based paint encapsulant. These surfaces need to be re-encapsulated if lead-based paint encapsulant shows signs of deterioration, damage, or flaking. See Attachment 2 for Sapulpa Armory Floor Plan Map.
2. The emblem located in the center of the Drill Room floor was cleaned and sealed with acrylic. The emblem needs to be resealed if acrylic sealant shows signs of deterioration, damage, or flaking. See Attachment 2 for Sapulpa Armory Floor Plan Map.
