TARGETED BROWNFIELD ASSESSMENT

PERRY ARMORY

ASTM E 1527-05
Phase I Environmental Site Assessment
All Appropriate Inquiry

March 16, 2010

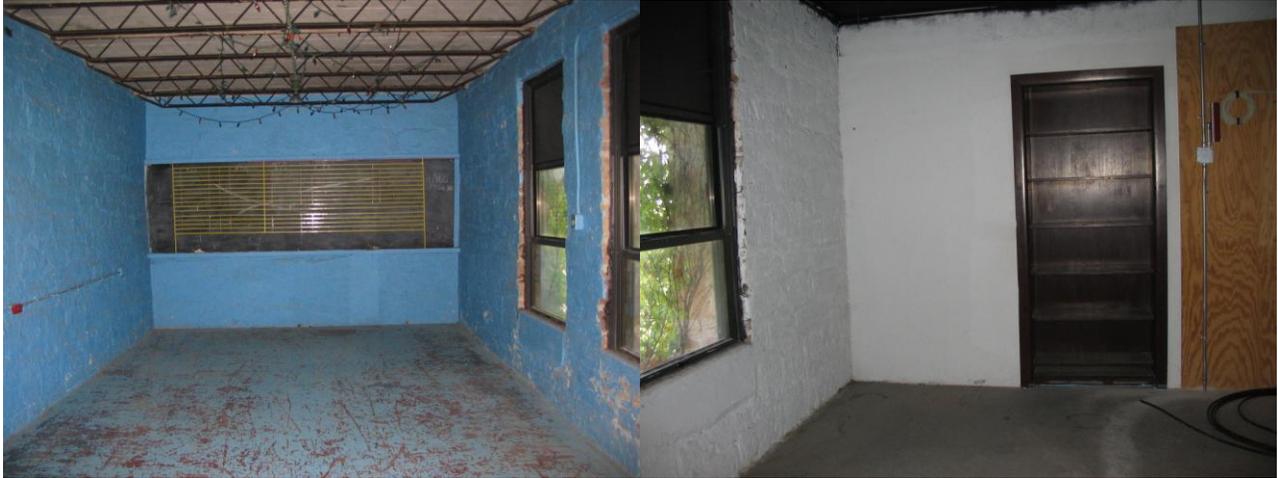
Communications storage room and office; paint peeling (Photos: KP)

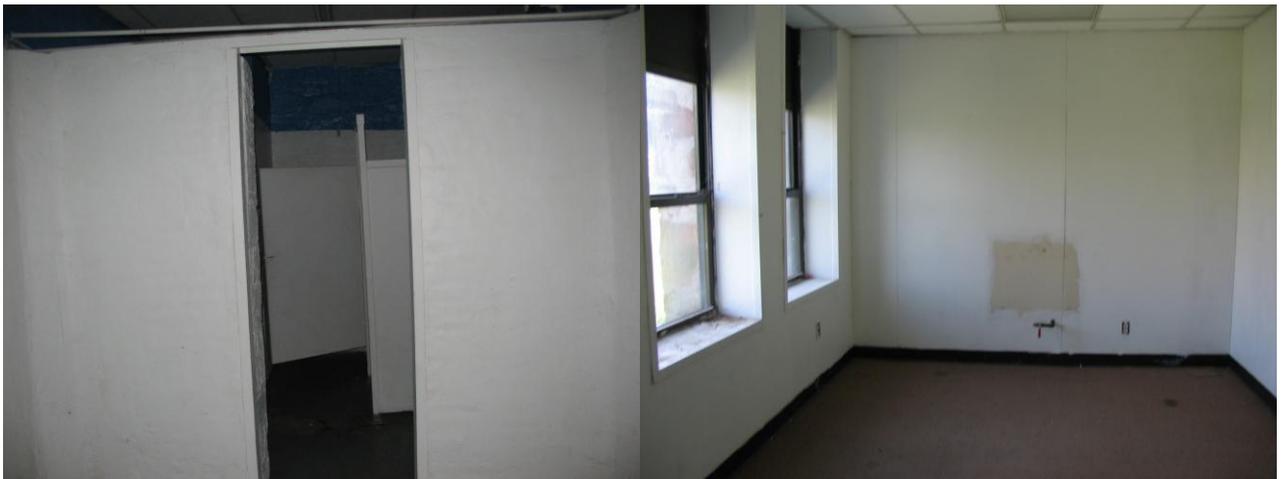
Bathroom and office with gas pipe coming out of the wall (Photos: KP)

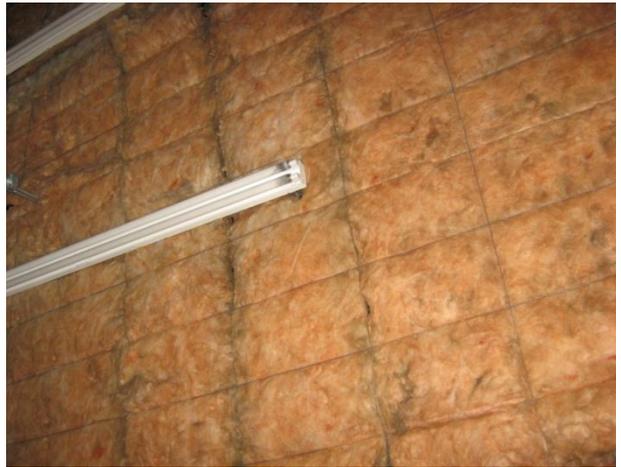
Insulation in office.

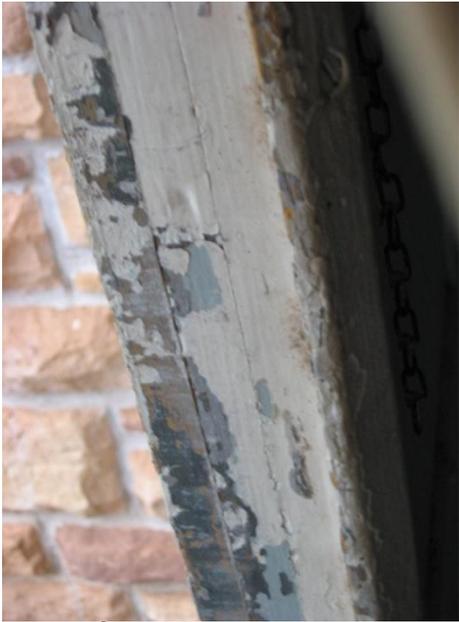
Right: Peeling paint on door frame.

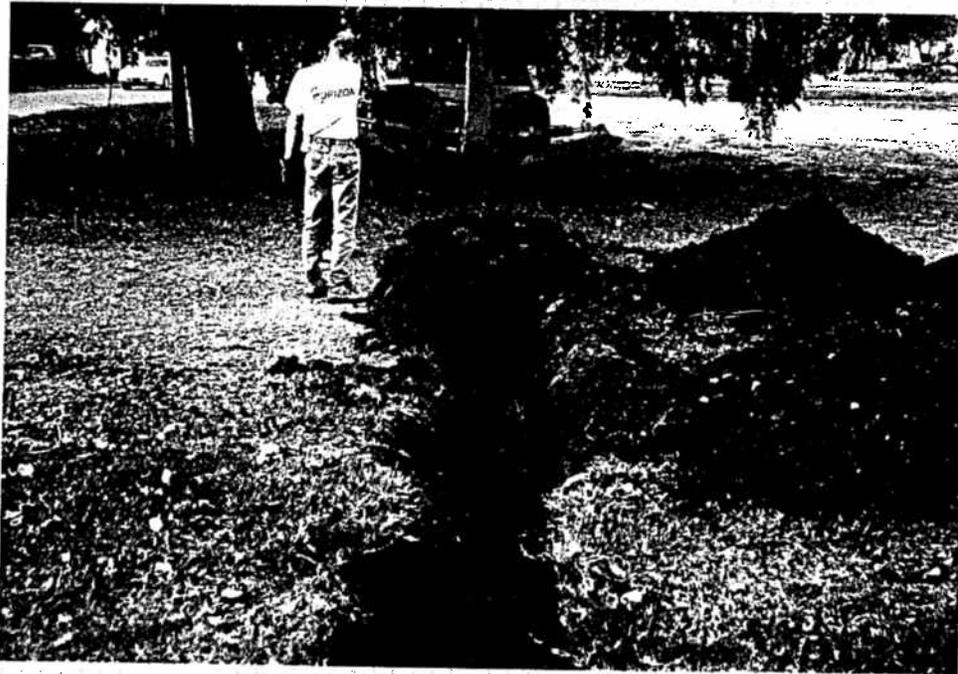
Digging up vent
line to find
UST
